TRD Pro Bumper/Fender Interference

YEAR(S)	MODEL(S)	ADDITIONAL INFORMATION
2015 - 2023	4Runner

Introduction

Some 2015 – 2023 model year TRD Pro Edition 4Runner vehicles may exhibit an abnormal noise when in Reverse with the wheels at or near full lock due to interference between the tire and bumper and/or fender liner. Follow the Repair Procedure in this bulletin to address this condition.

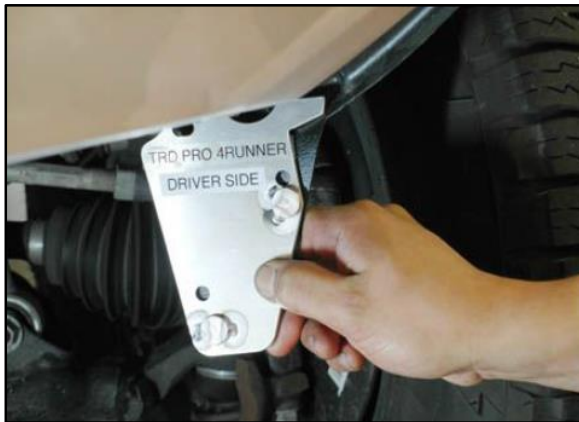
Figure 3.

5. Install the driver-side metal fender liner template (from the TRD Pro trim kit) on the front side of the fender liner.

Make sure to place the alignment pins into the two existing holes.

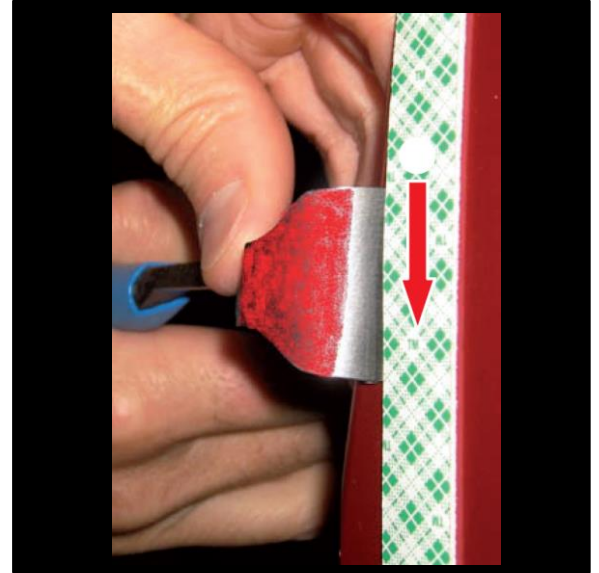
Figure 11. Top to Bottom

- Do NOT make full cuts across the face of the bumper cover.
- ONLY MAKE HALF CUTS BEFORE MOVING TO MAKE THE NEXT CUT.

Failure to make ONLY half cuts may result in uneven cuts, a wavy appearance, or bumper replacement.

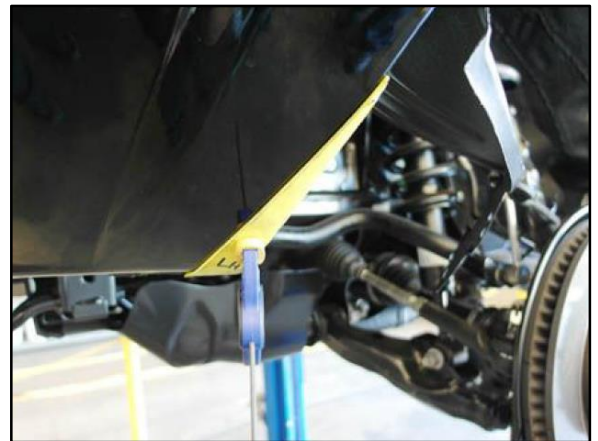
Figure 19.

- Locate the left-hand bumper template and secure it to the bumper cover with a clamp.

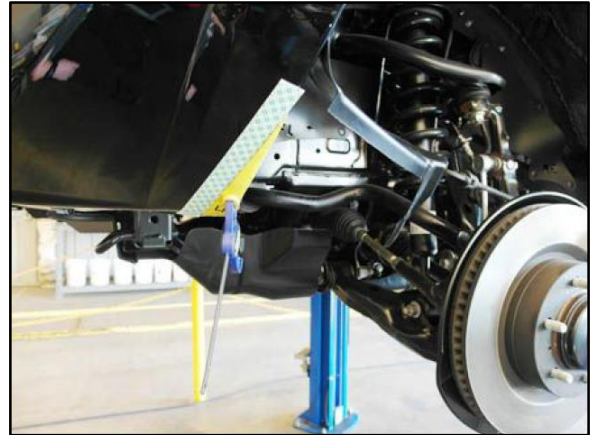
Figure 20.

4. Cut an 8-in. (203 mm) strip of double-sided foam tape and apply it to the edge of the marking template. Ensure the tape is straight and flush against the template.

- Do NOT remove the backing from the tape.
- A NEW piece of tape MUST be used when repeating this step for the opposite side.

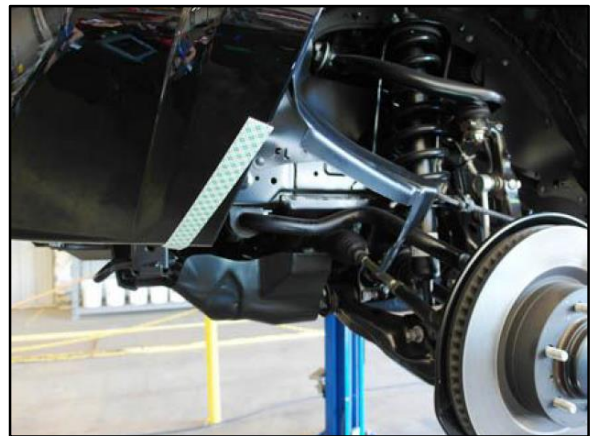
Figure 21.

5. Remove the marking template and clamp.

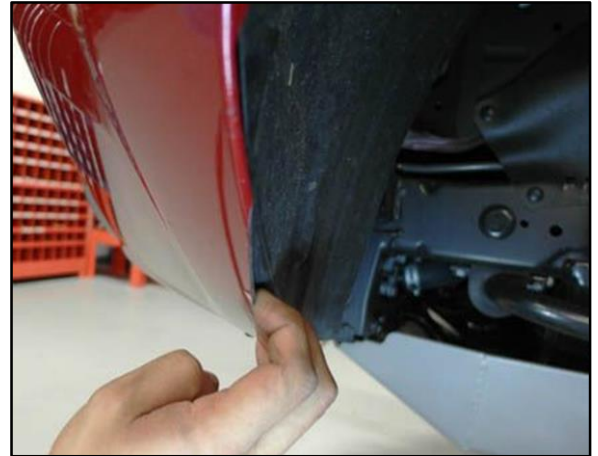
Figure 26.

13. Using your hands, verify the fender liner and bumper are flush.
