Cracking on B-Pillar Cover of Front and/or Rear Doors: Replacing B-Pillar Cover (191/23)

Model Line: **Macan (95B)**

Model Year: **As of 2022 up to 2024**

Concerns: **B-pillar cover for front and/or rear doors**

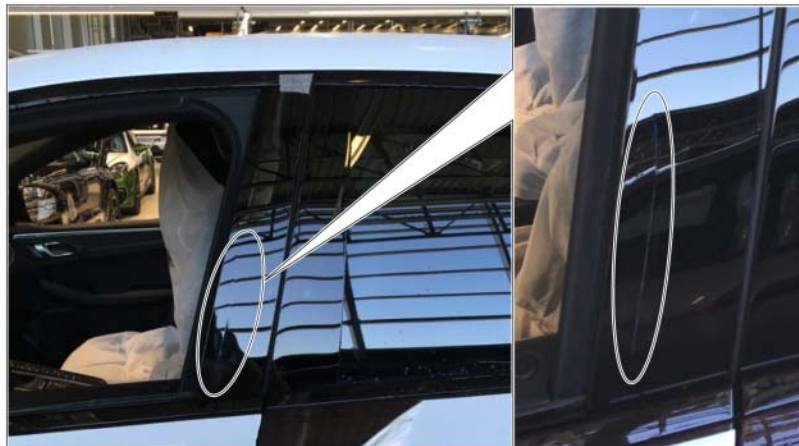
Cause: **Customers complain that one or more B-pillar covers have cracks on the front and/or rear doors of the vehicle.** ⇒ *Cracking on B-pillar cover*

Cracking on B-pillar cover

Action: The work procedure for cracking on the front and rear B-pillar covers is different:

- Replace both **front B-pillar covers on the front** doors with a **new component level**, even if the front B-pillar cover only has a crack on one door.

If the B-pillar covers on the front doors have already been replaced in the past, only the respectively damaged front B-pillar cover needs to be replaced.

- Only replace the affected rear B-pillar cover on the **rear** doors. (No new component status available)
