## Technical product information

| <b>Topic</b> | Electronic Parking Brake (EPB) functionality issues |
| <b>Brand</b> | Bentley |
| <b>Transaction No.</b> | 2062184/9 |

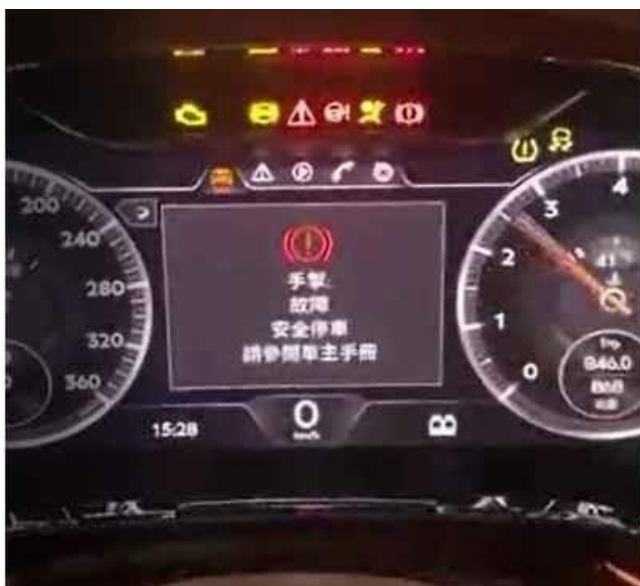
Figure 1

- Electronic Parking Brake (EPB) found not operating to specification
- EPB may not hold the car effectively
- Parking brake components showing signs of wear
- Parking brake warning light may also be evident within the DIP (See example shown in Figure 1)

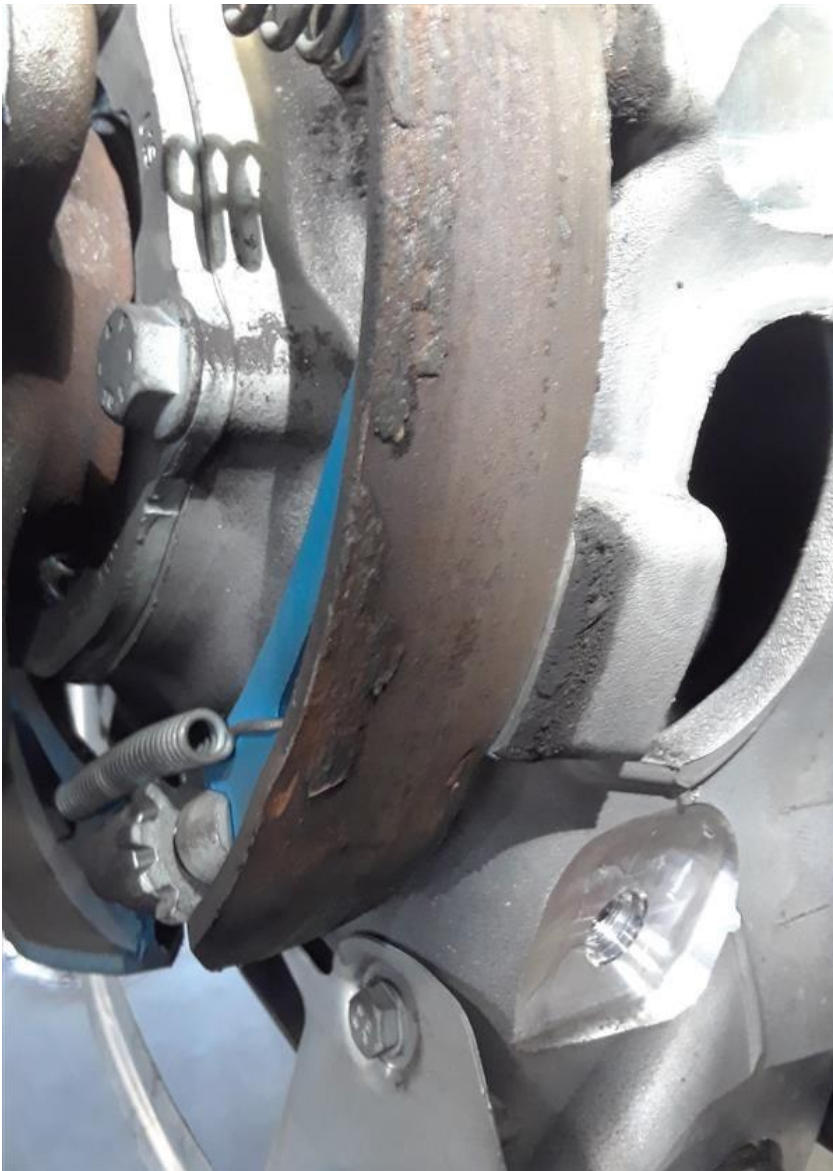
- Right and left hand (EPB) Actuators
- Right and left hand rear brake shoes (EPB) - See example shown in Figure 2

1) Carry out a full inspection of the (Electronic Parking Brake EPB) system including the following components:

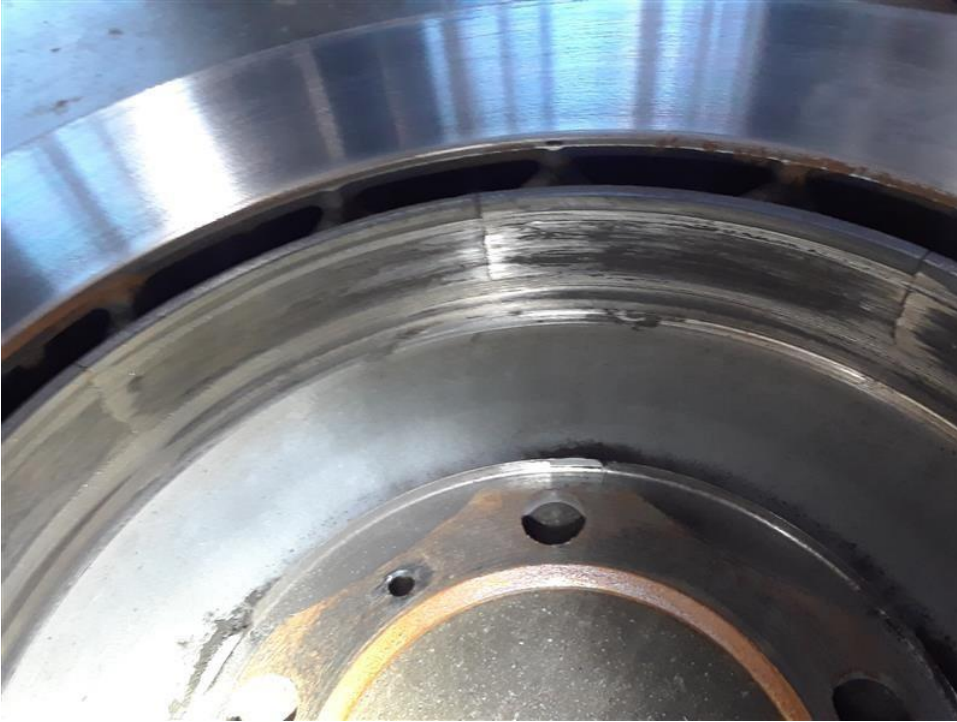
- Right and left hand rear brake discs - See example shown in Figure 3
