# PREVOST

## WARRANTY BULLETIN

### WB23-32A

| SUBJECT: | <b>HEADLAMP REPLACEMENT</b> | | |

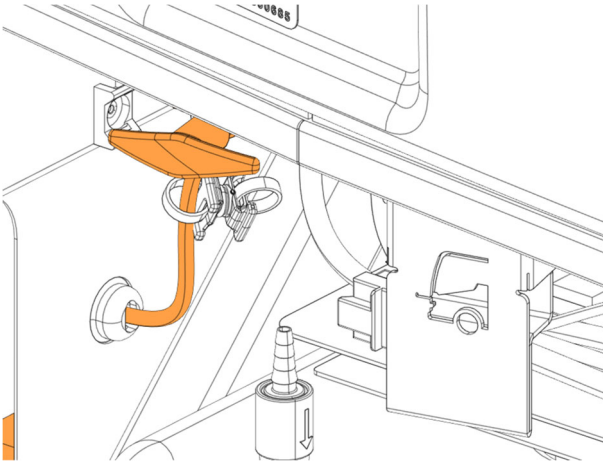
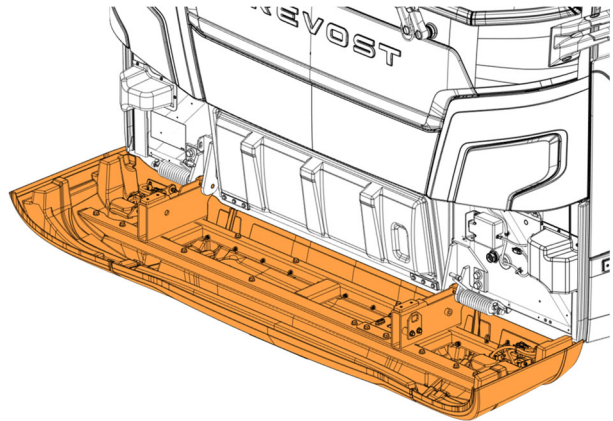
1. Open front service door and pull the handle to open spare compartment.

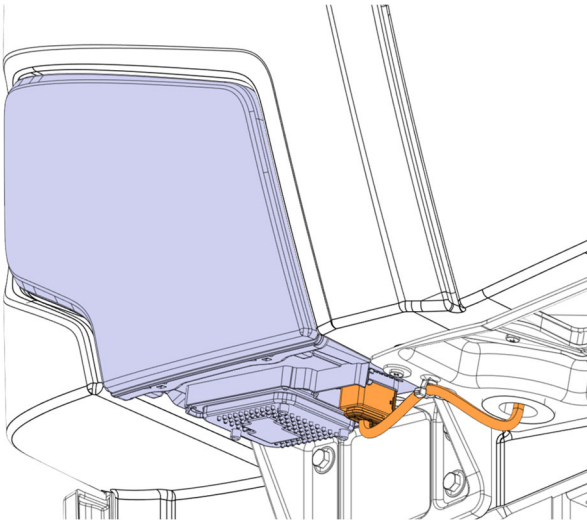
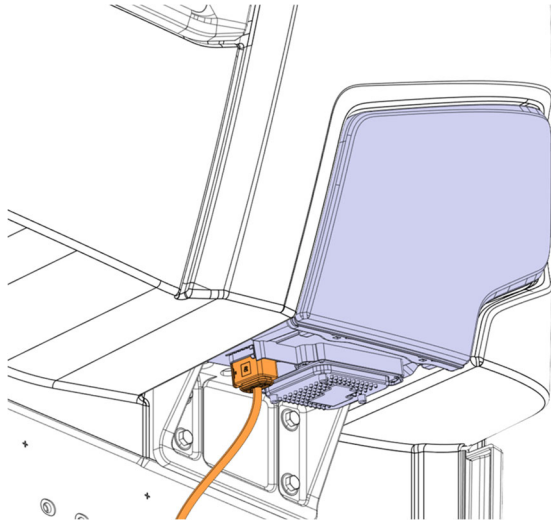
2. Unplug both headlamps.

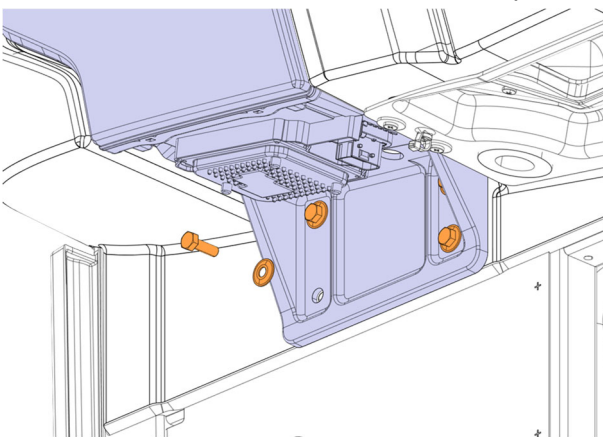
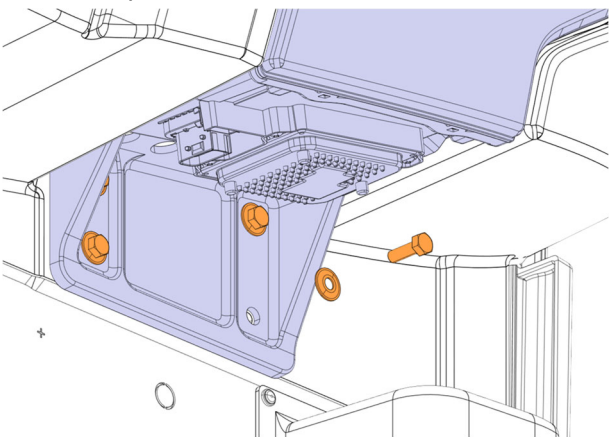
3. Unscrew bolts and washers of headlamps assemblies, keep hardware.

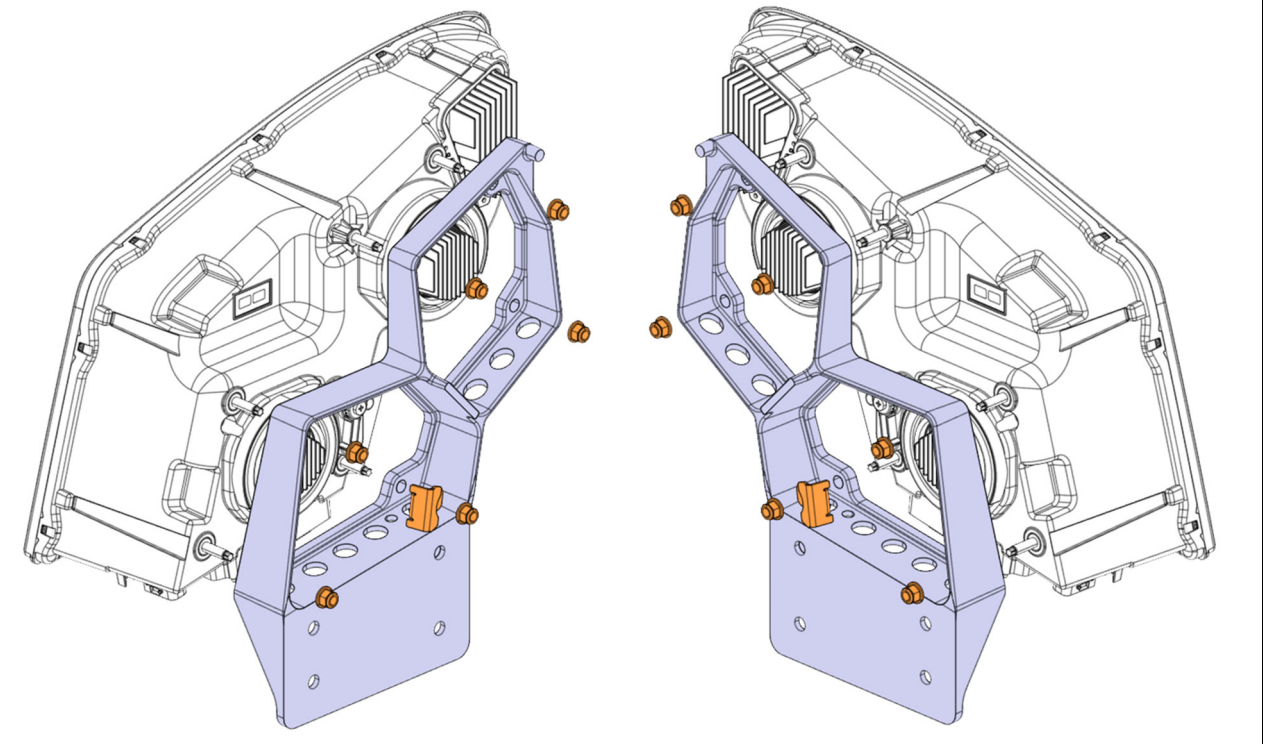
4. Unscrew nuts and keep headlamp supports, guides and nuts.

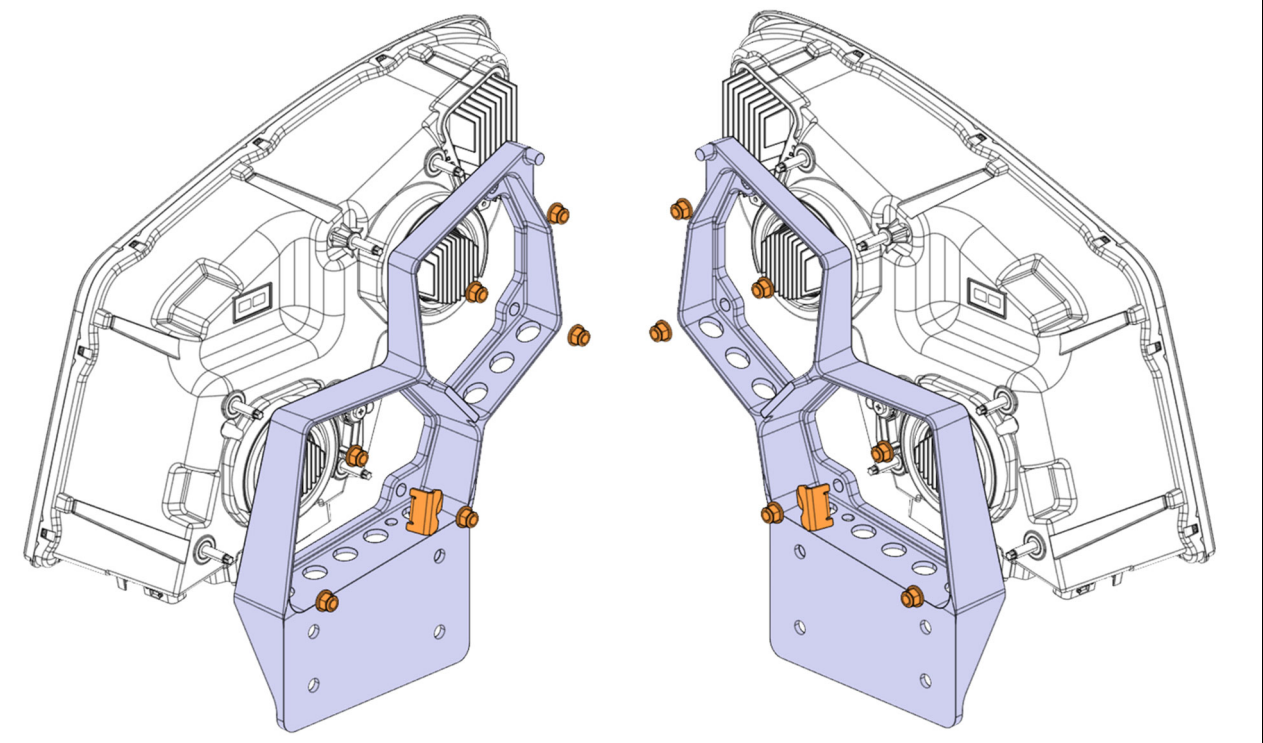
1. Reuse nuts and guides to install new headlamps on supports.

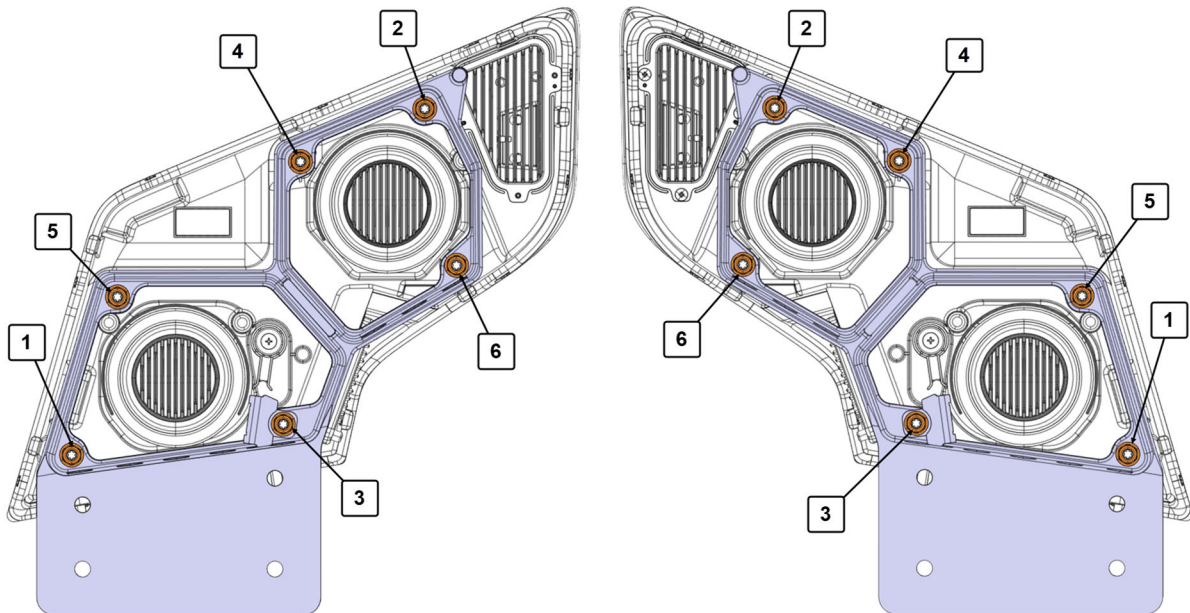
2. Perform the final tightening with a torque of 14lb-ft tightening with the sequences 1 to 6

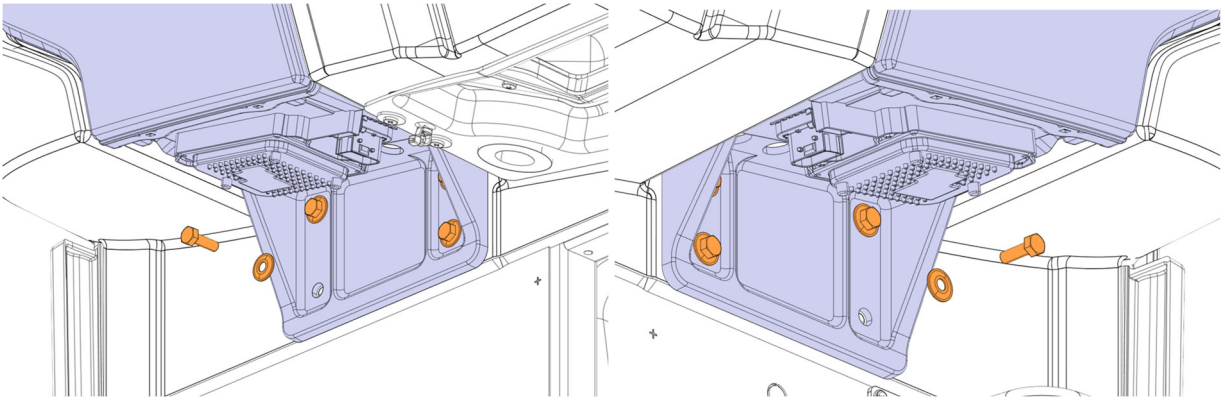
3. Reuse bolts and washers to install headlamps assemblies. Tighten so that the headlamps hold in place, the final tightening will be done after adjustment.

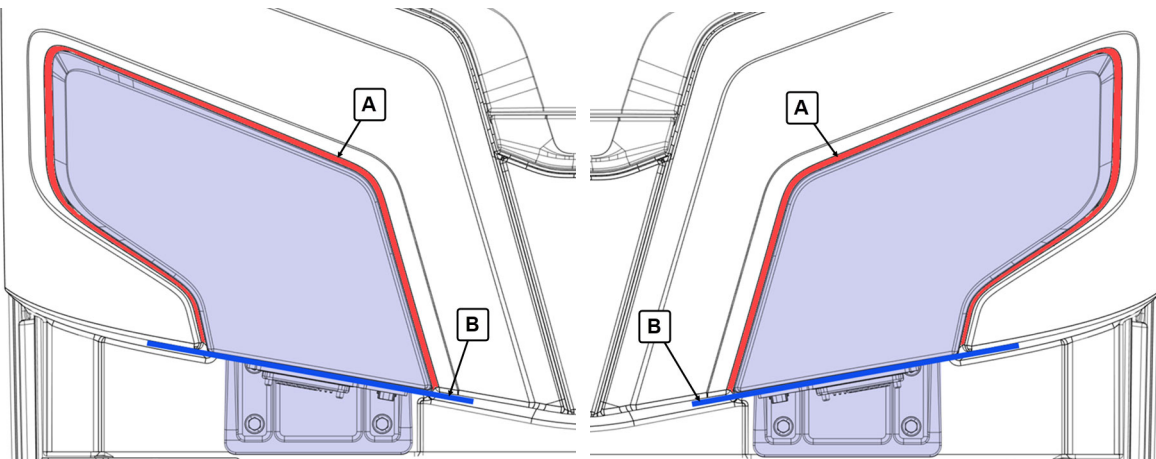
4. Headlamps adjustment with the bolts slightly tightens, center headlight in the opening to distribute the play evenly on each side.

| Reference | Value | Tolerance |
| A play | centered | $\pm 1.5$ mm |
| B straightness | 0 mm | $\pm 3$ mm |

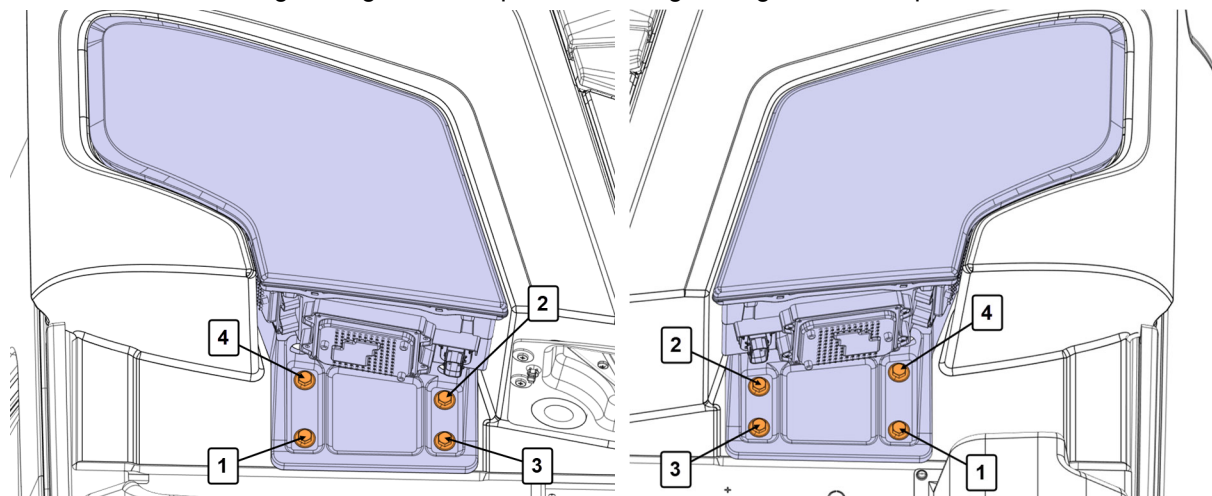
5. Perform the final tightening with a torque of 14lb-ft tightening with the sequences 1 to 4

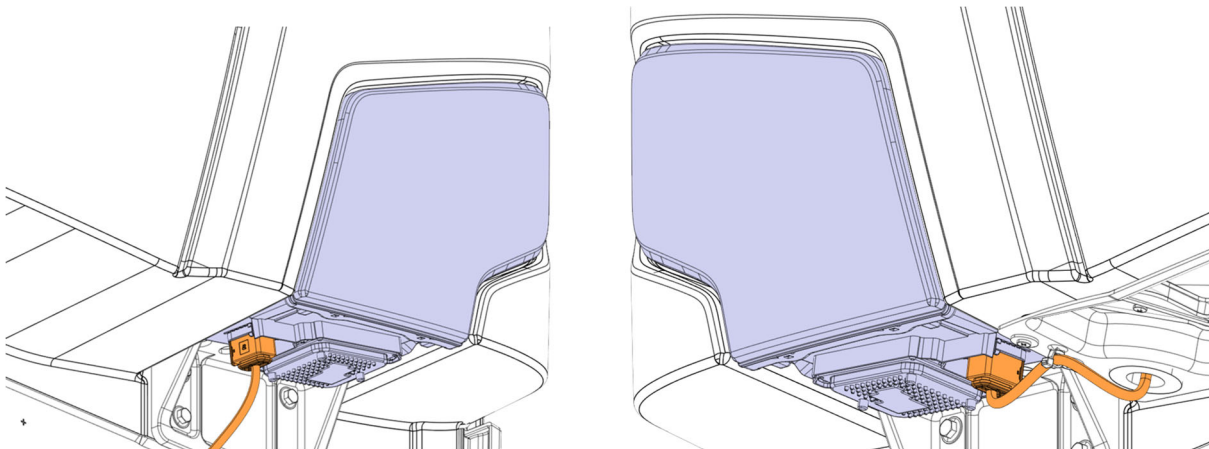
6. Plug both headlamps.
