HEADLAMP WASHER NOZZLES LEAK FLUID WHEN NOT IN USE

Defender

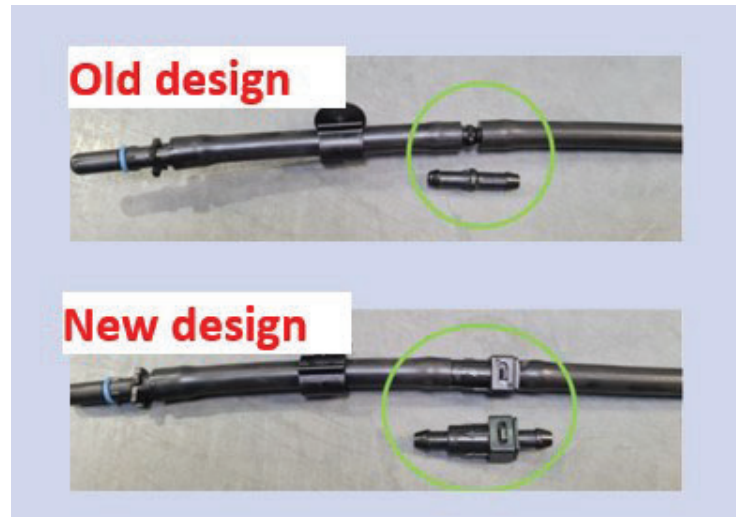
- The headlamp washer nozzles seep fluid when not in use and leave residue on the bezels.

- This may be caused by a headlamp washer nozzle check valve that is not sealing fully.

- A change to the check valve design has been introduced to robustly address this concern.
- Guided flows have been published on TOPIx Cloud to provide repair guidance.
- The check valves are only serviced as a complete washer hose assembly.
- The procedure for replacing the headlamp washer hoses is published in the **Workshop Manual Section: 501-16: Wiper and Washer > Removal and Installation > Headlamp Washer Fluid Hose.**
