| | | <b>Tesla, Inc.</b><br>Service Bulletin | | <b><i>Inspect Contactor DC Link Busbar Bolts</i></b> |
| <b>SB-20-16-003</b><br>December 28, 2023 | | <b>R1</b> | | |

Certain Model 3 high voltage batteries may not have a sufficient quantity of bolts for the contactor DC link busbars, which may prevent the vehicle from charging or powering properly.

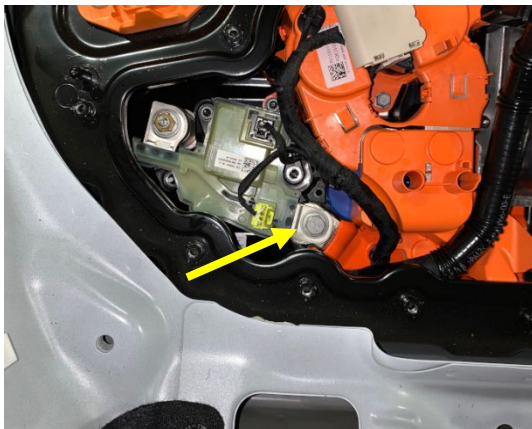
**Figure 1 — Negative DC link busbar bolt present**

5. Inspect the negative contactor for the negative DC link busbar bolt, and the positive contactor for the positive DC link busbar bolt (Figures 1 and 2).
- If both bolts are present, skip to step 13.
  - If any bolt is missing (Figures 3 and 4), take very close up photos of the contactor and DC link busbar joint where the bolts are missing, and then upload the photos to the Repair Order. Continue to the next step.

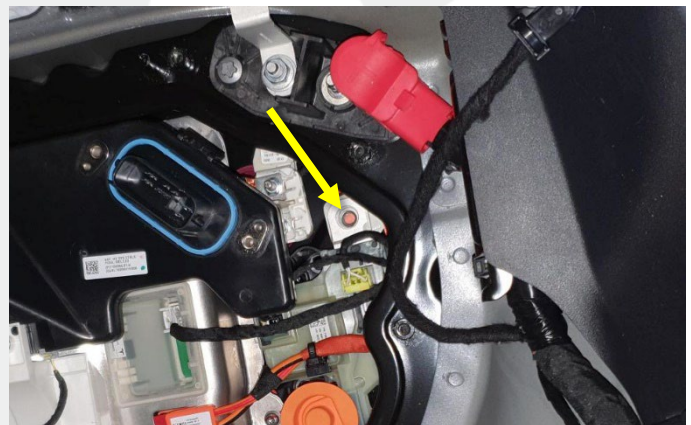
**Figure 4 — Positive DC link busbar bolt missing**

8. Remove the pyrotechnic battery disconnect (refer to Service Manual procedure [16300002](#)).
9. Install a new bolt where one is missing from a contactor DC link busbar joint, and then mark the bolt with a paint pen after it is torqued (torque 9 Nm).
