GROUP	MODEL
	Emissions Service Campaign	2023MY Sportage (NQ5a) w/2.5L GDI
	NUMBER	DATE
	SC285	January 2024

VOLUNTARY EMISSIONS SERVICE CAMPAIGN

VEHICLE EMISSION CONTROL INFORMATION (VECI) LABEL REPLACEMENT (SC285)

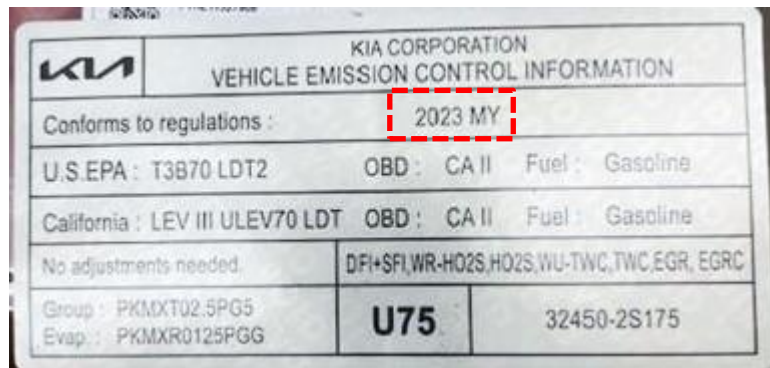
Updated VECI Label

This bulletin provides information to replace the Vehicle Emission Control Information (VECI) label on certain 2023MY Sportage (NQ5a) vehicles with 2.5L GDI engines produced from July 10, 2023 through July 19, 2023. An incorrect VECI label was installed during production of these vehicles. The VECI label is extremely important when performing maintenance, emissions inspection, or ordering engine and engine management related parts. It also contains the code that tells a testing facility which test to perform to ensure the vehicle is tested to the correct emission standard. The U.S. Environmental Protection Agency and California Air Resources Board consider the under hood VECI label an integral part of state emission testing. If the VECI label is incorrect, the vehicle may fail the emission testing, even if it meets applicable emissions standards. Follow the procedure outlined in this publication to affix the correct VECI label. Before conducting the procedure, verify that the vehicle is included in the list of affected VINs.

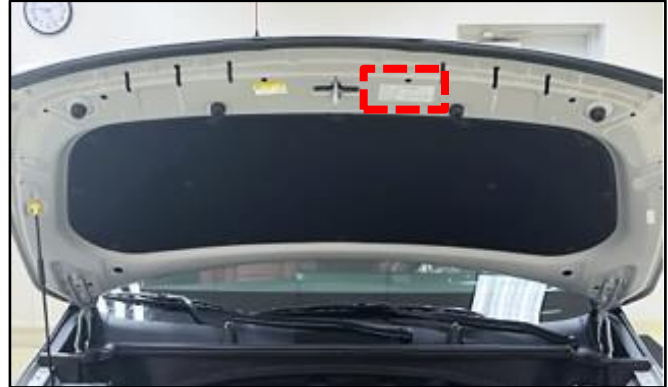
Model	Incorrect VECI Label	New VECI Label
NQ5a

- Open the hood and locate the existing Vehicle Emission Control Information (VECI) label.
 - If the vehicle has the correct **23MY (OK)** VECI label shown below, then dealer may close the campaign.
 - If the vehicle has the incorrect **24MY (NG)** VECI label shown below, proceed to step 2.

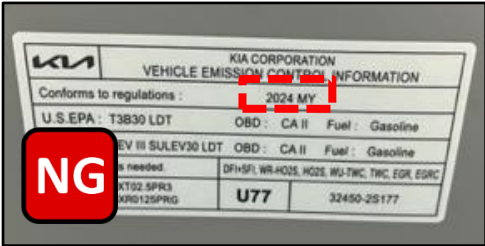
<p style="text-align: center;">INCORRECT Model Year: 2024 MY PN: 32450 2S177 (U77)</p>

- Clean the surface of the incorrect VECI label with an alcohol wipe or an equivalent cleaner.

Failure to clean the surface from debris or grease will prevent the new VECI label from adhering properly. Use a clean cloth to wipe the surface dry.

- Carefully affix the new provided VECI label over the old VECI label, ensuring complete coverage of the old label with the new one.

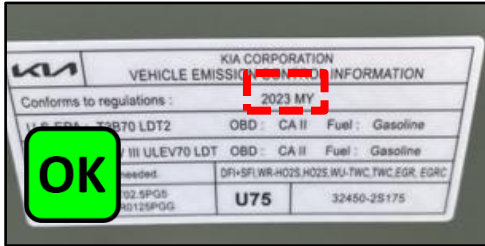
<p style="text-align: center;">CORRECT Model Year: 2023 MY PN: 32450 2S175 (U75)</p>
