SIB 01 08 18

I01 (I3) DRIVER'S SIDE FRT AIR BAG MODULE EXT LTD WTY (ELW) 10 YRS/120,000 MILES

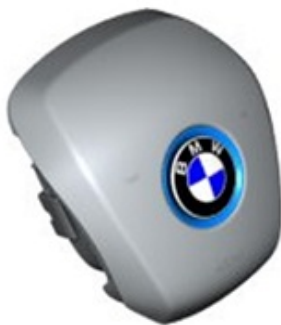
GRUSB0117-26

For the eligible vehicles and for the issue described below, BMW of North America, LLC (BMW NA) is extending the limited warranty for the vehicle's **Driver's Side Front Air Bag Module (show)** to:

If a vehicle listed above arrives at your center with the issue described above, perform the corresponding diagnosis and when applicable, replace the driver's air bag module as instructed or as determined by the diagnosis.
