## Battery Electric Vehicle (BEV) 3-Way Valve Calibration Failure

Published 1/23/2024

Mack LR-E

Volvo VNR-E

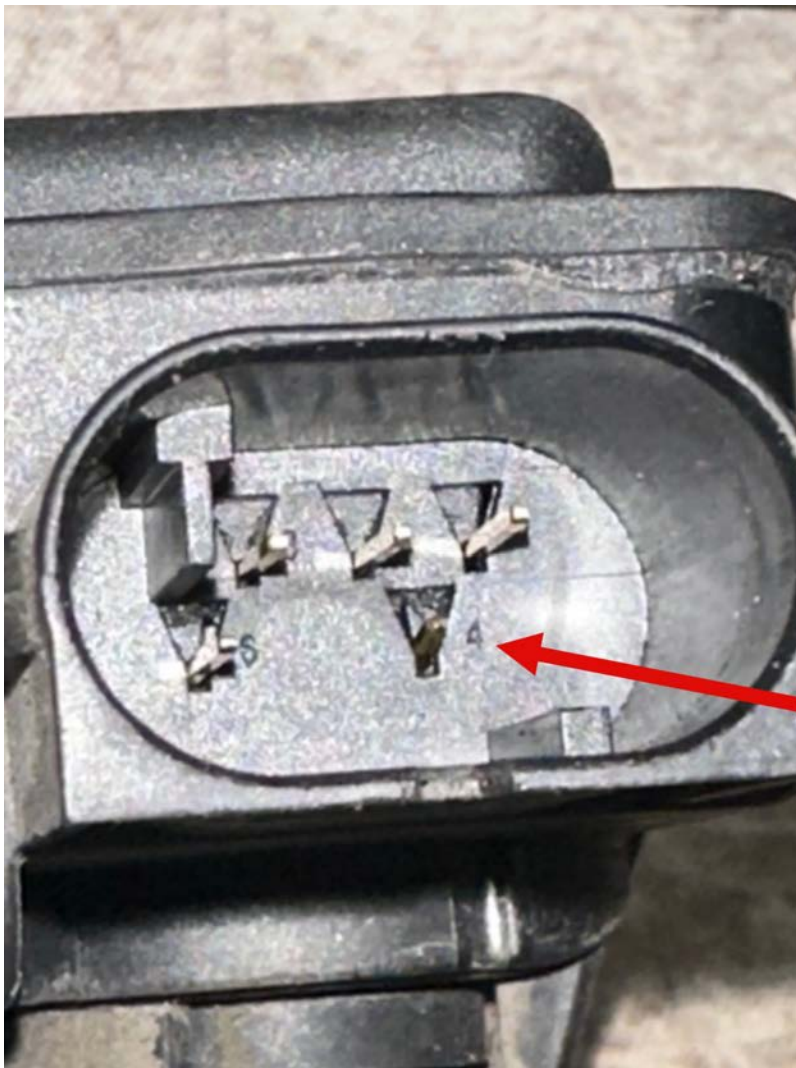
It may be possible for the BEV 3-way valve to fail the calibration procedure, this could be due to broken pin #4 in the connector.

1. Unclip the harness from the 3-way valve connector.
2. Inspect pins.

If broken pins are found replace the 3-way valve and recalibrate the valve.

**NOTE:** The connector needs to be inserted straight into the mating connector paying close attention not to angle it upwards.
