**Document ID:** IK0800664  
**Revision:** 1  
**Created:** 12/11/2023  
**Last Modified:** 1/10/2024  
**Author:** Anthony Tondola

**Title:** LT/RH Aftertreatment PDM F2 Fuse Falling Out or Cracking

**Applies To:** LT/RH

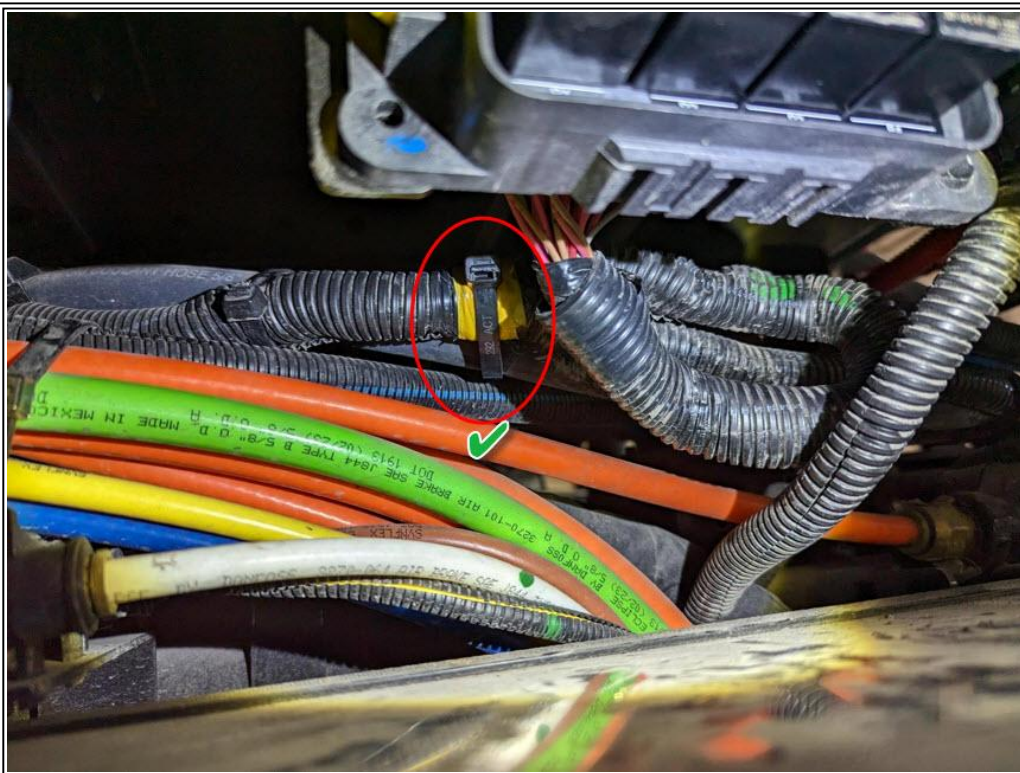
Figure 3: New Harness Securement Location

1. Cut any tie straps that secure the aftertreatment PDM harness within 10 inches of the back of the PDM. (Figure 2)
2. Install a new tie strap around the main trunk of the harness, while ensuring there is 8-10 inches of unsecured harness from the back of the PDM. (Figure 3)
  - The section of unsecured harness allows for cab suspension travel, without stressing the the AFT PDM fuses and terminals

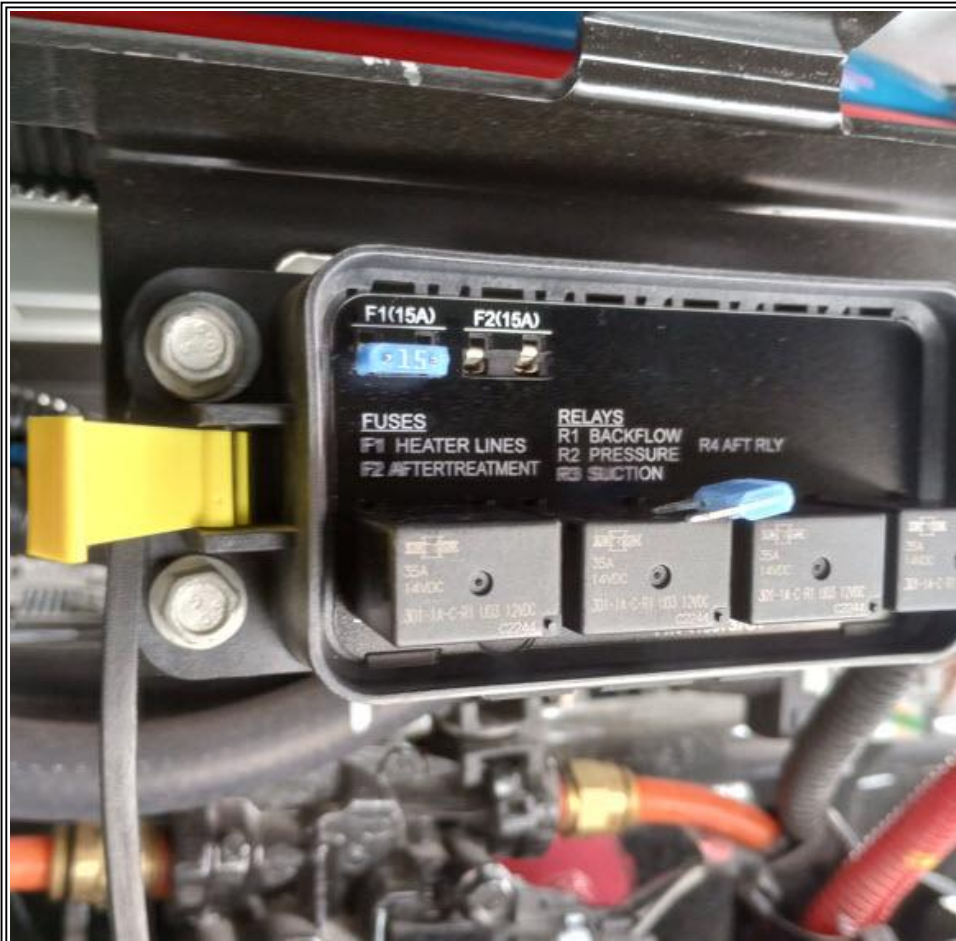
- The fuse falling out is most commonly caused by excess vibrations. (Figure 4)

**Figure 4: F2 Aftertreatment Fuse Loose in PDM Cover**

- 1.) Verify proper harness routing per repair steps for "Fuse Cracking without a circuit fault."
- 2.) Check for any engine performance issues that would cause excess 3rd order engine vibrations
  - 3rd order engine vibrations cause a "tuning fork" effect through the PDM support bracket, which can shake the fuses out of their terminals
- 3.) Make a foam block that fits inside the PDM cover that will prevent the fuse from falling out. (Figure 5)
  - This foam block needs to apply slight downward pressure on the fuses only, avoiding the relays.

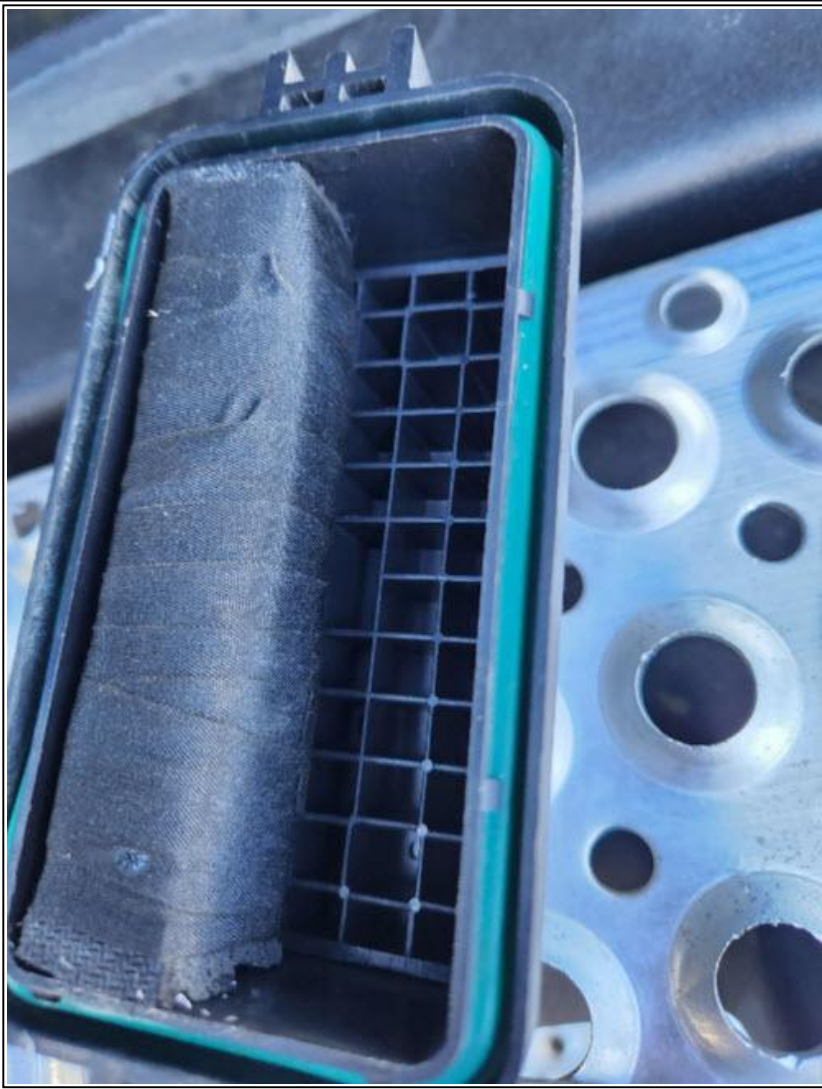
Figure 5: Foam Block Installed in PDM Cover

The foam block will need to be sourced and made locally. A service part is not available at this time.
