Cayenne Forward Roof Console Rattles

Models	Model Year	Model Type	VIN Range	Vehicle-Specific Equipment
Cayenne	As of 2019 up to 2024	9YA, 9YB	N/A	N/A

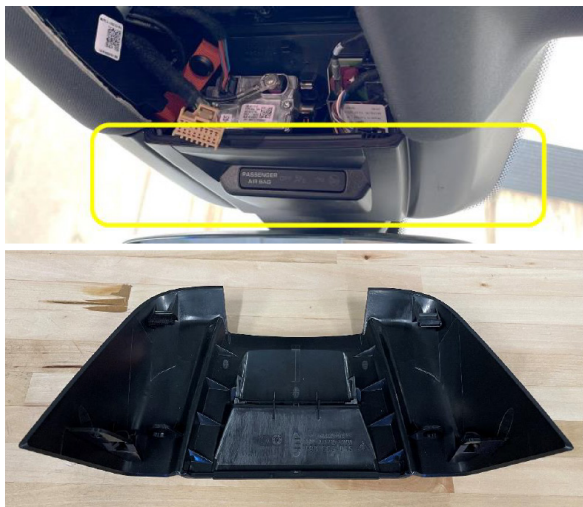
Figure 1

Loose contact between the Rear View Mirror Inner Cover and the mounting clips will rattle when the vehicle travels over certain surfaces. Analysis found this to be more likely the case of the rattling as opposed to the overhead roof console unit itself. Steps should be taken to reduce rattle using felt tape.

Please install felt tape upon the surfaces highlighted in yellow on the Rear View Mirror Inner Cover and both of the gray plugs in the images below (Part # 9AY00698800 and 9Y3863081). Be sure to reinstall the gray plugs very firmly on their respective pins.
