**992 Windshield Seal Melting/Deteriorating**

**Vehicles Affected**

Models	Model Year	Model Type	VIN Range	Vehicle-Specific Equipment
911	As of 2020 up to 2023	992	N/A	All except VW4 Lightweight Glass

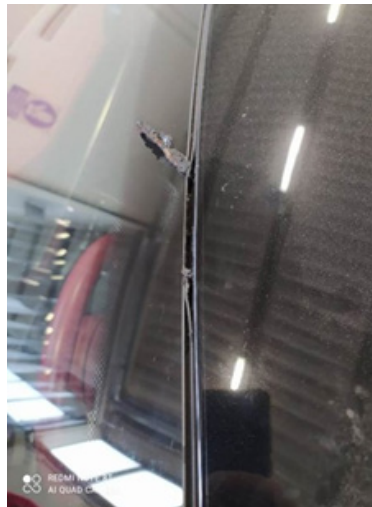
Figure 1

The observed condition can be the result of a material incompatibility between the windshield seal material and the adhesive used for fixing the windshield. When these two substances come into contact, a chemical reaction occurs, forming a melted and sticky appearance of the windshield seal. It is important to note that extended exposure to sunlight can make this condition worse.

The service recommendation is to replace the **affected** windshield(s) with one of the following new part numbers:

Part	Part Number
Front Windshield Glass	992.845.011.AN
Rear Windshield Glass	992.845.047.DY

Reference WM 641219 "Removing and Installing Windscreen" and/or WM 648619 "Removing and installing rear window".
