Preliminary Information

PIP5958 Information On PICO Recording For CVT Transmissions With Noise Concerns

Involved Region or Country	North America
Condition	Whine noise from the transmission while driving
Cause	Internal transmission noise

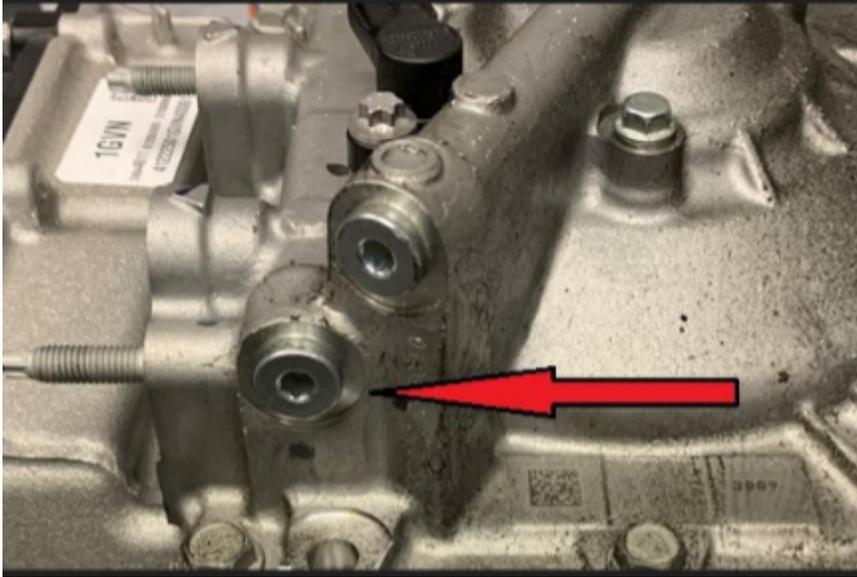
1. Place the PicoScope sensor on the plug located on the left side of the transmission, at the base of the unit. This plug is used as a pressure tap for the pulley assembly. The sensor cable can be run into the passenger compartment with the hood closed

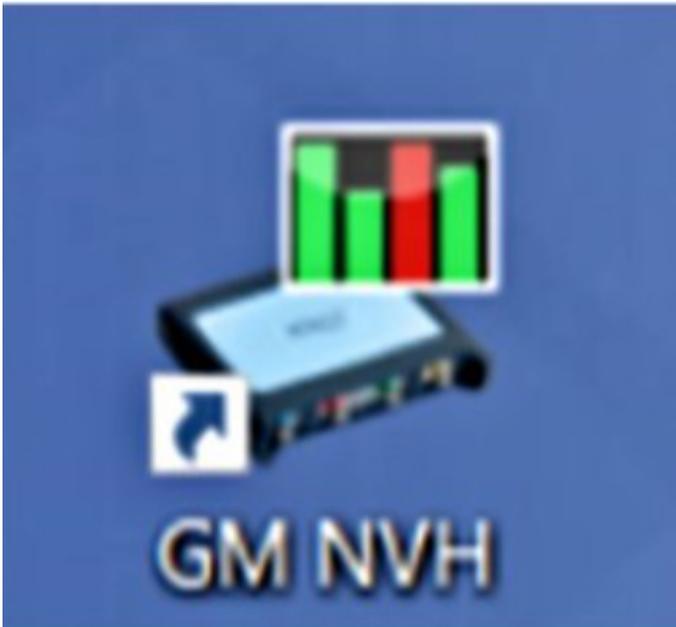
2. Open the most current version of GM NVH

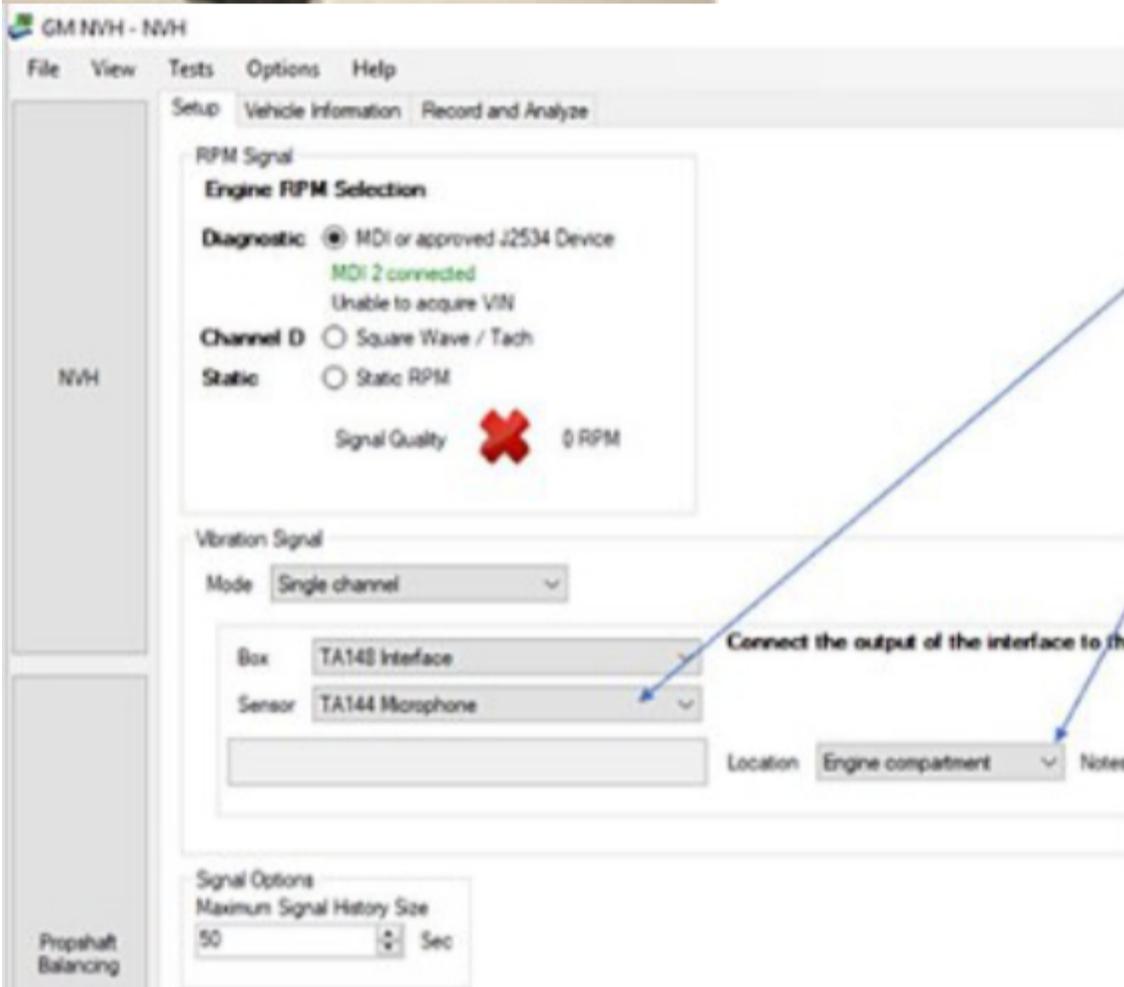
3. After completing the wizard, go back into the setup tab under Vibration Signal and select Single Channel. Select TA148 Interface in the "Box" dropdown and TA144 **Microphone** for the "Sensor" Drop down. Select the Location as Engine Compartment. Also under the Vehicle Information tab set the correct tire size and the proper final drive ratio. For Malibu Final Drive Ratio is 5.10 and For the Trailblazer and Encore GX the final Drive Ratio is 5.44

Note: If using 3 axis, use center channel only and set up as single axis.

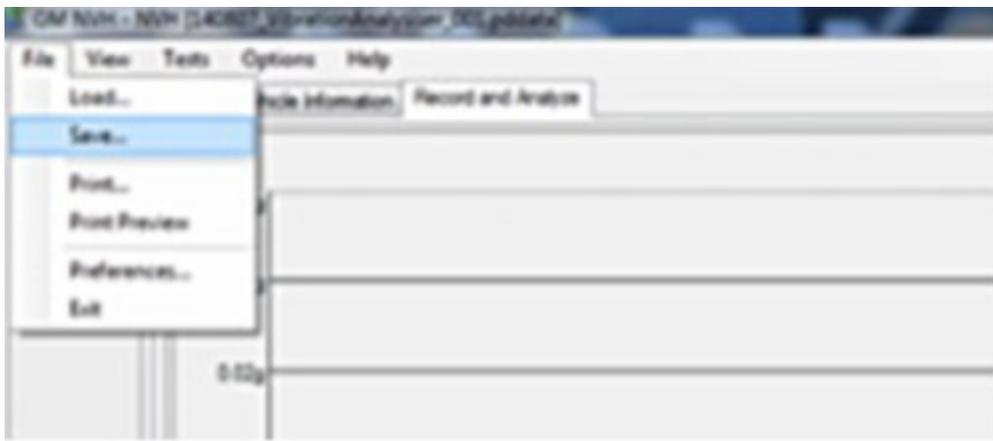
4. Drive the vehicle to verify the condition. Once the condition is present please bookmark the beginning of the noise/vibration and maintain the noise to obtain a good recording .
5. While the reviewed data is still on the screen, click file save. It should be formatted as .pddata

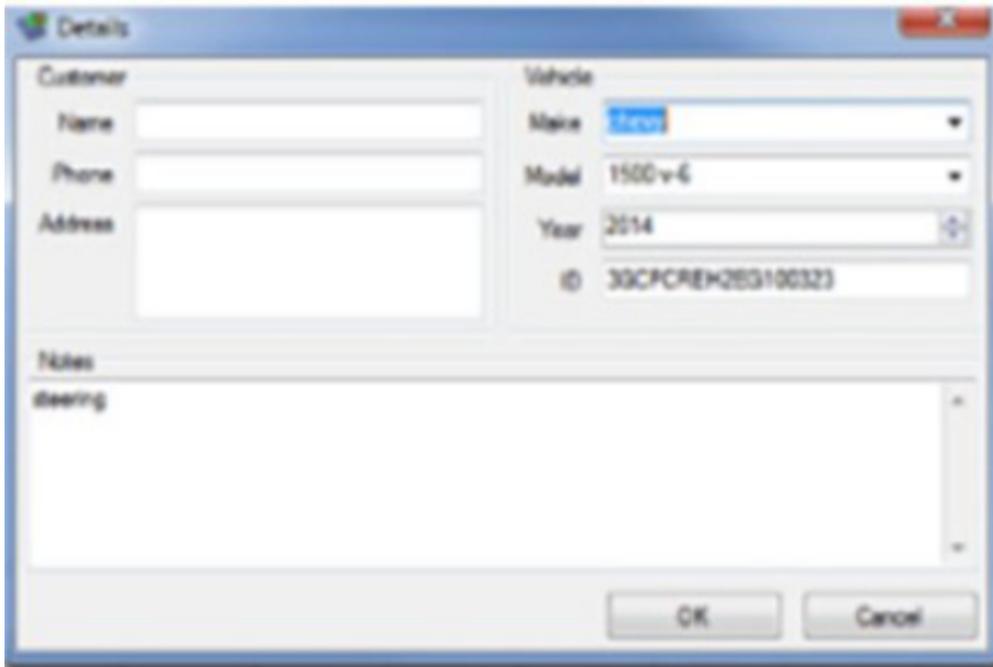
- The next box allows you to save the vehicle information as well as customer information and notes in the Notes box. This could be sensor location, sensor direction and even road surface name, etc. Click Ok when you are done adding information.
