# Technical product information

<b>Topic</b>	Rear Seat Entertainment screens are not working
<b>Market area</b>	Australia E04 Bentley rest Asia and Australia (6E04),China 723 Volkswagen (Anhui) Automotive CO (6723),China 796 VW Import Comp. Ltd (Vico), Beijing (6796),Germany E02 Bentley rest Europe (6E02),Japan E03 Bentley Japan (6E03),Korea, (South) E08 Bentley South Korea (6E08),United Arab Emirates E06 Bentley Middle East and Africa (6E06),United Kingdom E01 Bentley UK (6E01),United States E05 Bentley USA and rest America (6E05)
<b>Brand</b>	Bentley
<b>Transaction No.</b>	2069686/2
<b>Level</b>	EH
<b>Status</b>	Approval
<b>Release date</b>

Rear Seat Entertainment screens are not working

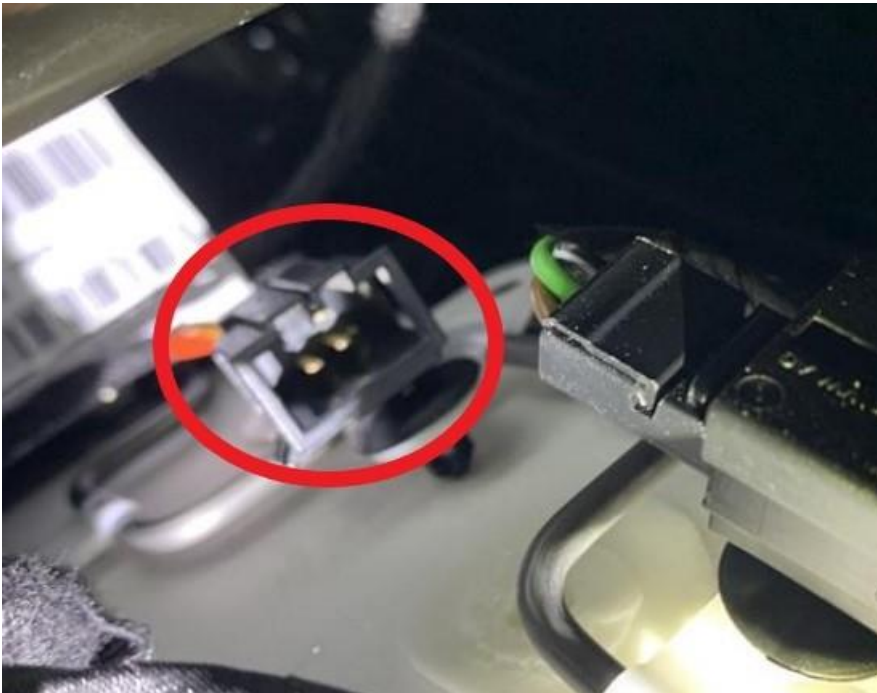
1) Referring to Figure 1 check the following:

- Check to confirm if the link harness is connected into the plug (For clarity the harness is not connected in the example shown)

2) In the event the harness is not fitted and the issue is still evident - Conduct the harness fit process from Step 3

In the event the harnesses are fitted but not connected - Connect the harnesses and check the operation of the rear screens

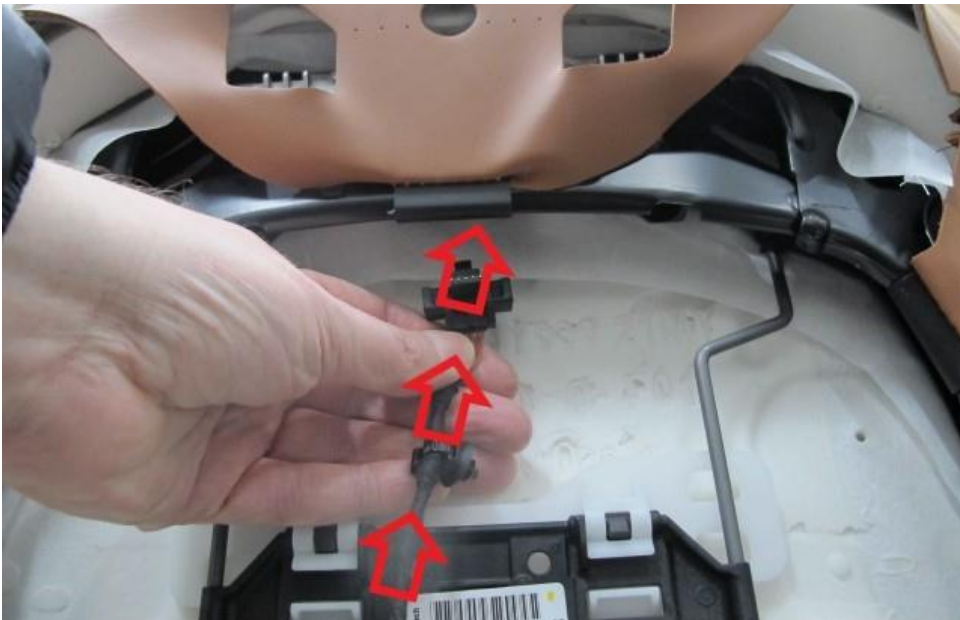
5) Referring to Figure 4 - Insert the 5 pin upper plug upwards towards the upper connection as shown (in between the squab and seat frame)

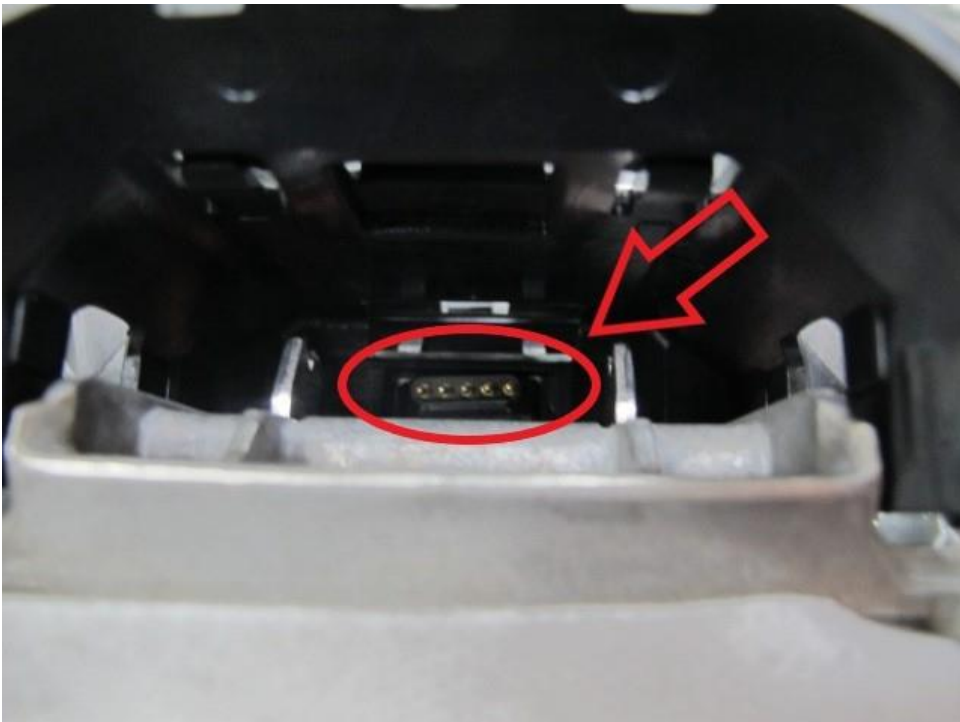
- Referring to Figure 6 - Once correctly fitted the upper RSE connection will be as shown

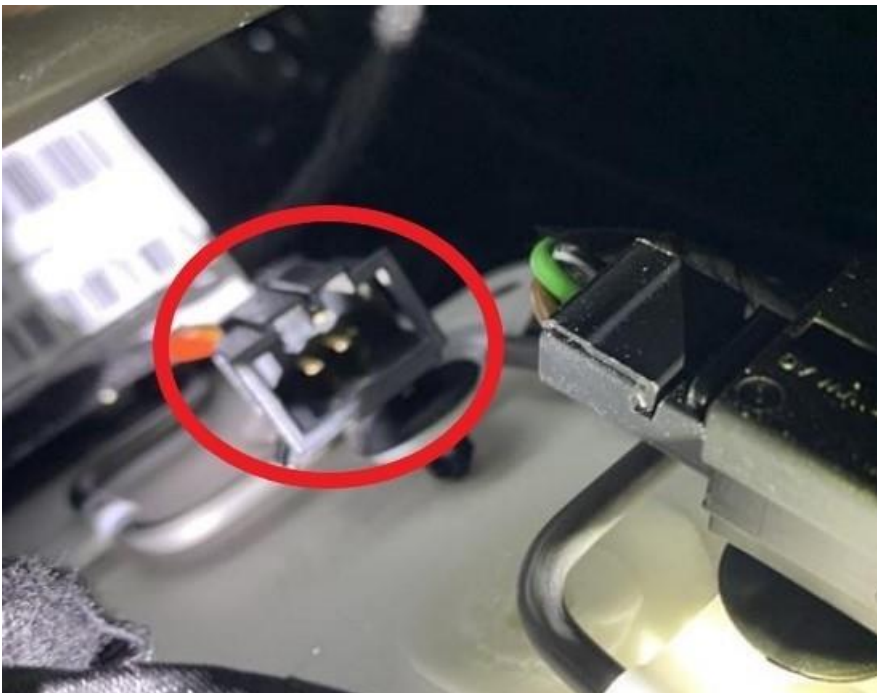
Figure 10

9) Locate the unpopulated plug on the underside of the seat cushion (Figure 10)

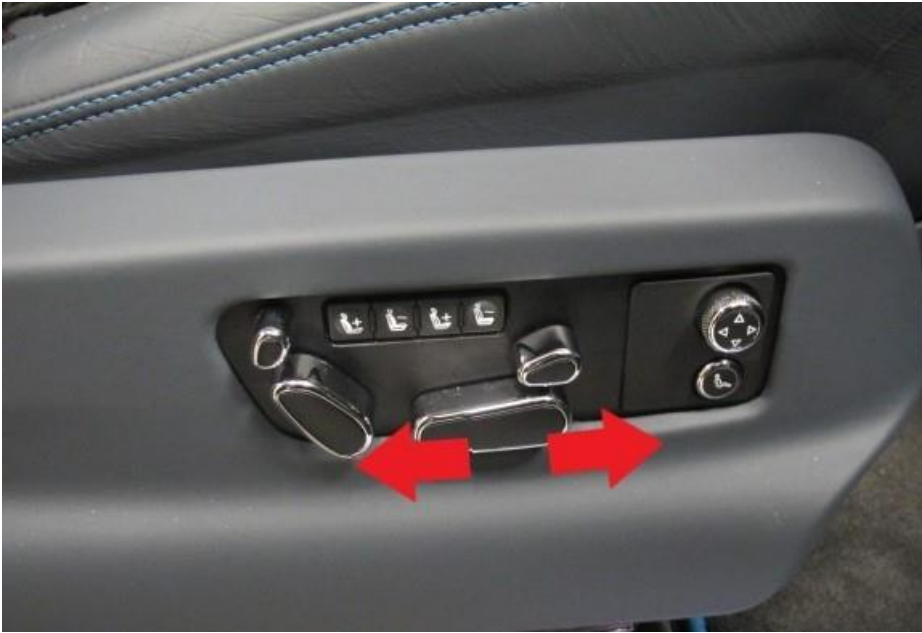
12) Referring to Figure 13 - Operate the seat forwards and rearwards whilst checking to confirm the harness is not being stretched or loosened/damaged during the operation

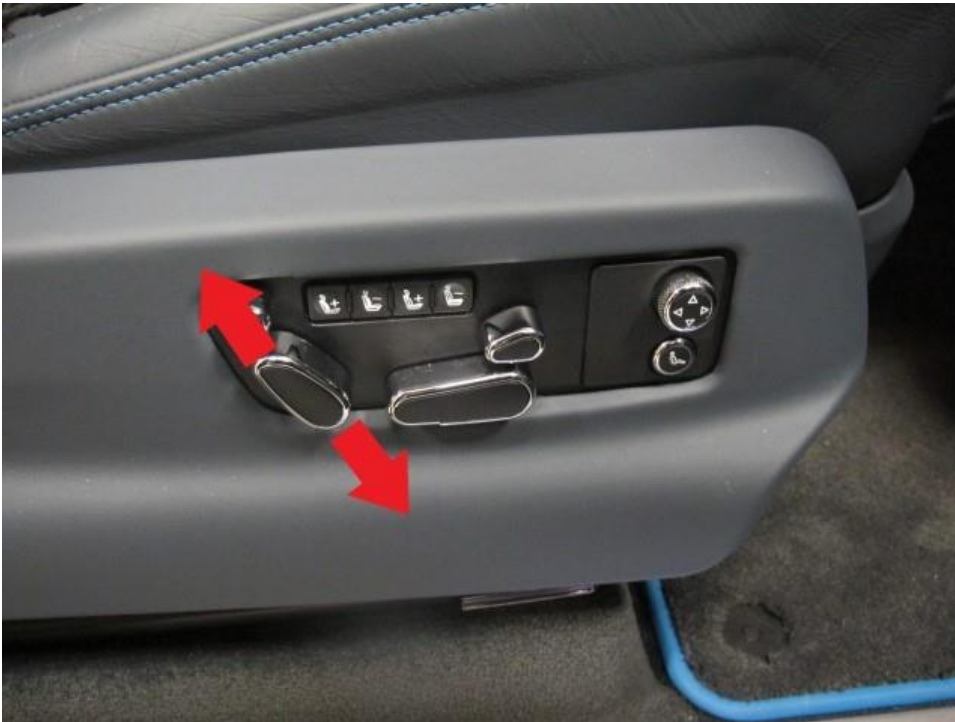
13) Referring to Figure 14 - Operate the seat up and down whilst checking to confirm the harness is not being stretched or manipulated during the operation

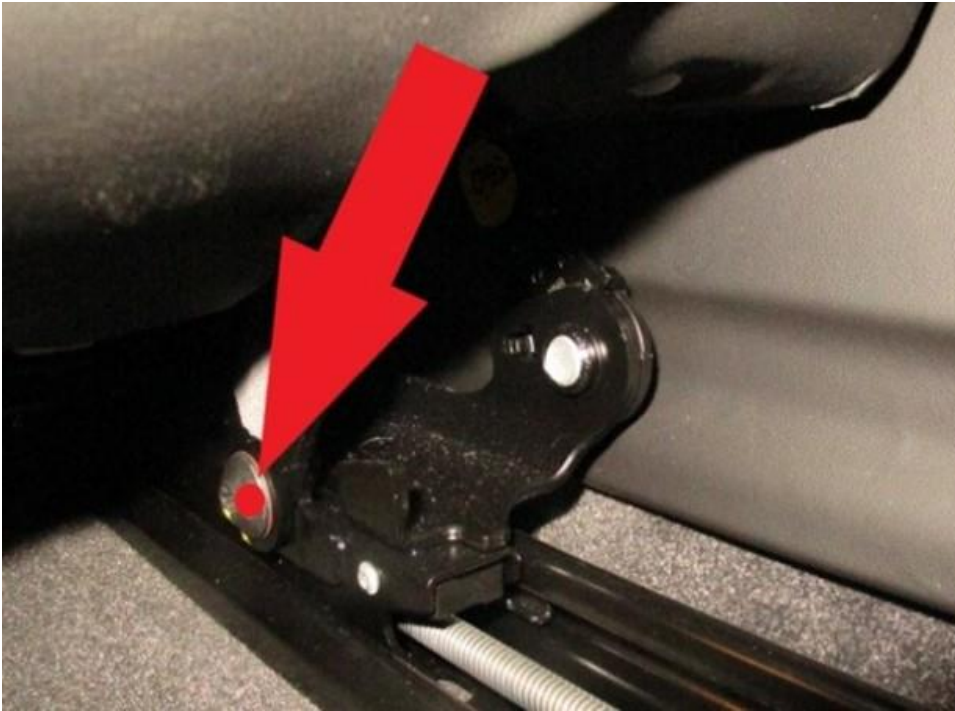
17) Referring to Figure 15 - Apply a white paint completion mark on the left hand front seat outer rail
