# Service Bulletin

Bulletin No.: 24-NA-019  
Date: February, 2024

Subject:     Roof Rail Gap

| Brand: | Model: | Model Year: | | VIN: | | Engine: | Transmission: |
|---|---|---|---|---|---|---|---|
| BrightDrop | Zevo 400 | 2024 | 2024 | - | - | All | All |

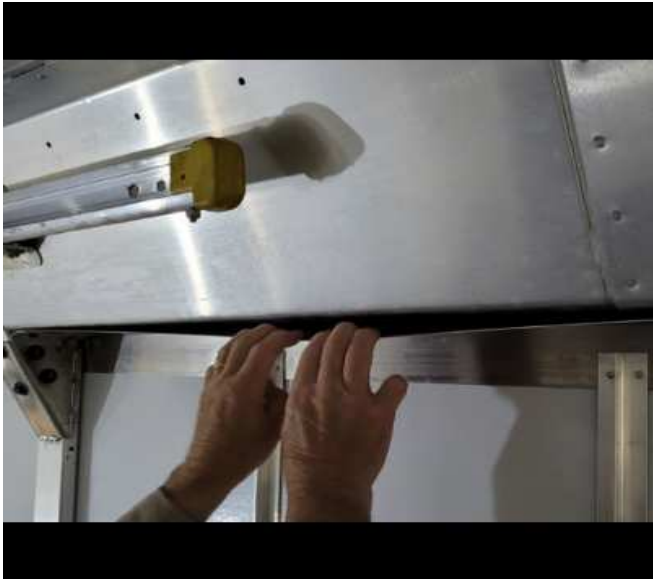
| Condition | <div></div> <div>6531963</div> <p>Some customers may comment on a gap in the roof rail.</p> | |
| Cause | The cause of the condition may be a build quality concern. | |

| Correction | Install rivets by following the procedure outlined below. | |
