Service Bulletin

Bulletin No.: 24-NA-024

Subject: Mobile Phone Inductive Charger Bin Liner Installation Tips

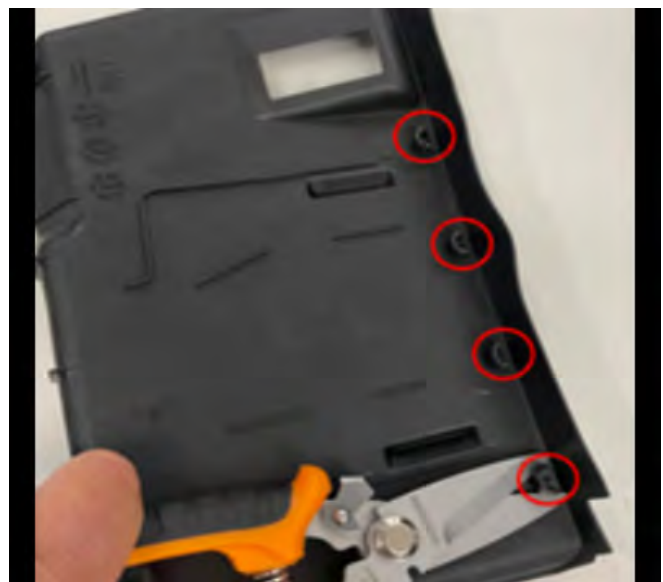
6537574

To aid the re-installation, cut off the top 4 rubber retainers (tabs) from the backside of the liner as shown in Figure 1. By doing so, the liner can easily be reinstalled into the plastic bin.

Order a new liner and perform the tab removal process before installation.

To aid the re-installation, cut off the top 4 rubber retainers (tabs) from the backside of the liner as shown in Figure 1. By doing so, the liner can easily be reinstalled into the plastic bin.

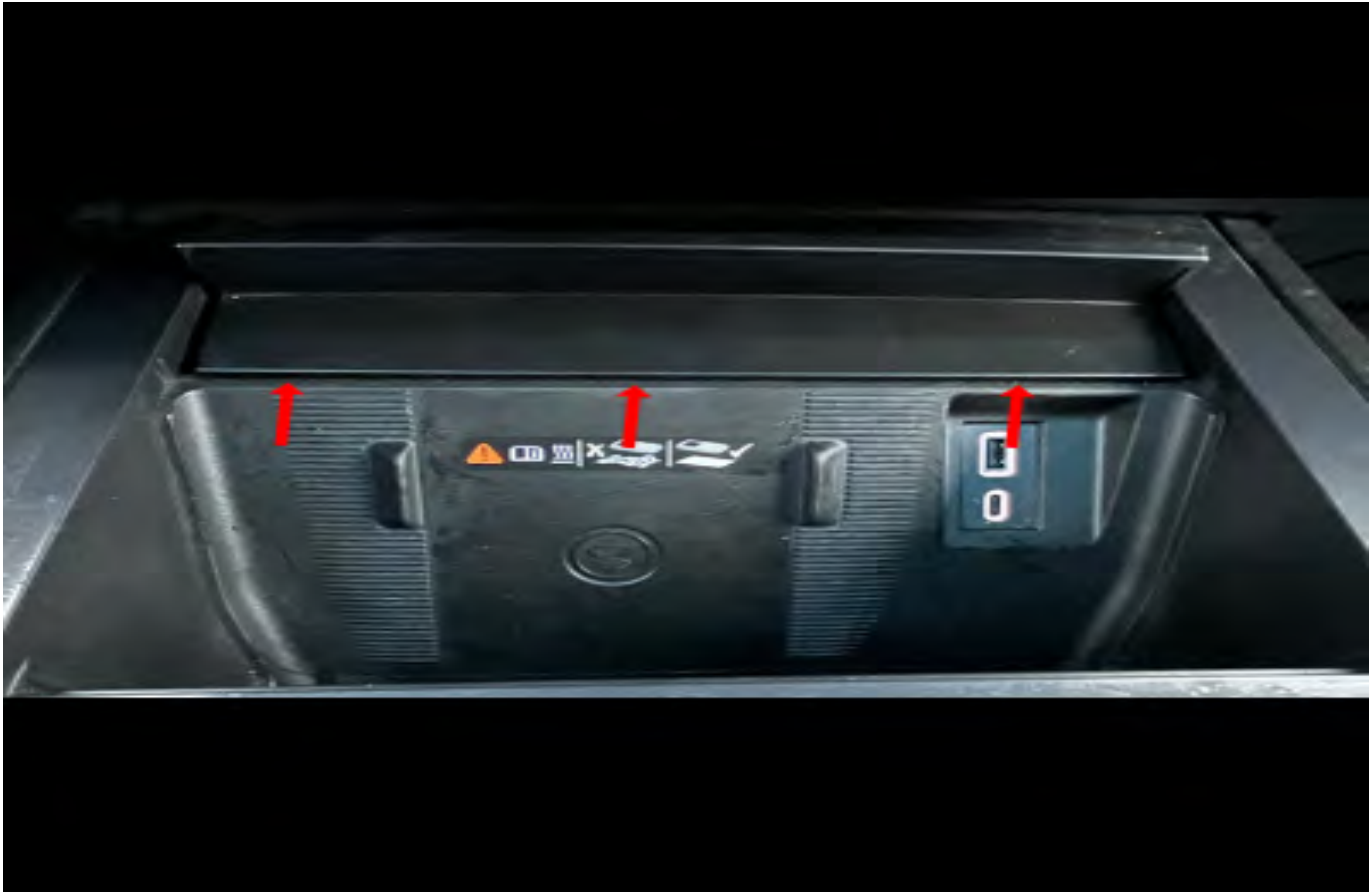
6537575

Verify the top edge of the liner is fully tucked under the door (see figure 2). Close and open the door to verify the liner does not catch on the door.
