SIM 51 01 24

REPLACE THE VIN LABEL ON THE DRIVER B-PILLAR

E-Series	Model Description	Production Date
R50	MINI Cooper Hardtop	November 30, 2001 – July 03, 2002
R53	MINI Cooper S

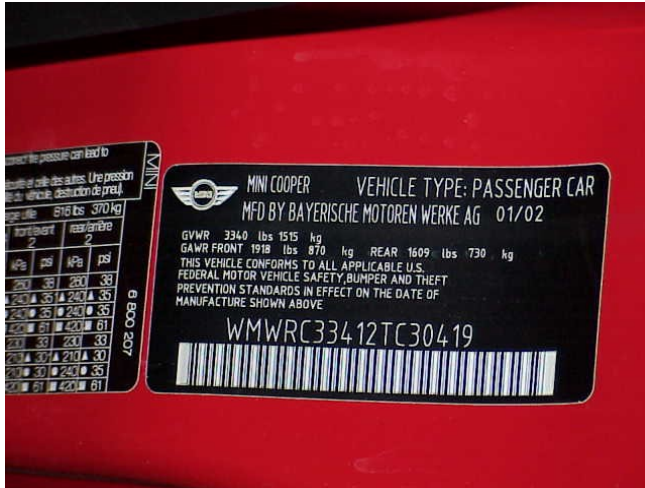
The bar code on the vehicle identification number (VIN) label ([aka Manufacturer Compliance Label](#)) cannot be read.

Vehicle's with [such an](#) incorrect label do not meet federal regulations.

Remove and replace the VIN label on driver's B-pillar.

**Note: DO NOT place the new label on top of the old label!**

- Using a heat gun, evenly apply heat to the entire label.
- Using a plastic scraper or "fishbone" tool, peel off the original label.
- Using isopropyl alcohol, remove the adhesive residue from the B-pillar.
- Compare the VIN on the new label with the vehicle's VIN.
- Smoothly apply the new label using the same orientation as the original label.
- Smoothly press down over the entire label ensuring that there are no trapped bubbles under the label.
