# Keystone RV Company

## SERVICE ADVISORY # 24-450

### Bullet & Passport Skylights

It has been determined that Polycarbonate skylights used on Alpha Flex and Alpha Ply roof systems may crack. The following procedure describes how to identify and replace the polycarbonate skylights.

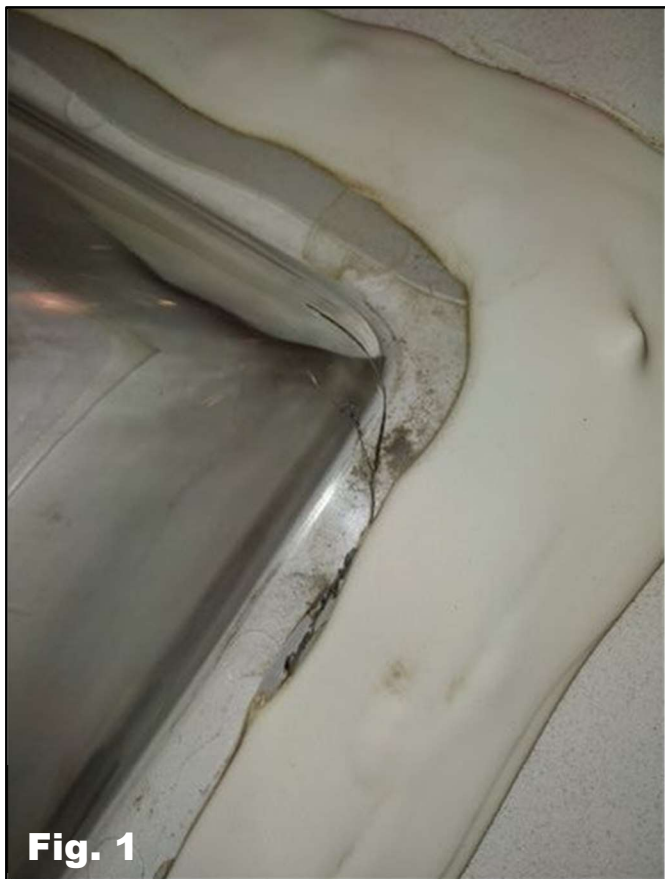
The remedy is to inspect the clear polycarbonate skylight on the Alpha Flex or Alpha Ply roof systems. Inspect the clear skylight for cracks and replace if cracks are found. See Figure 1 as an example. A clear picture is required for authorization and the claim.

Locate the skylight on the exterior roof and inspect for cracks. See Fig 1. If the skylight is cracked, take clear pictures for the authorization showing the defect. If no cracks are present, proceed to warranty reimbursement below and submit a claim for inspection. If the skylight is cracked, proceed to Step 3.

If the skylight is cracked, remove the clear polycarbonate skylight using normal industry standards and replace with the new polypropylene skylight (KRV # 634185) using butyl tape under the skylight as a primary seal and Alphathane (KRV # 639155) as a self-leveling secondary seal, then proceed to warranty reimbursement.
