MC20 – ECM DTCs U113F-00 - U1140-00 Lost Communication with Active Exhaust Valve 1 - 2

DATE: JANUARY 8 2024

SECTION: 01.81 - 1 SILENCERS

MODEL: MC20 – MC20 Cielo (All MY)

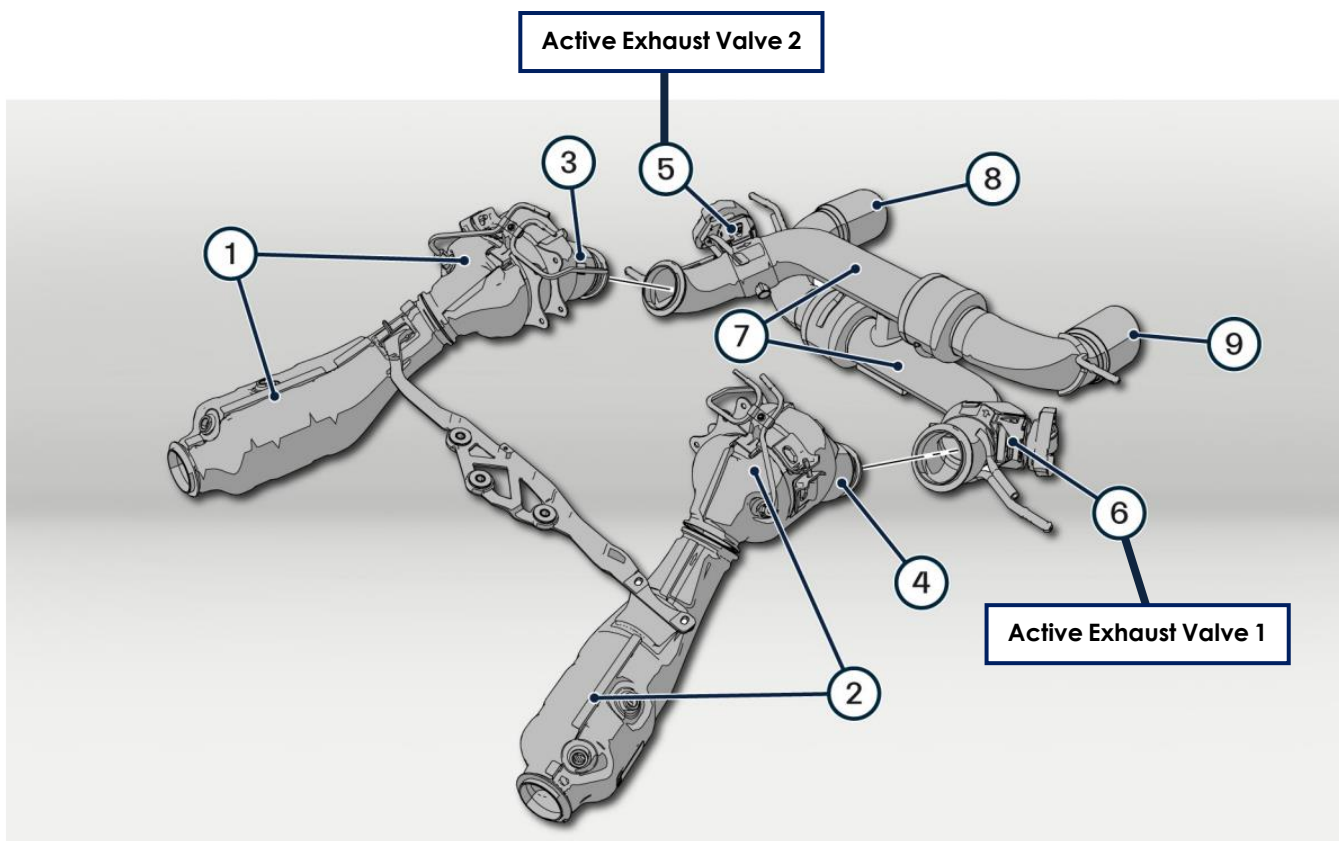
- 1. Right hot-end
- 2. Left hot-end
- 3. Right decoupling joint
- 4. Left decoupling joint
- 5. Right electric exhaust valve
- 6. Left electric exhaust valve
- 7. Cold-end
- 8. Right exhaust pipe
- 9. Left exhaust pipe

EEV1 (Electronic Exhaust Valve 1)	
Main functions	Left exhaust valve opening/closing
Position in the vehicle	On the exhaust pipe, near the terminal
Connected to	ECM via a LIN line
Diagnosis	Master module (ECM)

EEV2 (Electronic Exhaust Valve 2)	
Main functions	Right exhaust valve opening/closing
Position in the vehicle	On the exhaust pipe, near the terminal
Connected to	ECM via a LIN line
Diagnosis	Master module (ECM)

ACTION: Open a BOL as “Support Request” attaching a full vehicle scan report (All modules, DTC + Parameters) in HTML or PDF format.

Please do not perform any additional checks or repairs. Wait for BOL Instructions.
