## Technical Info

## Grecale - New Granturismo: air suspension system check

DATE: JANUARY 31, 2024

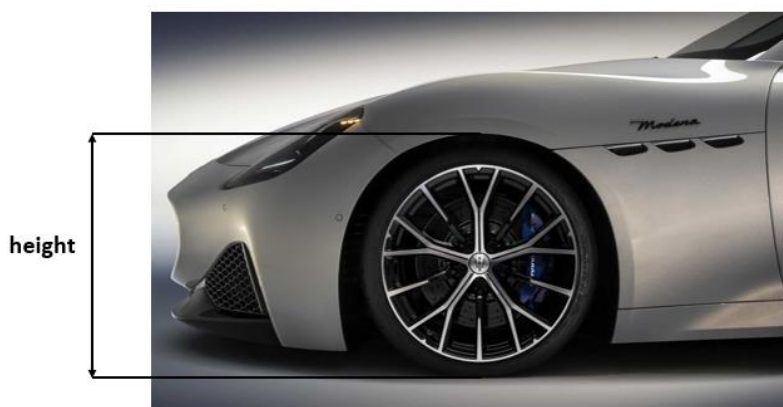
- f) disconnect the OBD tool through the window opened (doors closed)
  6. Measure the height from the ground to the highest point of each front wheel arch (Figure 1) and indicate the values in the checklist at the end of section 1. Figure 1

8. Measure the height from the ground to the highest point of each front wheel arch (Figure 1) again and indicate the values in the checklist at the end of section 1.
9. connect the EVO to the vehicle through the window opened (doors closed, don't sit in the vehicle)
10. check the pressure of the four tires from the vehicle cluster or the diagnostic tool in RFHM ECU and indicate the values in the checklist at the end of section 1 of the bulletin.
11. read the height from the ground of the highest point of each front wheel arch (height) with the diagnostic tool in VDCM ECU - 7005 - Vertical Dynamic Ride Height Sensors – and indicate the values in the checklist at the end of section 1 of the bulletin.
12. Run the "Get Out of In-Plant Mode" routine.

Compare the measures at pt.6 and pt.8 → on each corner, the difference must be smaller than **6mm**.

Compare the measures at pt.5b and pt.11 → on each corner, the difference must be smaller than **6mm**.

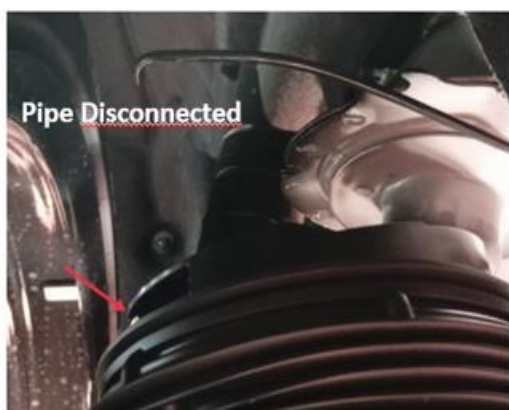
Sample of incorrect Air Suspension pipe installation on the Rear Air Spring

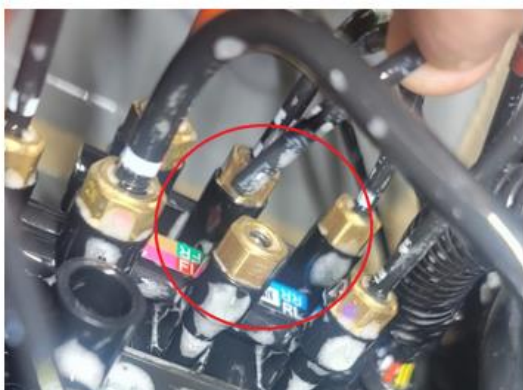
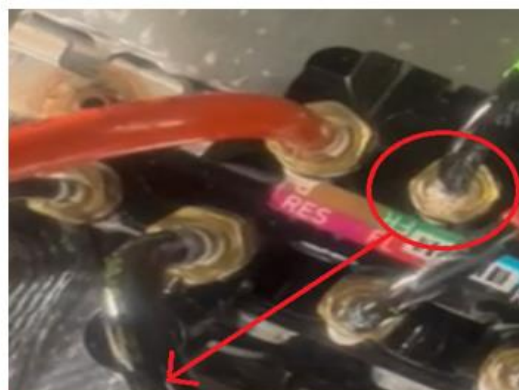
### 4 – Air Valves Block pipes – disconnected or wrongly fitted

Check the air valves block pipes to ensure that there isn't any disconnected and/or wrongly installed line.

Use soapy water to detect potential air leak through the system.
