Diagnostic Sheet

Grecale – Tips for HALF SHAFT - CLICKING NOISE

DATE: January 21, 2024

MODEL: Grecale M182 (All MY)

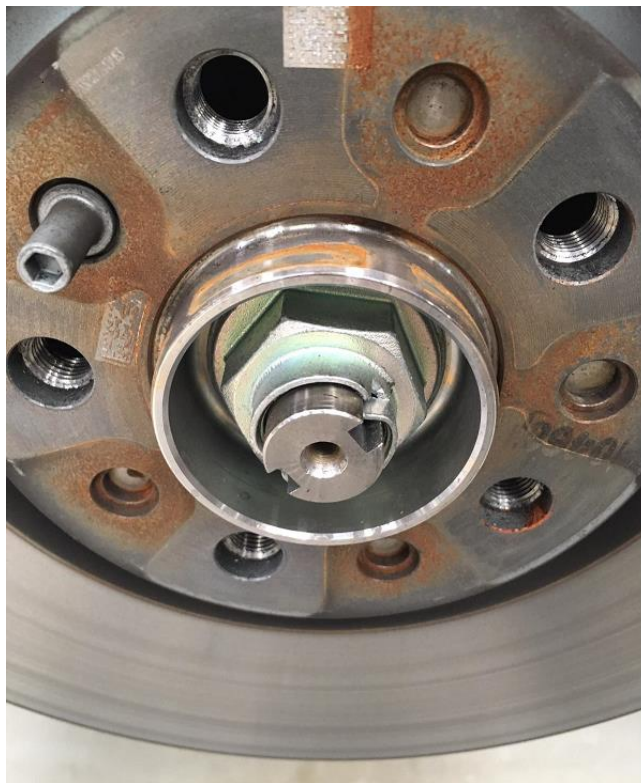
Pic. 2

Complaint: FRONT/REAR CLICKING NOISE DURING MANEUVER

CLICKING NOISE FROM FRONT:

- Remove the M24 axle nut (Pic.2), carefully clean the grooves and hub threads using isopropyl alcohol (or equivalent). Always replace the M24 nut with a new one (component #12 in spare parts table 03.22-2 FRONT WHEELS TRANSMISSION)
- Apply molykote copper grease (or copper antiseize equivalent) on the vertical surface as shown below in picture – (Pic.4)
- Perform axle shaft nut tightening procedure as indicated in the workshop manual (refer to 03.22-2 component #6 operation 03.22.003 00 LH COMPLETE FRONT AXLE SHAFT)

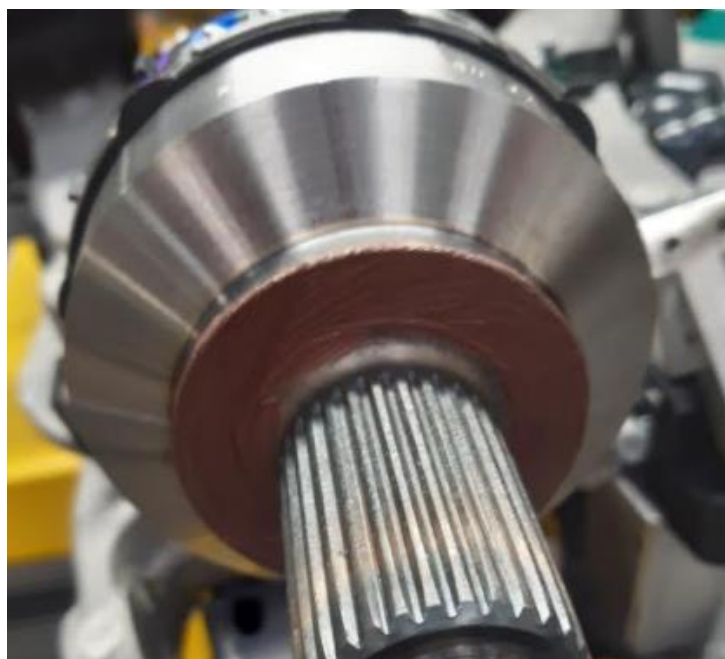
Pic. 4

CLICKING NOISE FROM REAR:

- Perform the same procedure as indicated for the front shafts clicking noise
- Apply molykote copper grease (or copper antiseize equivalent) on vertical surface as shown below in picture – (Pic.4)
