REFERENCE:	Nova Bus Manuals
SECTION:	14: Heating and Ventilation
RS N°:	MQR 7621-2507
EFFECTIVE IN PROD.:	NA

SUBJECT:	HVAC coolant pipe leaks.
JUSTIFICATION:	HVAC coolant pipe leaks from various solder locations

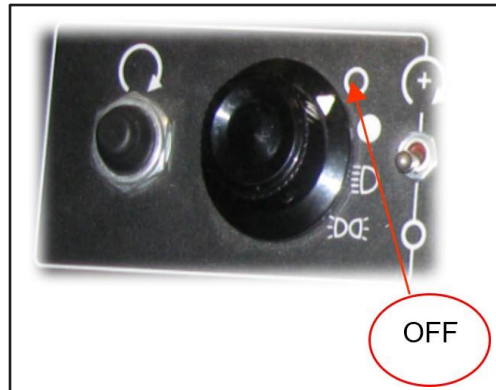
- 1.7. Ensure that the Master switch, located on the driver side console is in the OFF position.

Figure 2 - Master Switch in OFF Position

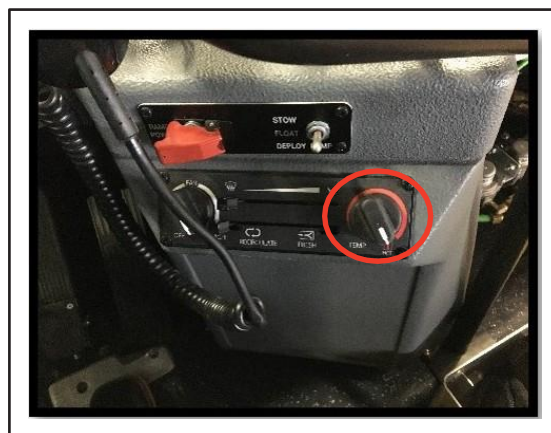
- 1.11. Place the Heater Defroster Control valve in the fully open position.

Figure 6 - Heater Defroster Contr

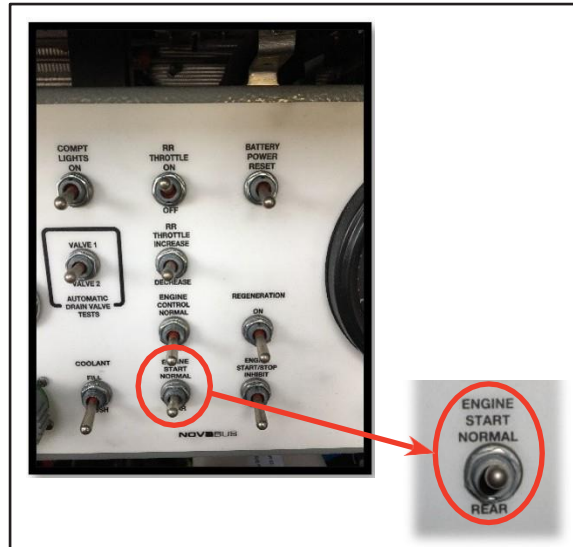
- 1.14. Press down the engine start switch on the rear engine control box for 5 seconds and release. Press down again on engine start switch for 1 second and release.

Figure 9 - Engine Start Switch

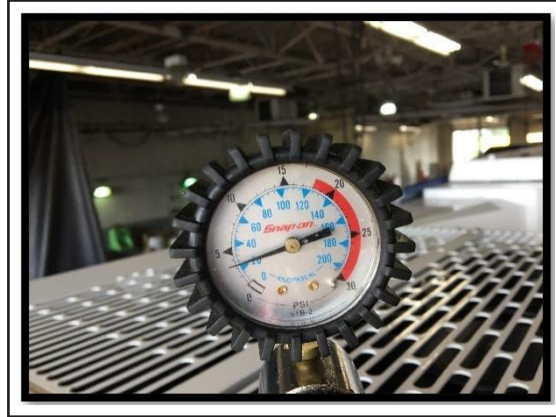
- 1.16. Pump the pressure up to 20 to 21 psi and check to see if pressure holds. Check for leaks.
- 1.17. Wait for 20 minutes and Check whether the pressure regulator gauge shows a decrease in pressure. If there is a decrease in pressure a leak check must be performed (see leak checking below).

Figure 11 - Pressure Check

A decrease in the gauge pressure indicates a leak in the engine coolant system. If there is no decrease in pressure indicated on the gauge, the engine cooling system is good and posable air was trapped in the system.

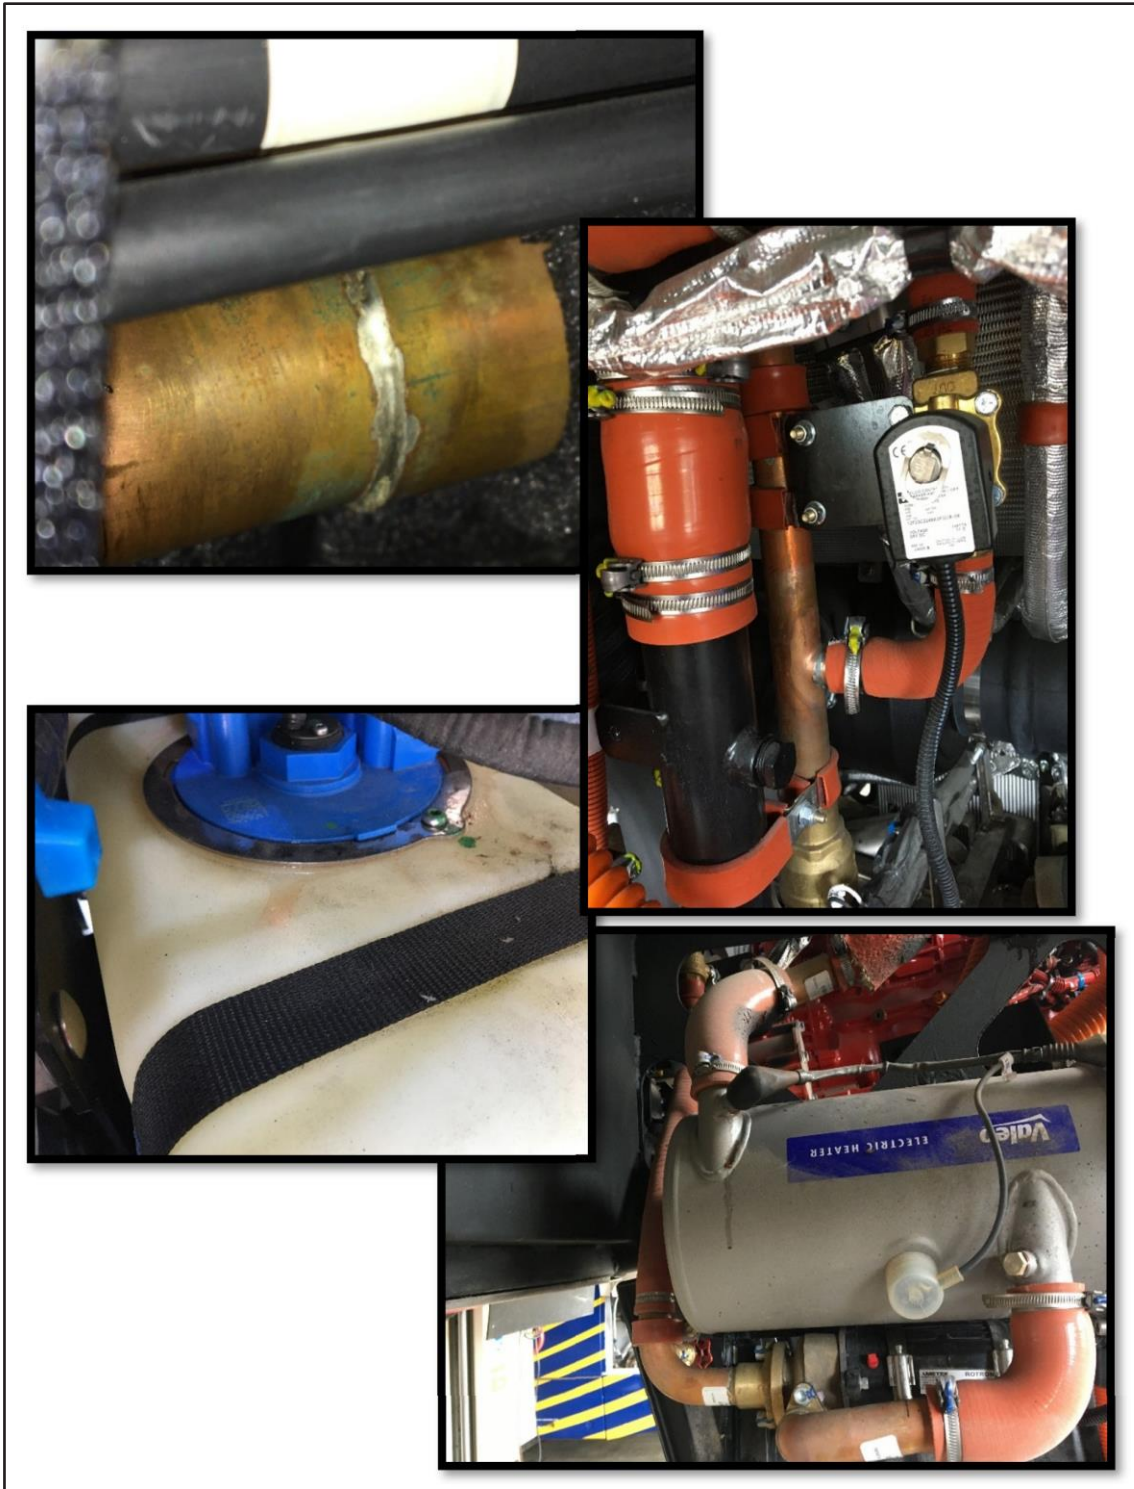
If the gauge shows a decrease in pressure, there is a possible leak in the system. You will need to pressurize the engine cooling system with air, to the same pressure you used to check for leaks. Spray the cooling system with the use of a spray bottle with soap-water solution and check for leaks.

For system with coolant still in the system look for a coolant leaking from the fitting and hose's.

Figure 12 - Leak Testing

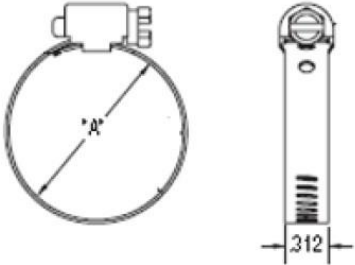
Diameter Range and Torque requirement for "BREEZE MINI" clamps

<p>5/16" (7.9 mm) band</p>	Torque				
	2 +/- 0.25Nm				
	EFFECTIVE DIAMETER RANGE				
SAE Size	Min.		Max.		
	in.	mm.	in.	mm.	
4	7/32	5.6	5/8	16	
6	7/16	11	25/32	20	
8	1/2	13	29/32	23	
10	9/16	14	1-1/16	27	
12	11/16	17	1-1/4	32	
16	15/16	24	1-1/2	38

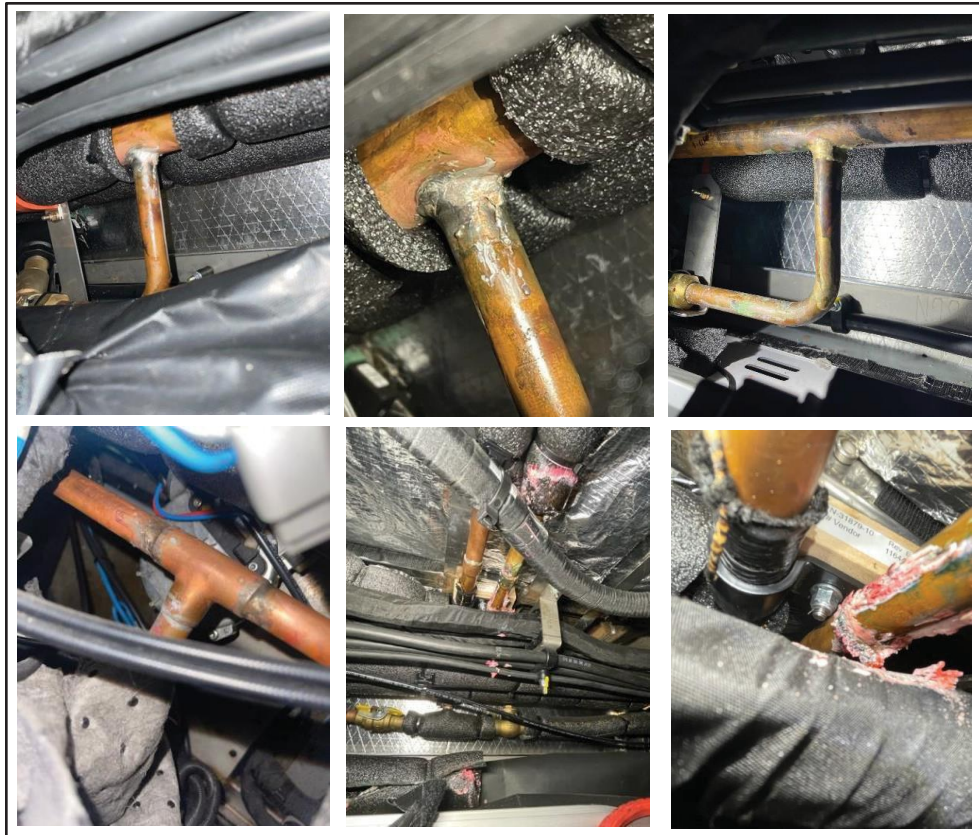
- 1.28. Release the pressure from heating control valve.
- 1.29. Open the street side baselight/ceiling panel to access the valve.
- 1.30. Disconnect the elbow connector of the supply cable from the pilot valve.
- 1.31. Disconnect the pneumatic hose from the valve.
- 1.32. Loosen the fittings on both sides of the valve and remove the valve.
- 1.33. Remove the loom and tube insulation from the heating pipes.
- 1.34. Disconnect and remove the pipes.

Figure 17 - Removal of Damaged Pipes

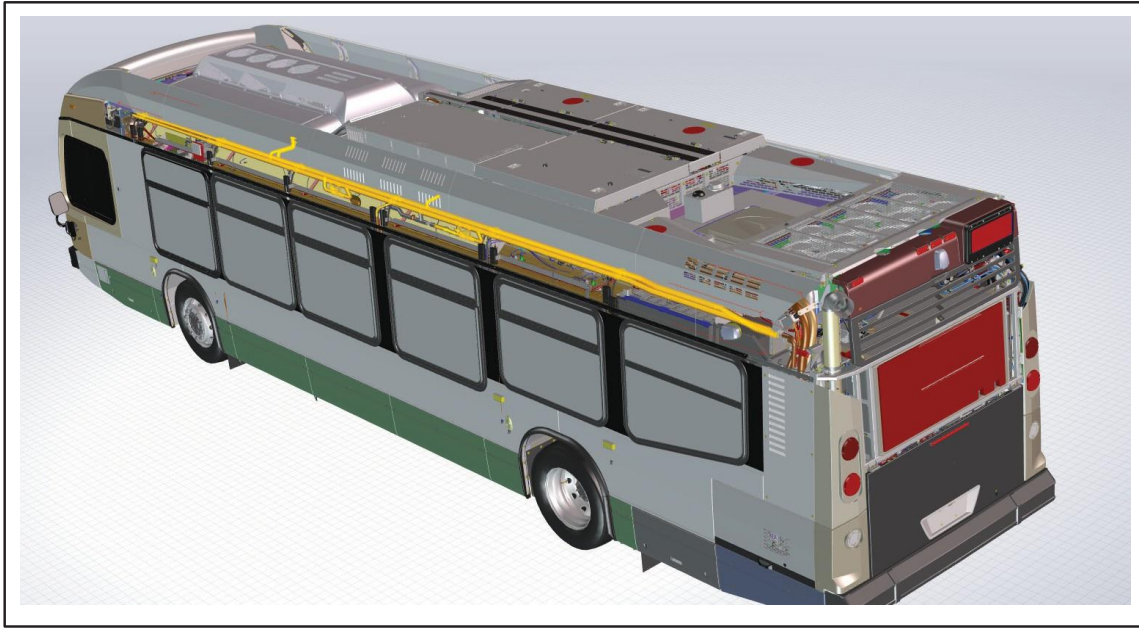
Figure 23 - View of Installed Pipes
