Technical Service Bulletin: 04-1738

TECHNICAL SERVICE BULLETIN 04-1738 REMEDY INSTRUCTIONS

Make(s): SALEM & WILDWOOD
Model(s): SMT44VIEW & WDT44VIEW
Model Year(s): 2024

Concern:
The compression insert may not be installed into the ice maker water line.

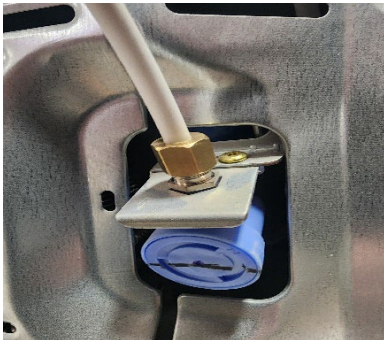
FIGURE 1

STEP 2: LOOSEN THE ½" NUT ON THE BACK OF THE REFRIGERATOR THAT THE ICE MAKER LINE IS PASSING THROUGH (FIGURE 1);

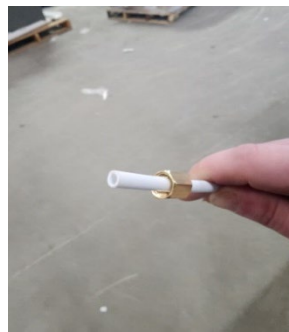
FIGURE 2

STEP 3: SLIDE NUT ½" NUT BACK ON THE ICE MAKER LINE AND CUT OFF ROUGHLY AN INCH, SO THAT THE END IS STRAIGHT (FIGURE 2);

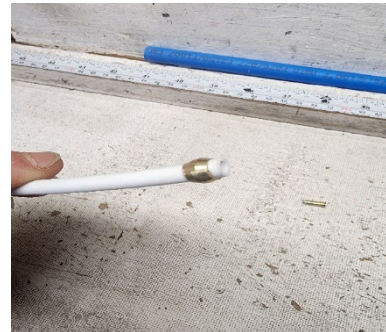
FIGURE 3

STEP 4: SLIDE BRASS COMPRESSION SLEEVE ONTO ICE MAKER LINE (FIGURE 3);

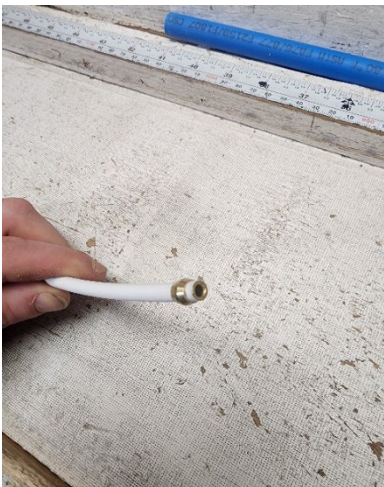
FIGURE 4

STEP 5: INSERT THE BRASS STIFFENER INTO THE END OF THE ICE MAKER LINE (FIGURE 4);

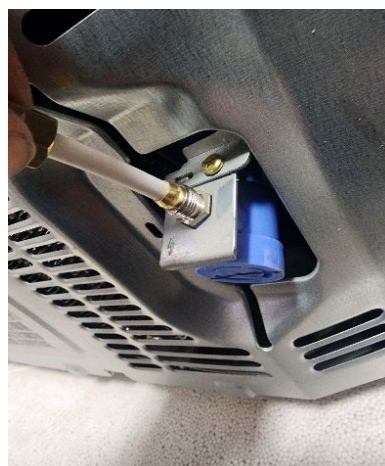
FIGURE 5

STEP 6: SLIDE ICE MAKER LINE INTO BACK OF REFRIGERATOR (MAKING SURE THE BRASS STIFFENER TOUCHES THE BOTTOM OF THE VALVE BEFORE SLIDING COMPRESSION FITTING TO THE TOP OF THE VALVE (FIGURE 5);

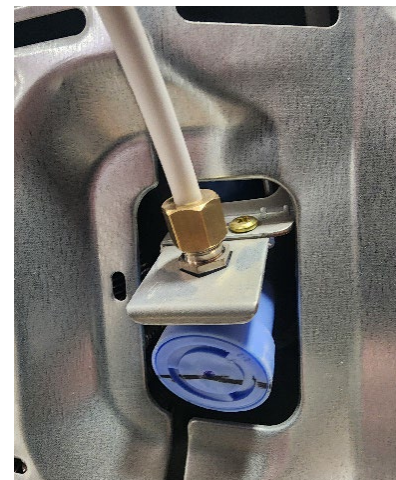
FIGURE 6

STEP 7: USING A ½" WRENCH, TIGHTEN NUT ONTO THE ICE MAKER VALVE ON THE BACK ON THE REFRIGERATOR UNTIL SNUG AND TIGHT (FIGURE 6);
