Technical product information

Topic	V8 Kovomo - Bentayga - Water pump drive gear cover (Deletion)
Market area	Australia E04 Bentley rest Asia and Australia (6E04),China 723 Volkswagen (Anhui) Automotive CO (6723),China 796 VW Import Comp. Ltd (Vico), Beijing (6796),Germany E02 Bentley rest Europe (6E02),Japan E03 Bentley Japan (6E03),Korea, (South) E08 Bentley South Korea (6E08),United Arab Emirates E06 Bentley Middle East and Africa (6E06),United Kingdom E01 Bentley UK (6E01),United States E05 Bentley USA and rest America (6E05)
Brand	Bentley
Transaction No.	2065918/4
Level	EH
Status	Approval
Release date

V8 Kovomo engine

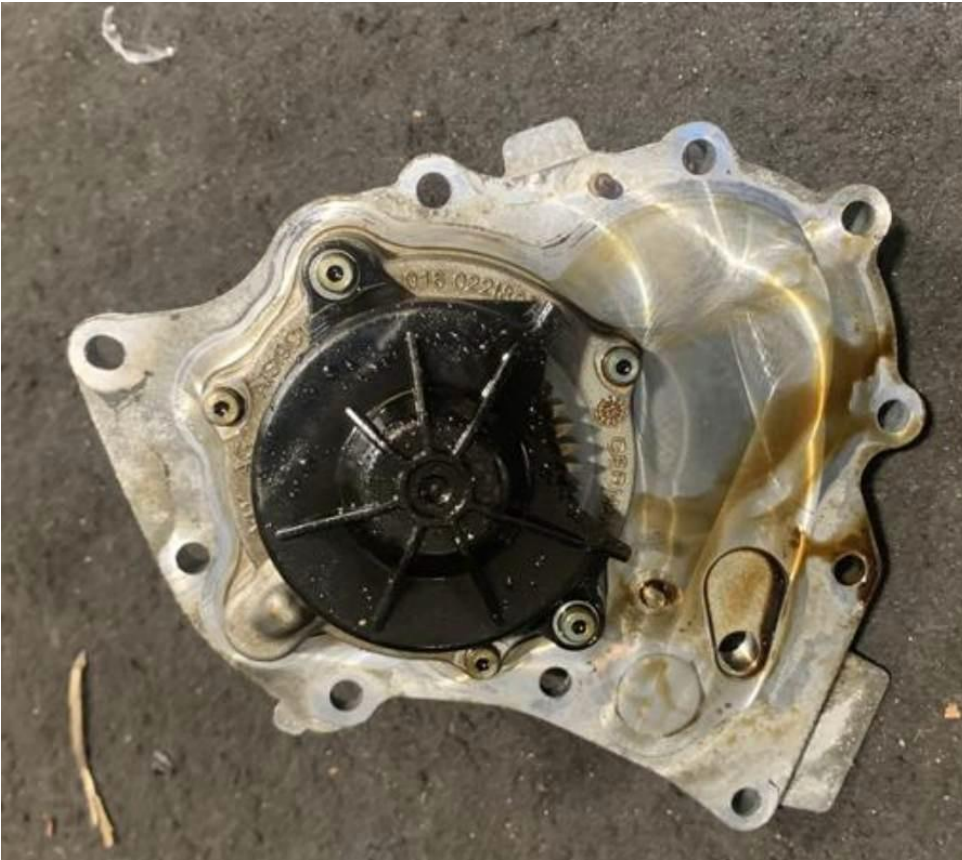
Figure 1

The original water pump has a cover fitted directly over the top of the water pump drive gear (Figure 1)

The cover is no longer fitted on replacement water pumps, the cover is not required and **MUST** not be transferred to the new water pump

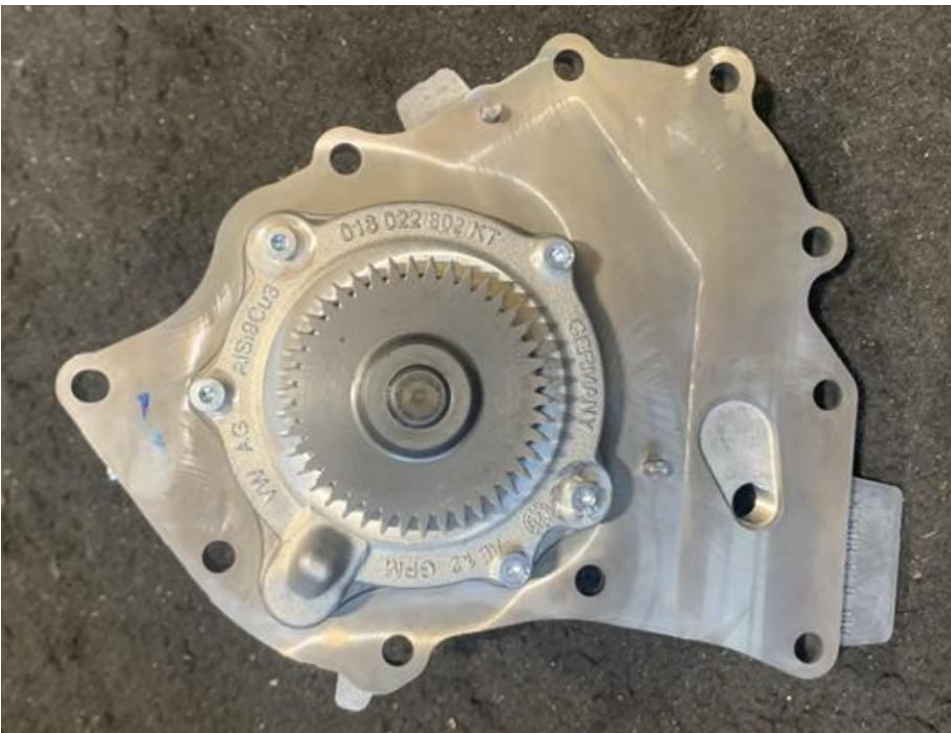
However the replacement water pump does not have a cover fitted (Figure 2)

The operative should fit the new water pump without the cover as shown in Figure 2
