## FIREFLY POLARIS PRO TOUCHSCREEN

| <b>Bulletin Type:</b> | TSB | <b>Publication Date:</b> | February 2024 |
| <b>Bulletin #(s):</b> | 24-003 | <b>Make(s):</b> | Entegra Coach |

| <b>Incident:</b> | When left on for long periods of time, the touchscreen may become Inoperable. |

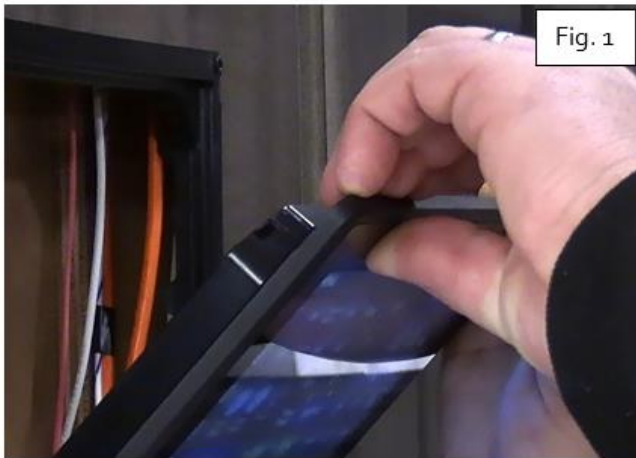
*Removing the screen from the wall mount*

*Step 1: Removing the screen from the wall mount. (Fig. 1)*

1. If your unit has been placed on the list for a touchscreen replacement you will want to verify that the touchscreen actually does need to be replaced. To do this you will need to remove the 10" Polaris Pro Touchscreen, and locate a white sticker with a QR code on the back side of the screen.
  - a. This sticker will have another code on it that will determine whether the screen needs to be replaced or not.
2. To remove the screen from the wall, place your fingers across the top of the touchscreen, and then while applying pressure downward, pull outward with your finger tips. The screen should "pop" out of the mount. Be careful not to drop the screen when it pops out.

Once the screen has been removed from the wall flip it over and locate the sticker. See the next page for more information on what to look for.

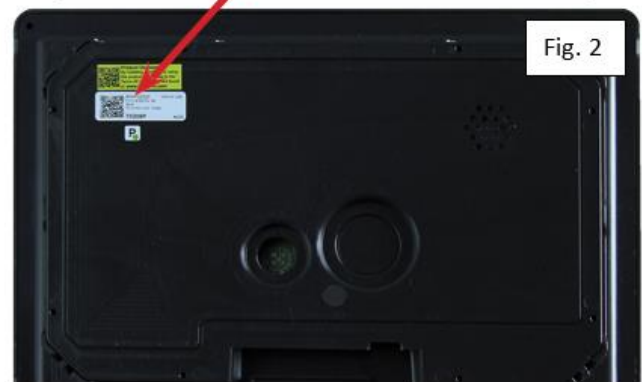
*Step 2: Locate the sticker on the backside of the screen that has a QR code on it.*

*Polaris Pro Touchscreen Backside*

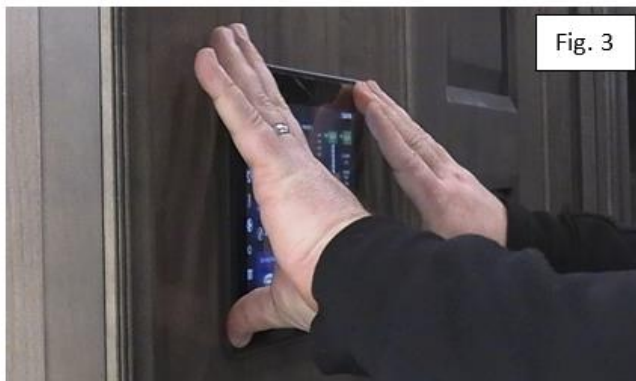
*Snapping the screen back into the wall mount*

*Step 3: Snapping the screen back into the wall mount. (Fig. 3)*

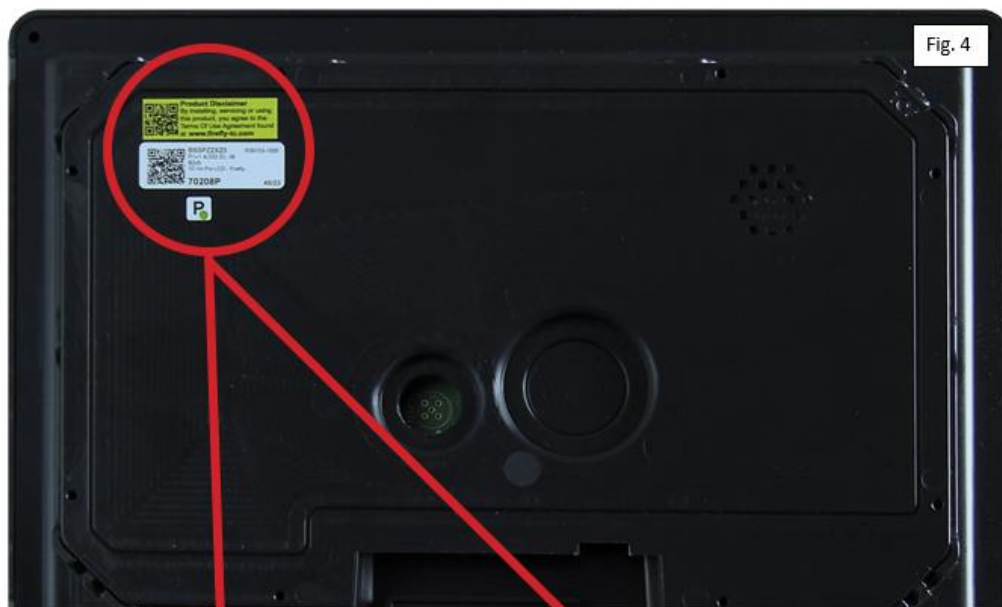
Fig. 4

- You will find a white sticker containing a QR code on the backside of the 10" Polaris Pro Touchscreen (Figure 4). This sticker contains the information needed to determine whether the screen needs to be replaced or not. Just under the line BSSPZZXZ0 will be a code that looks similar to P1v0 as seen in Figure 5 above. Any screen with a code of P1v0, P1v1, P1v1.1, P1v1.2, or P1v1.3 must be replaced. Figure 6 above shows what the screen code should read. (P1v1.4) If your screen reads P1v1.4 you do not need to replace it.

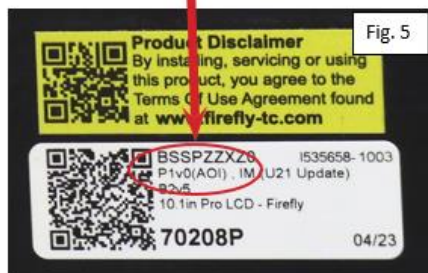
Fig. 5

**MUST be Replaced**

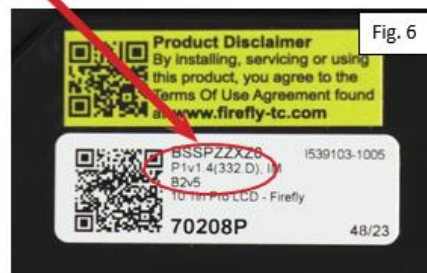
Fig. 6

**To be Replaced with**

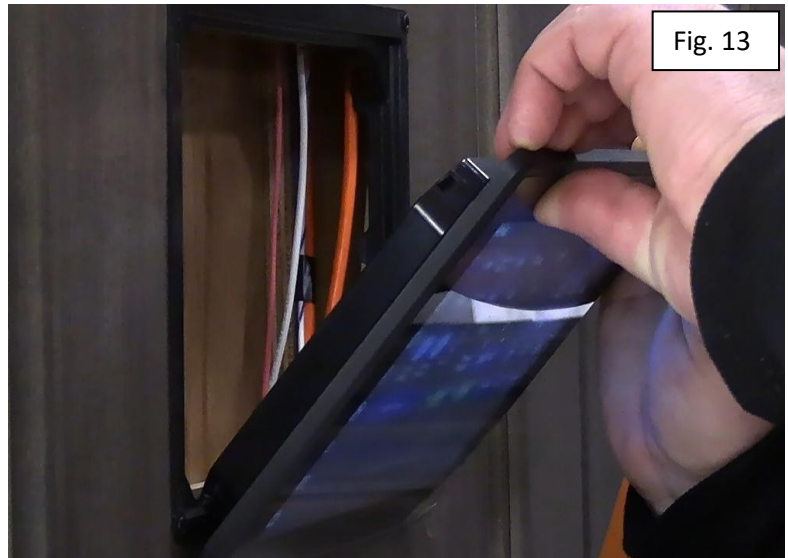
7. Locate the replacement touchscreen. Verify that the code on the back of the screen matches P1v1.4, and reconnect the touchscreen cable to the drop cable coming out of the wall (Figure 13). Once the cables are connected place the screen into the wall mount and snap it into place by pushing on all four corners simultaneously. (Figure 14) Your screen replacement is now complete.
