## SHOWER SURROUND CORNER POST SECURING

| <b>Bulletin #(s):</b> | 24-006 | <b>Make(s):</b> | Entegra Coach |

## SHOWER SURROUND CORNER REPAIR INSTRUCTIONS

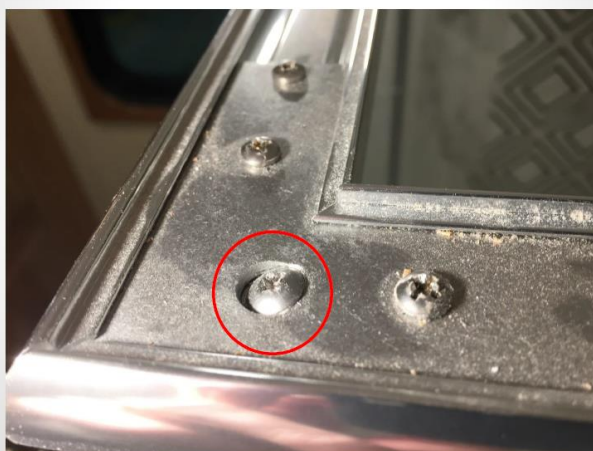
To access the screw in the white plastic anchor block at the bottom rail. First remove the screw at the top corner of the shower surround.

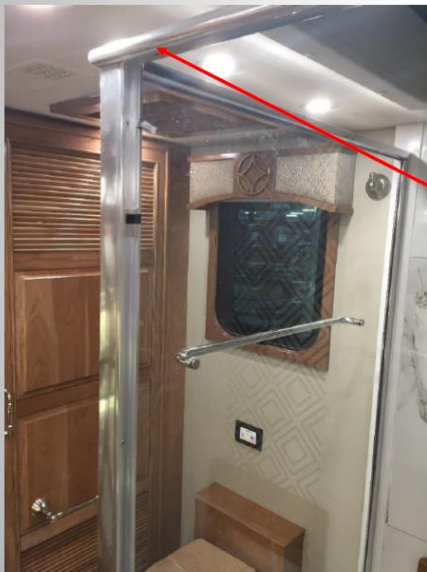
This will allow the top frame rail to lift and the vertical side rail to raise exposing the plastic anchor block and screw at the bottom of the frame.

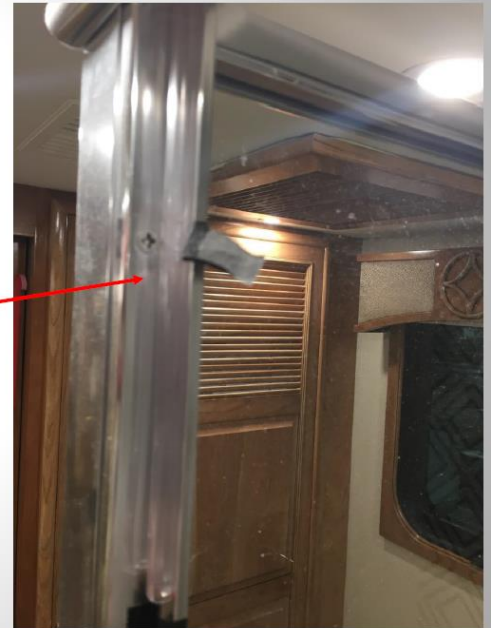
Top frame rail.  
Vertical side rail.

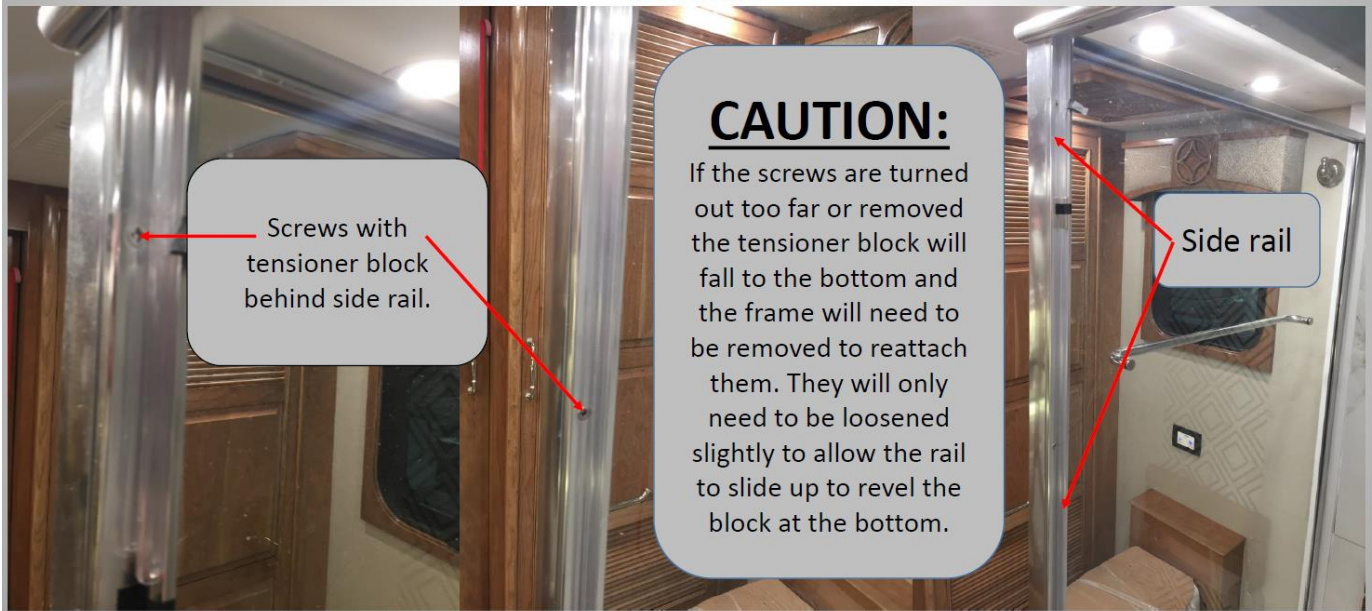
Only loosen the screws in the vertical side rail  $\frac{1}{4}$  turn to loosen the rail.

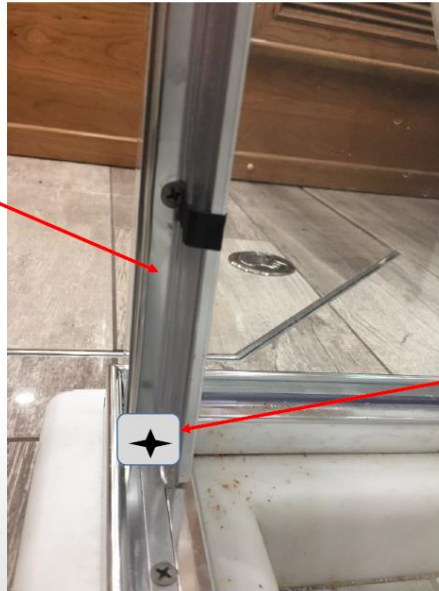
When the side rail is raised the white plastic securing block will be visible at the bottom of the surround frame.

Slide the side rail up to access the plastic securing block and screw.

The plastic securing block and screw will be visible when the side rail is raised.
