Technical Service Bulletin

19 Low coolant light is on but the coolant level is within specifications

19 24 55 2061918/6 March 12, 2024. Supersedes Technical Service Bulletin Group 19 number 24-49 dated February 7, 2024 for reasons listed below.

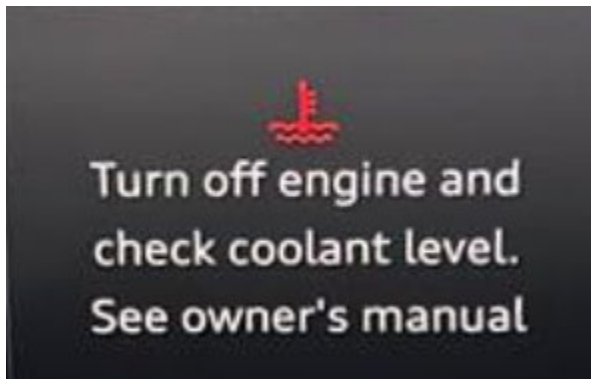
Figure 1. Coolant light.

- Please confirm the light that the customer is referring to is the coolant light (Figure 1) and not the distance warning light (Figure 2).
