Technical Service Bulletin

35 Gearbox Malfunction Warning, DTC P0C2900 in the TCM

35 24 48 2050723/5 March 12, 2024. Supersedes Technical Service Bulletin Group 35 number 23-46 dated October 9, 2023 for reasons listed below.

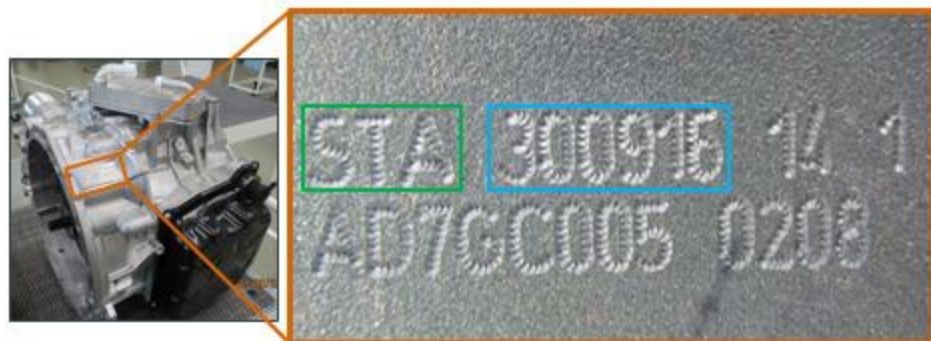
Figure 2. Transmission identification example.

Obtain the transmission identification information from the bell housing (Figure 2).

Explanation of data on gearbox:

Gearbox code: STA (green box)

Gearbox Production Date: **300916** = **03.09.2016** (blue box).

Date format: Day/Month/Year

- If the gearbox production date is after 26.09.2017, this TSB does not apply. Proceed according to Guided Fault Finding. Please note that in this case, the costs for the repair cannot be billed under this TSB.
- If the gearbox production date is on or before 26.09.2017, continue as described below.
