87-18-08 - Air Conditioning, Cleaning of the R1234yf Refrigerant Circuit (U.S. Only)

Release date: 3/11/2024

Debris can be dispersed throughout the refrigerant circuit after A/C component damage. In order to maintain A/C operating efficiency, it is important to flush the refrigerant circuit after A/C component repairs.

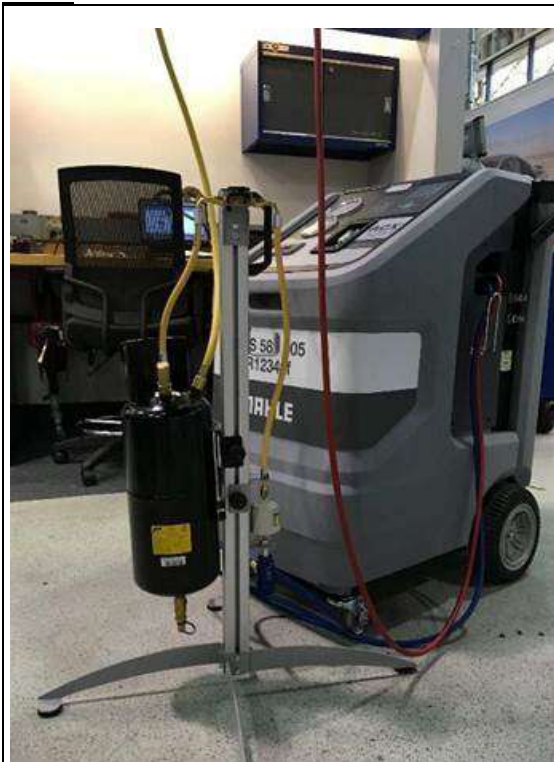
Figure 1. The VAS581005 Air Conditioning Service System with Flushing Device.

Use an approved R1234yf servicing machine and the R1234yf Flush Kit RTI360831840 (Figure 1).

Used for effective refrigerant handling and air conditioning circuit flushing after air conditioning component failure.

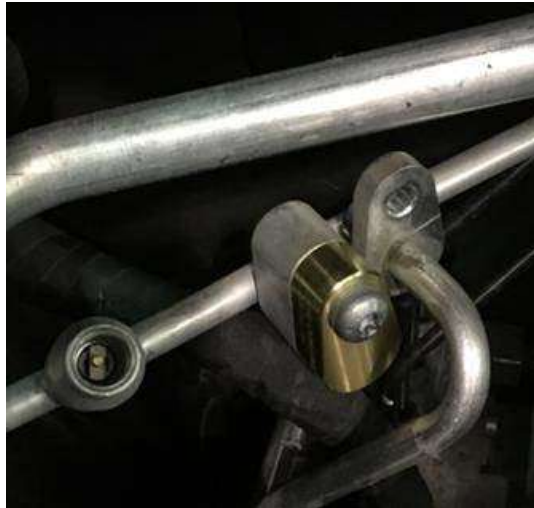
**Figure 4a.** Installation of high side rear A/C Line connection block adaptor VAS 6338/63.

**(Atlas ONLY)** The rear A/C unit refrigerant lines must be disconnected and replaced with block off adaptors VAS 6338/5 and VAS 6338/63 before performing the front A/C unit flush procedure.

8. (Atlas Only) Disconnect rear refrigerant lines and install adaptors VAS 6338/5 and VAS 6338/63 as shown. (Figure 4a, 4b)

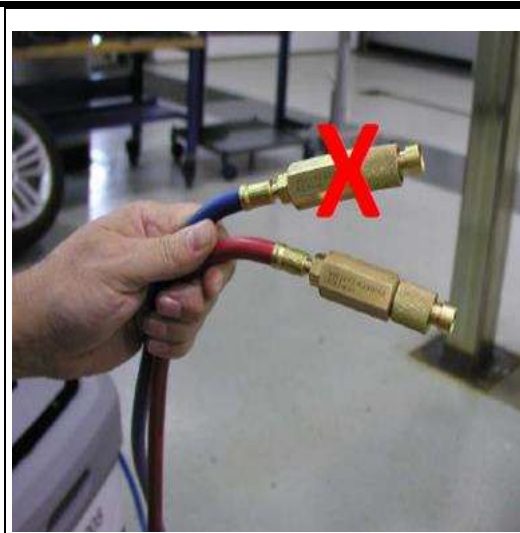
Figure 5. A.C hose adaptor 6338/44.

9. Remove A/C Recovery machine high side coupler from hose.  
Install flush adaptor VAS 6338/48 to high side A/C recovery machine hose. (Figure 5)

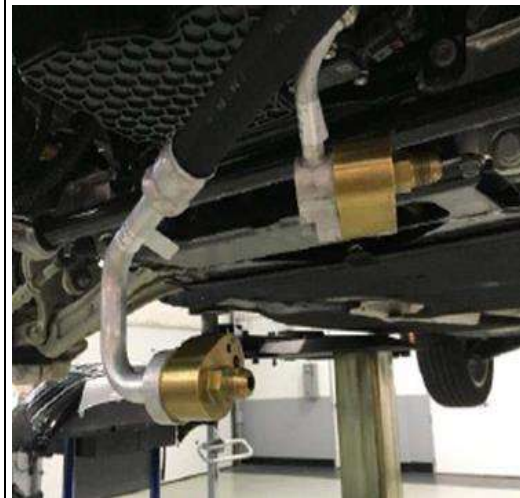
Figure 6. Installation of VAS 6338/3 and 6338/12.

10. Disconnect A/C compressor hoses from the compressor.  
Install flush adaptor VAS 6338/3 on the high side compressor hose.  
Install flush adaptor VAS 6338/12 on low side compressor hose. (Figure 6)

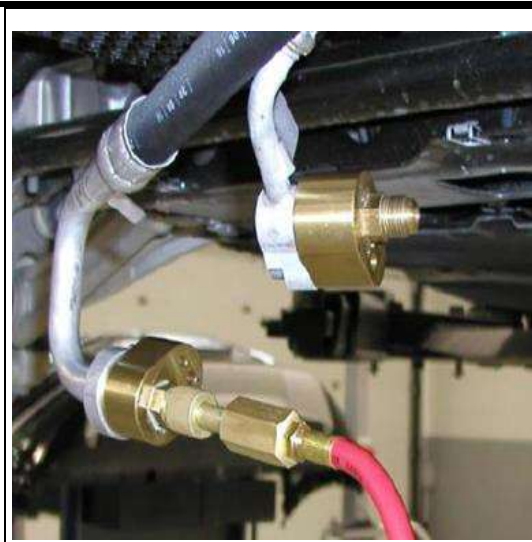
Figure 7.

This connection strategy allows for a system flush in the opposite direction of the normal refrigerant flow.

11. Attach high side A/C Recovery machine hose with VAS 6338/48 fitting to low side compressor hose adaptor VAS 6338/12. (Figure 7)

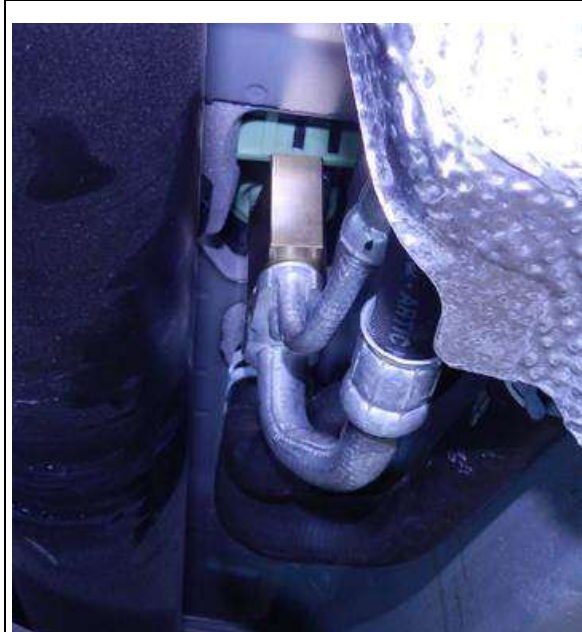
Figure 13. Location of rear air conditioning unit expansion valve.

23. Remove rear expansion valve and install VAS6338/38 as shown. (Figure 13)

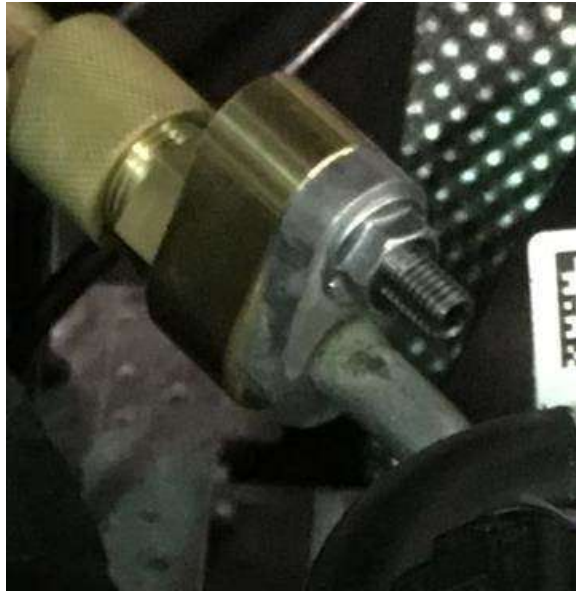
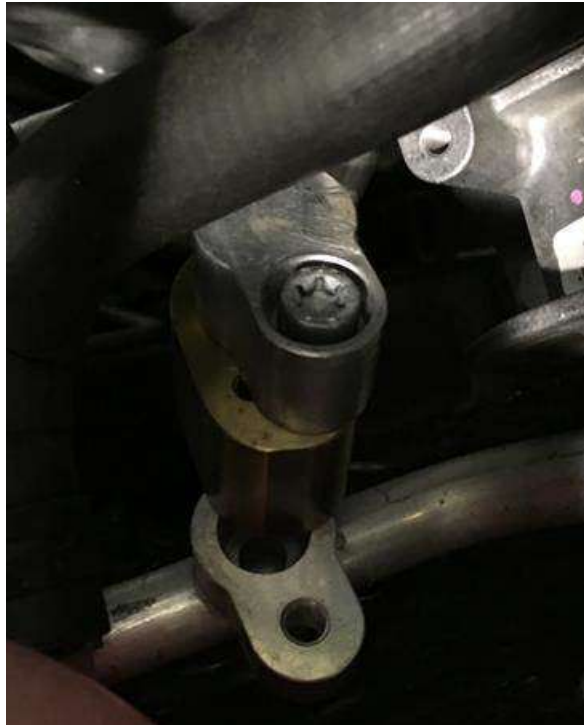
**Figure 14.** Location and connection of the adaptors for the rear unit A/C lines

24. Connect the VAS 6338/3 and VAS 6338/60 to the rear refrigerant A/C lines. (Figure 14)

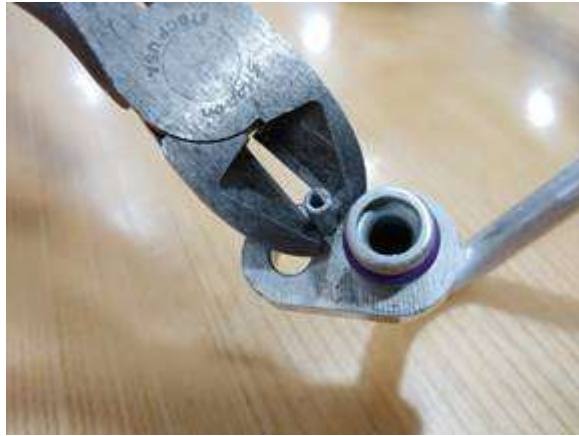
Figure 15. Removal of dowel pin.

Later models may have a dowel pin in the high pressure refrigerant line that does not allow the VAS6338/60 to be installed. The pin must temporarily removed to install the VAS6338/60. **DO NOT cut the pin flush with the refrigerant line connector.** Side cutters can be used to remove the pin and pliers to reinstall the pin. (Figures 15 and 16).

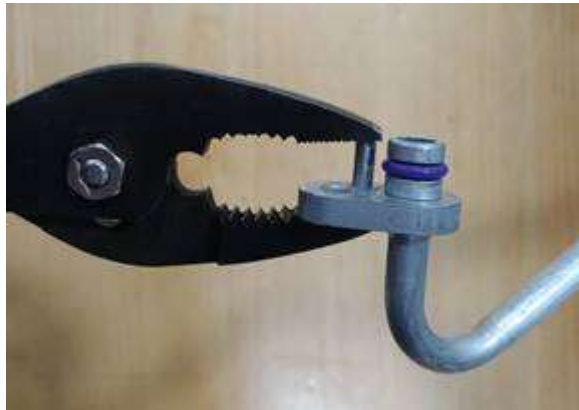
Figure 16. Installation of rear refrigerant line dowel pin.

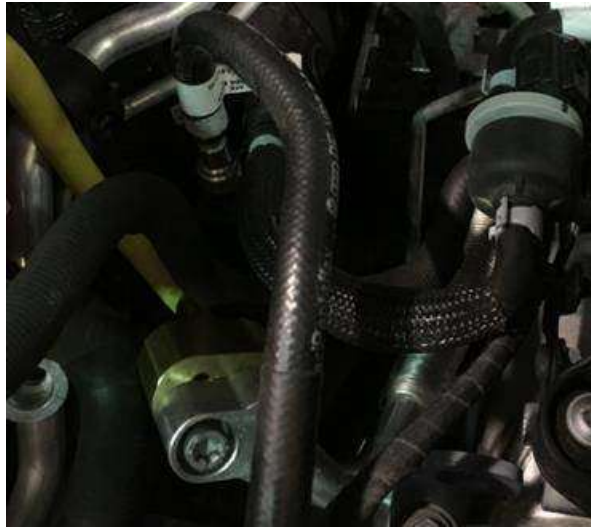
**Figure 17.** Attaching service station and flush hoses to rear A/C lines.

26. Connect flush tank hose (Yellow) to the high side compressor hose adaptor VAS 6338/3. (Figure 17)

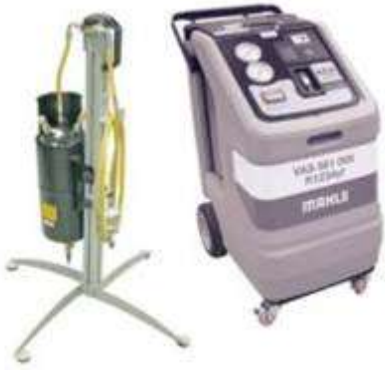
Tool Description	Tool No:
Air Conditioning Service System

MAHLE R1234yf A/C Service Unit VAS581005
	Or Robinair R1234yf - ROB1234YFX
	Or MAHLE RTI4608046401
	Or Ecotechnics EEAC830BVW
	R1234yf Flush Kit RTI360831840
