Bulletin No.: PIC6538

### PIC6538 Diagnostic Tip - Repeat Brake Pulsation

Brand:	Model:	Model Years:	VIN:		Engine:	Transmissions:
			from	to		
Cadillac	CT4-V	2022 - 2024	All	All	All	All
Cadillac	CT5-V	2022 - 2024	All	All	All	All

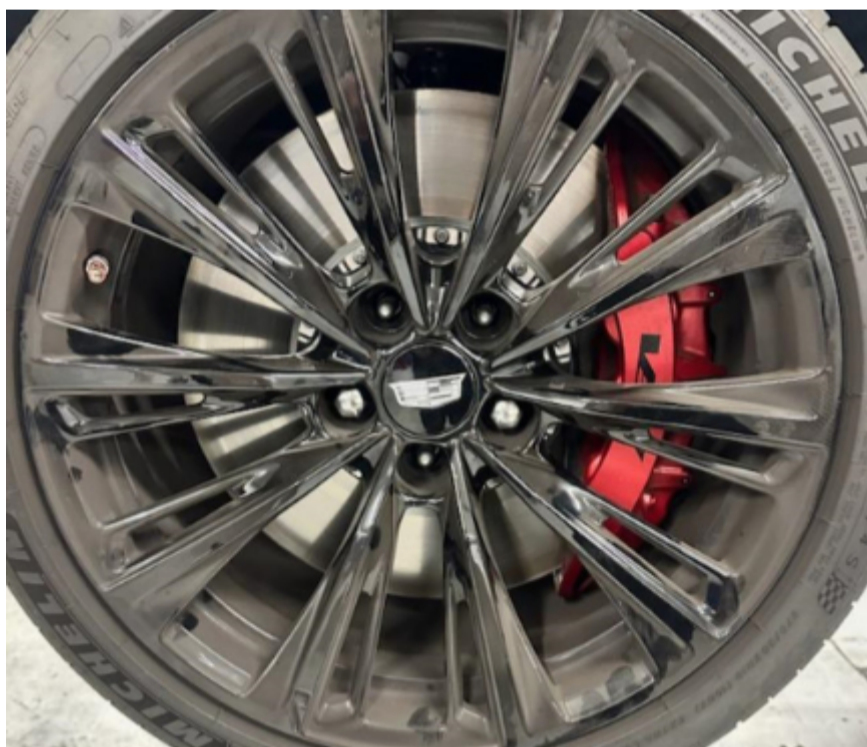
Above Image of Customer Painted Wheel - Note: Black Wheels not offered as OEM.

Inspect wheels for being painted

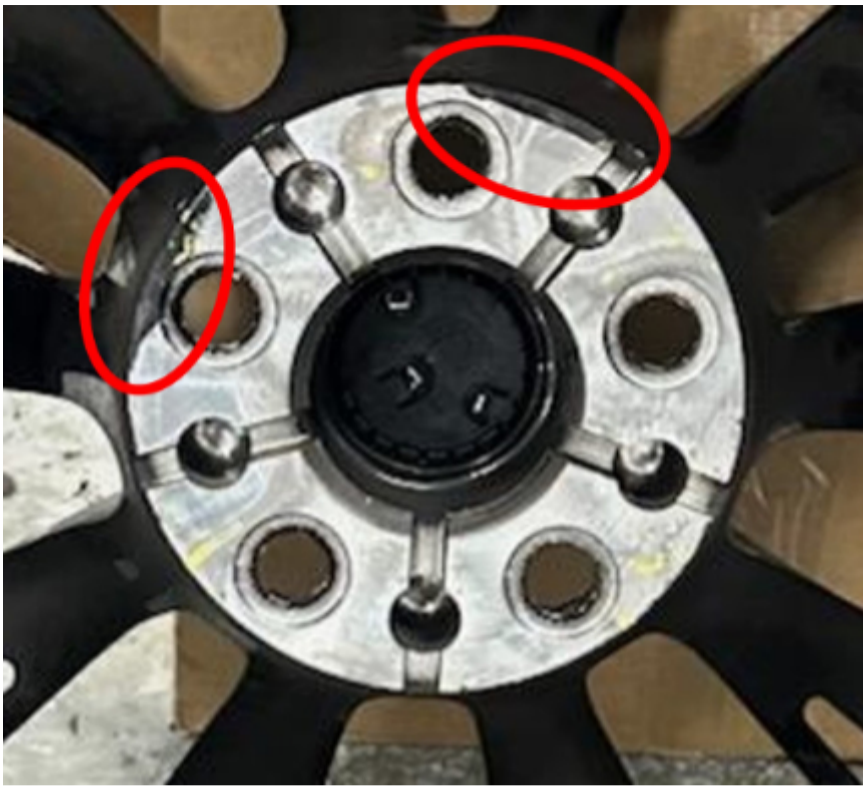
Above Image shows paint on the hub surface of the wheel, this paint may also get transferred to the hub bearing surface.

The paint on the hub surface caused the lateral run out to be .001 over spec of .002 which was enough to cause thickness variation of the rotors.

If customer painted wheels are found to be the cause of the concern, the wheel and hub bearing surfaces will need to be cleaned of paint, thickness variation of the rotors checked and replaced if out of specification.
