# Service Bulletin

Bulletin No.: 23-NA-151

**Subject:** Hybrid/EV Battery, High Priority DTC's , Potential Loss of Isolation, Vehicle Handling and RESS Shipping Requirements

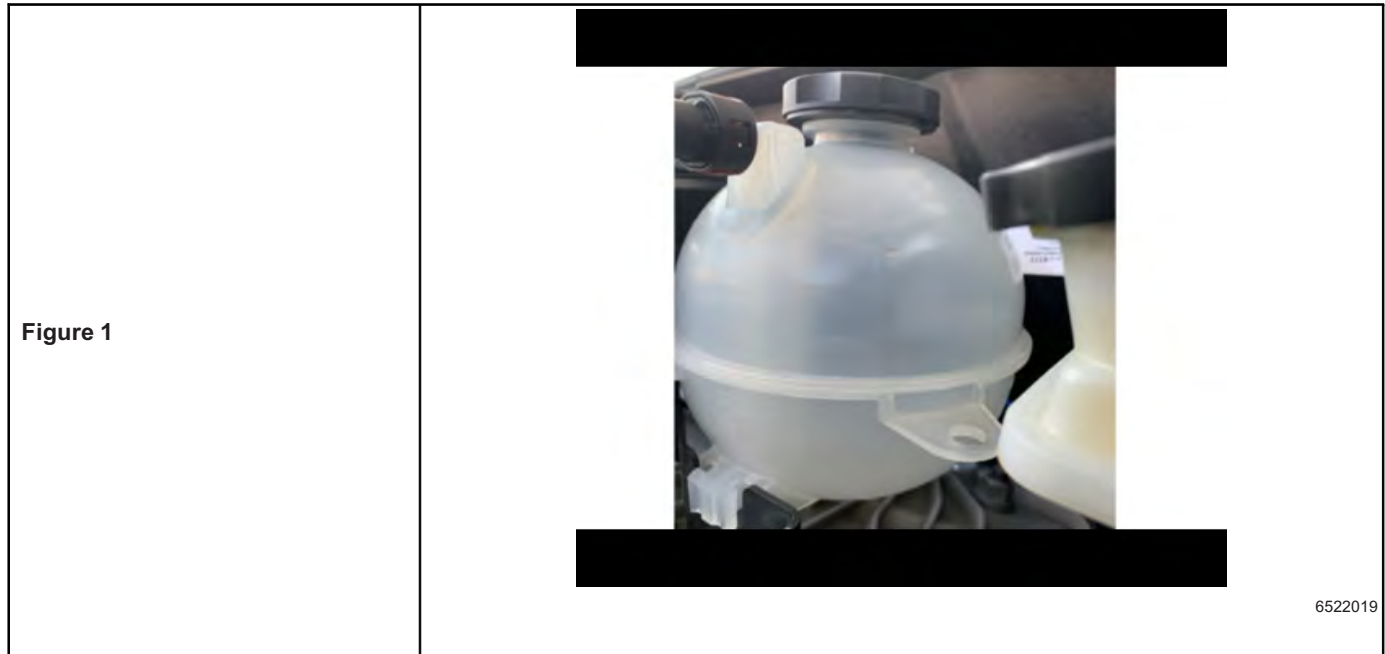
4. Visually inspect and document the coolant level in the high-voltage battery surge tank (Fig1) and document via photo. Inform TAC if coolant has previously been added.

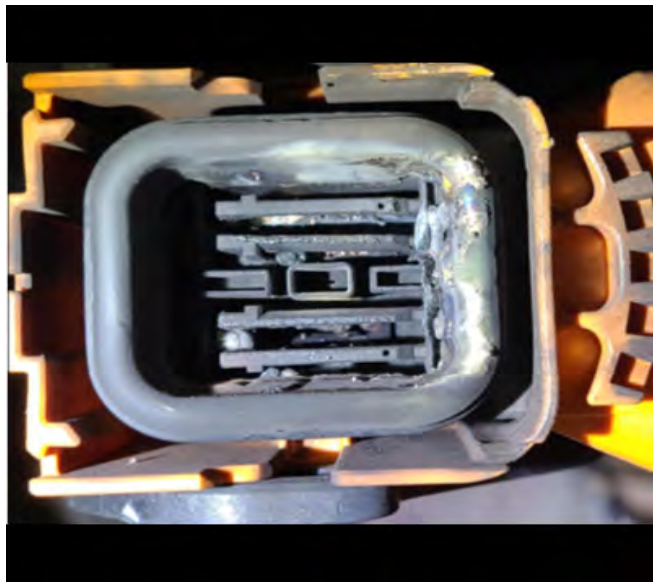
Figure 2 Soot Examples

11. During removal inspect the High Voltage Connectors at the High Voltage Battery for Corrosion, Moisture, and/or soot. (Fig2) Take Photos of HV Connectors and attach to TAC Case. Refer to the SI Procedure for High Voltage System Inspection.

**Note:** If corrosion or moisture is observed, stop all work and call TAC.

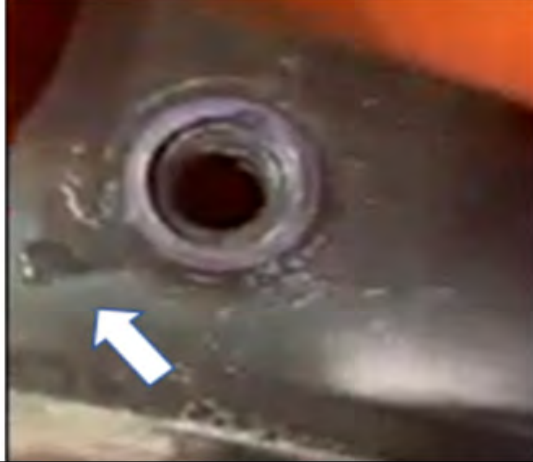
Figure 3 Liquid and Moisture Examples

13. After RESS is removed from vehicle, remove the High Voltage Battery Pressure Equalizer Vent Deflector(s) and/or Battery Inspection plug (if equipped) (Fig3). Using a cotton swab or paper towel to swab inside the enclosure for moisture or coolant. Take photos and attach to TAC case.

**Note:** If fluid is observed, stop all work and call TAC.
