SIB 31 01 22 DIAGNOSING FRONT AXLES ISSUES

2024-03-14

This Service Information Bulletin (Revision 1) replaces SI B31 01 22 **dated February 2022**.

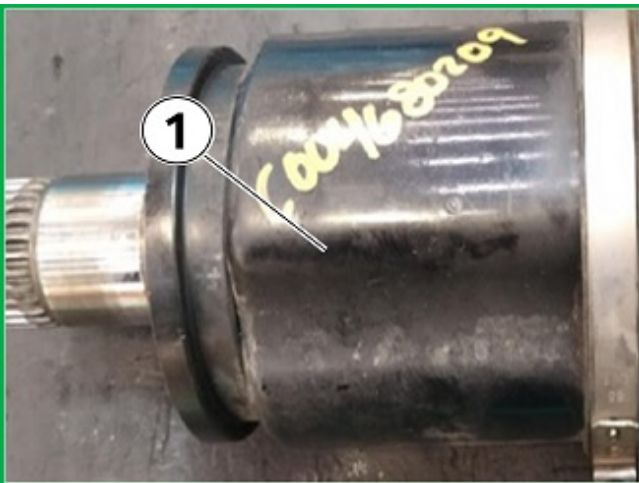
Example of dirt/contamination from outside influence (1).

A. The following are examples of good axles/boots. Do not replace.

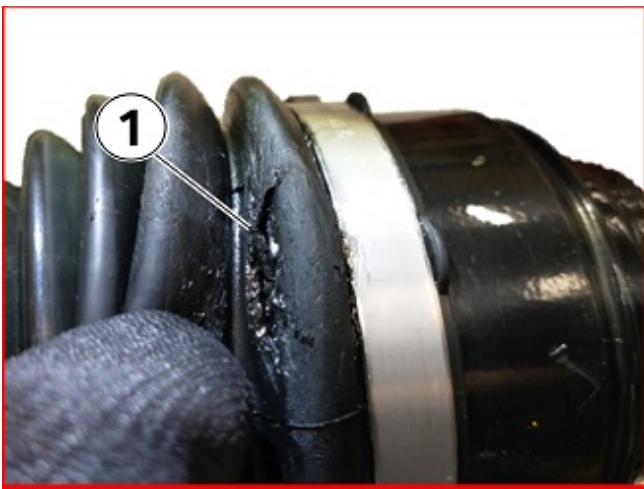
Tear or cut in the boot (1).

B. The following are examples of torn and/or leaking CV boots that require the necessary corresponding repair to be performed (CV boot/bellows repair kit installation or axle/output shaft replacement)

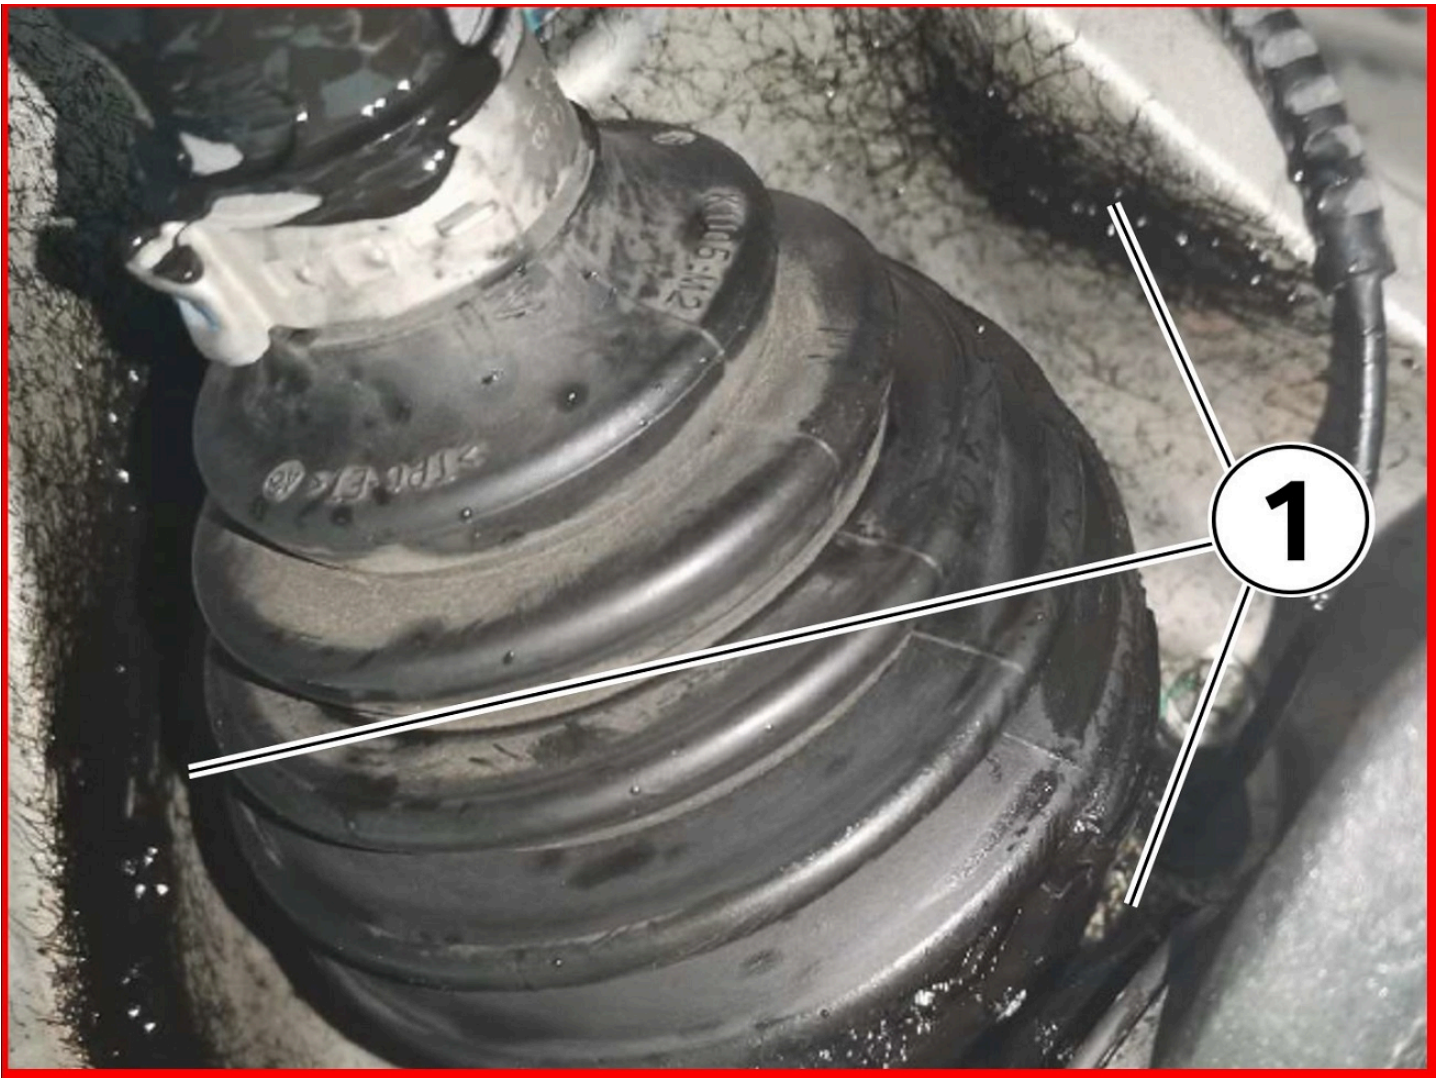
The below example is a boot that is dispersing grease around the outer carrier (1).

- There is a crack or tear in the CV boot
- There is a clamp missing from the CV boot
- The clamps can be easily moved/rotated (outside boot)
- There is visible grease slinging onto the components around the CV joint rotation area
