REFERENCE:	Nova Bus Manuals
SECTION:	12: Interior Furnishing
RS N°:	MQR 7621-2727
EFFECTIVE IN PROD.:	NA

SUBJECT:	Driver's Barrier Glass Breaking.
JUSTIFICATION:	The Driver's Barrier stationary glass is breaking in service due to possible metal to glass contact on the lower supports. The glass must have a minimum of 3mm gap all around the supports.

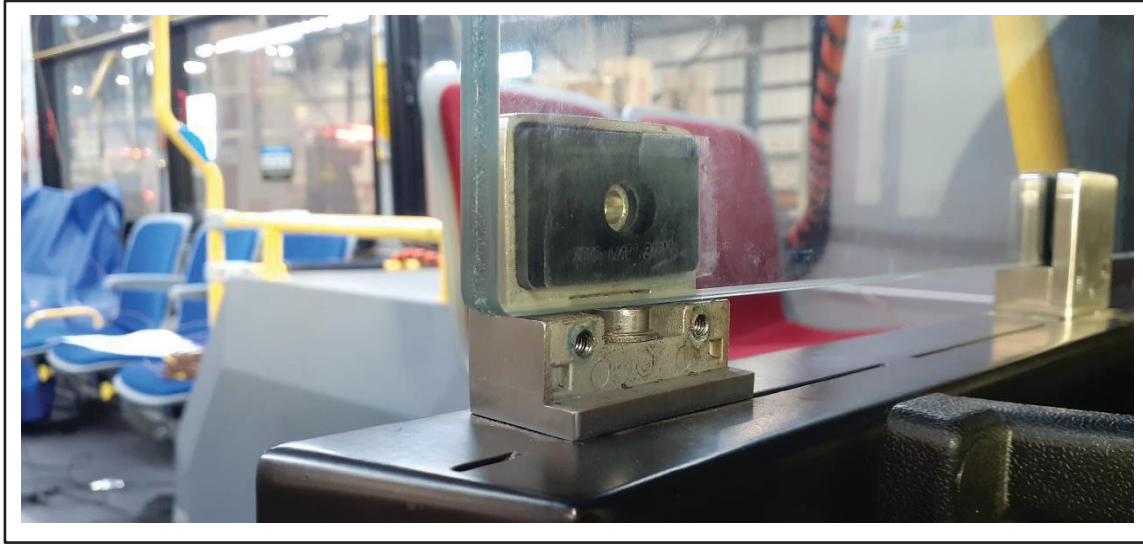
- 1.5. Remove the two bottom supports.

Figure 2 - Removal of Bottom Supports

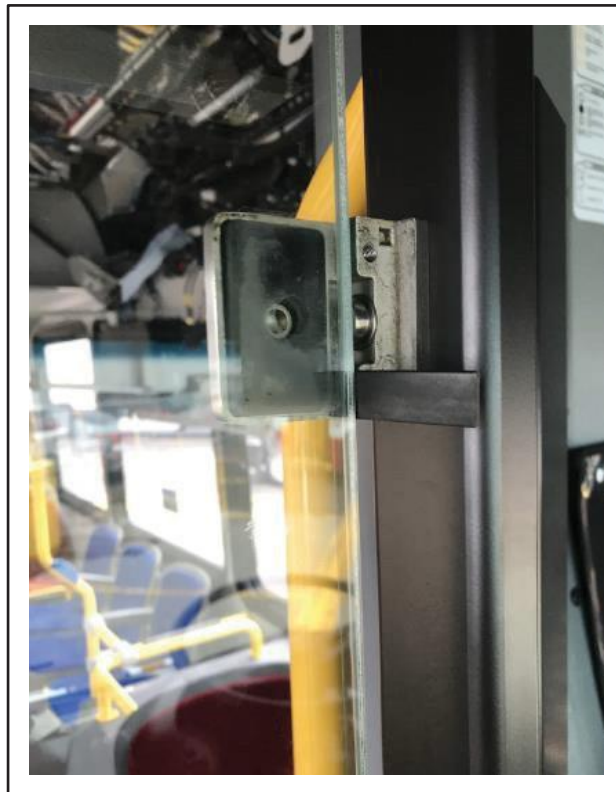
- 1.7. Use a 1/8" thick piece of rubber to ensure the side mounts have the 3 mm gap. Remove the support plates as required to ensure the glass is held securely.

Figure 4 - Ensure 3 mm Gap on Side mounts
