LIMITED SERVICE CAMPAIGN 20TD01 *Remedy Notice*

Certain 2012-2019 Model Year Sequoia Potentially Incorrect Toyota Genuine Carpet Floor Mats

LIMITED SERVICE CAMPAIGN 20TD01 (Remedy Notice)

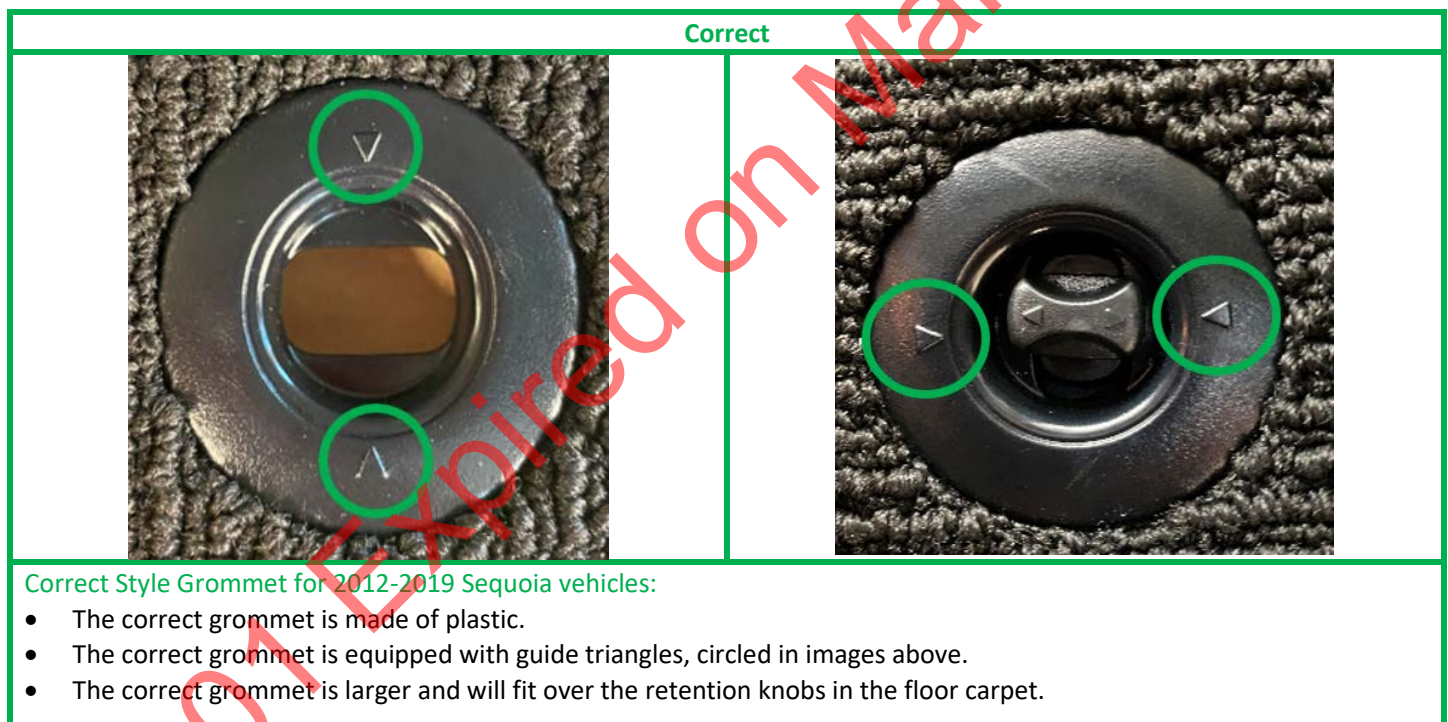
A2: Yes. Inspect attachment grommets in the **driver's floor mat** to determine if the vehicle has the incorrect Toyota Genuine carpet floor mats. See images below for examples.

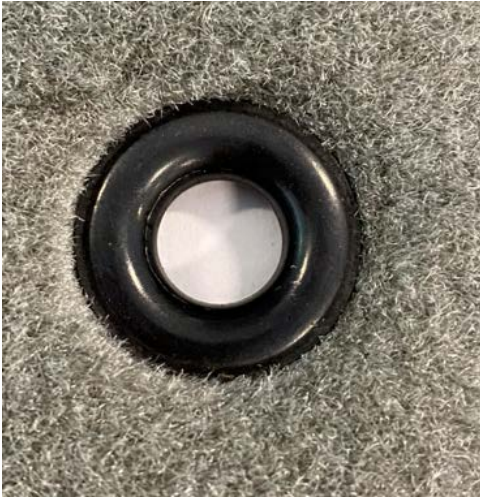
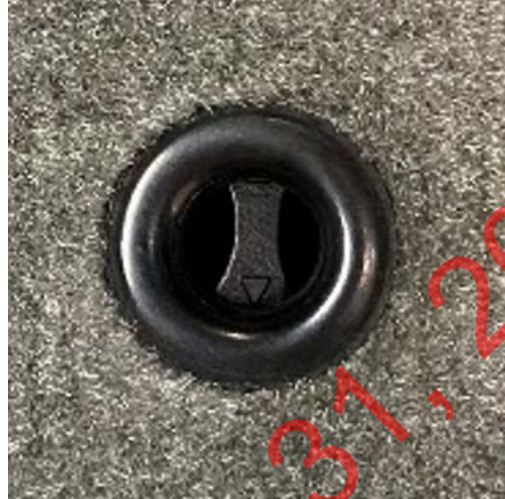
Incorrect Style Grommet for 2012-2019 Sequoia vehicles

- The incorrect grommet is made of metal.
- The incorrect grommet is **missing** guide triangles.
- The incorrect grommet is too small and will **not** fit over the retention knobs in the floor carpet.

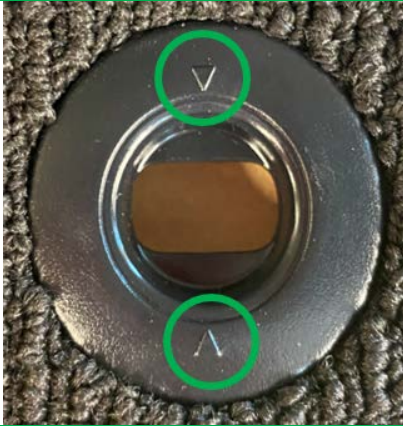
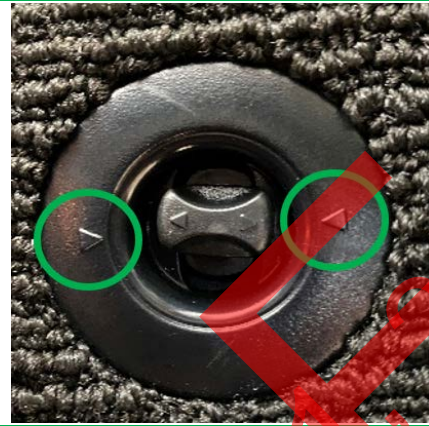
Correct Style Grommet for 2012-2019 Sequoia vehicles:

- The correct grommet is made of plastic.
- The correct grommet is equipped with guide triangles, circled in images above.
- The correct grommet is larger and will fit over the retention knobs in the floor carpet.

No: If you have completed the inspection yourself and the Toyota Genuine driver's carpet floor mat has the correct grommet like the example above in the **green** box, your vehicle was not equipped with the incorrect carpet floor mats designed for model year 2008-2011 Sequoia vehicles. In this case, please check the box on the attached insert and return it to us. No postage is necessary. Doing so will remove your vehicle's information from any future communication regarding this Limited Service Campaign.

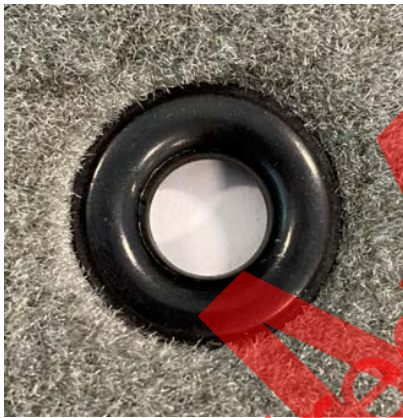
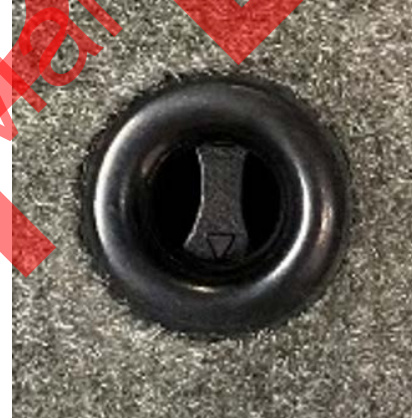
Incorrect Style Grommet for 2012-2019 Sequoia vehicles

- The incorrect grommet is made of metal.
- The incorrect grommet is missing guide triangles.
- The incorrect grommet is too small and will not fit over the retention knobs in the floor carpet.

Yes: If your Toyota Genuine driver's carpet floor mat has the incorrect grommet like the example above in the **red** box, please contact your authorized Toyota dealer to make an appointment to have the carpet floor mats replaced. The remedy will take approximately **thirty minutes**. However, depending on the dealer's work schedule, it may be necessary to make your vehicle available for a longer period of time. ***This Program will be offered until March 31, 2023, and will only be available at an authorized Toyota dealer.***
