Manufacturer's Communication to Dealer

MCD-003 Repair Instructions

Models Involved: 2016 – 2023 Allegro Open Road, Allegro RED 360, Allegro RED 340, and Phaeton Motorhomes equipped with an optional overhead bunk bed.

Purpose: Provide an additional latch if the operator of the motorhome does not properly latch the primary latch.

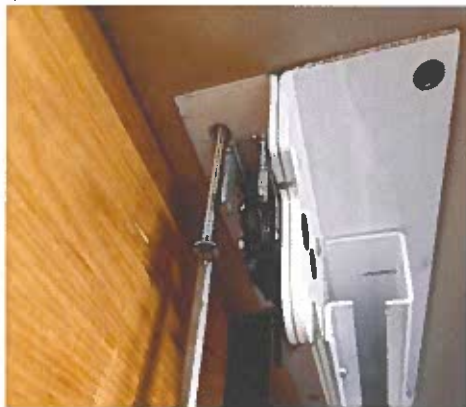
Figure 1

1. Using the 6" #2 Phillips head bit, remove rear screw on bunk unit just above driver's side latch (figure 1).

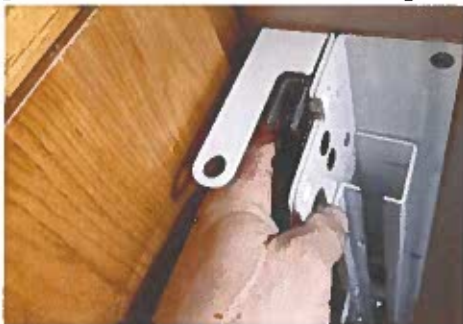
Figure 2a

2. Place bunk bracket 1 in position. Align the hole in the bracket with the hole the screw was removed from (figure 2a). Using the previously removed screw, secure the bunk bracket 1 to the bunk mechanism as shown in figure 2b. Make sure the bracket edge is aligned with edge of bunk mechanism.

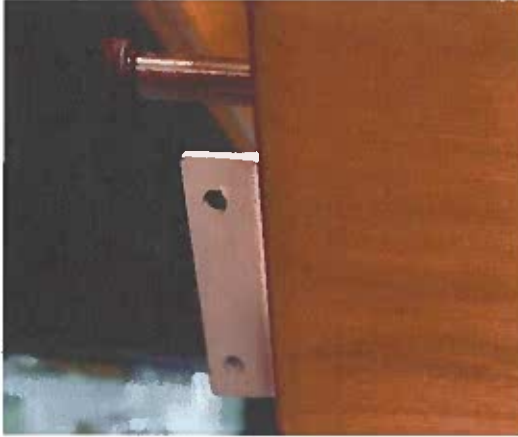
Figure 3a

3. Locate the white bucket on the driver's side of bunk (figure 3a). Secure bunk bracket 2 in position using the bolts, lock washers and nuts from the hardware kit. Bunk bracket 2 should be placed over bracket using the existing holes (figure 3b).

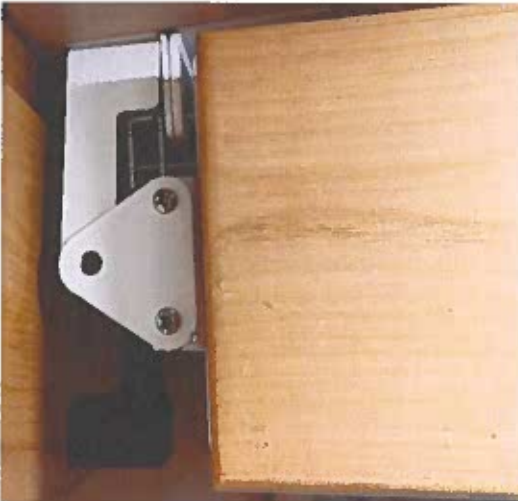
Figure 4a

4. Raise the bunk up to its top position, making sure both sides latch and that holes in bunk bracket 1 and bunk bracket 2 align (figure 4a). Place coupler pin from hardware kit through the aligned holes of the bunk bracket 1 and bunk bracket 2 (figure 4b).

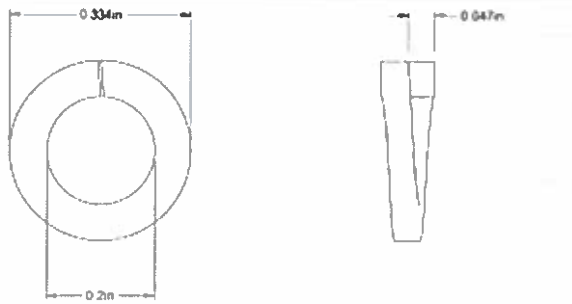
QTY - 2 18-8 STAINLESS SPLIT LOCK WASHER #10

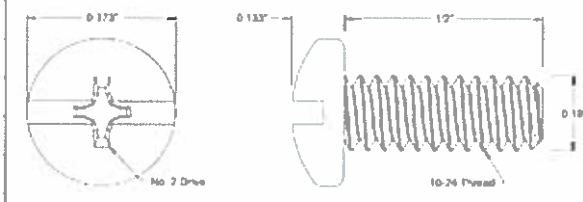
QTY - 2 10-24 STAINLESS BOLT 1/2"

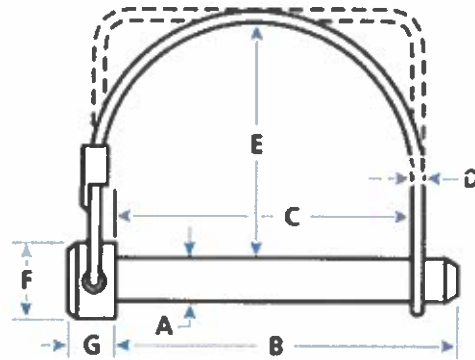
QTY - 1 COUPLER PIN - MCMaster-CARR

A - 1/4"
 B - 2" MAX
 C - 1 3/8" MAX

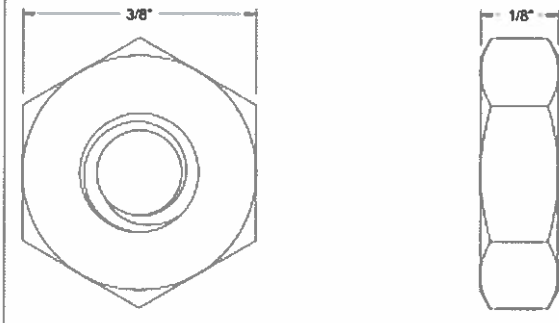
QTY - 2 18-8 STAINLESS HEX NUT 10-24 THREAD
