# Technical Service Bulletin

<b>GROUP</b>	<b>NUMBER</b>
<b>BODY</b>	<b>24-BD-005G</b>
<b>DATE</b>	<b>MODEL(S)</b>
<b>MARCH 2024</b>	<b>GV60 (JW1)</b>

**SUBJECT:** FRONT SEAT TRACK MINOR PLAY REPAIR

**Description:** This bulletin describes the procedure to repair front seats that exhibit minor play while the vehicle is accelerating and/or braking. The repair procedure involves replacing the seat track bolts and washers and initializing the power seat module.

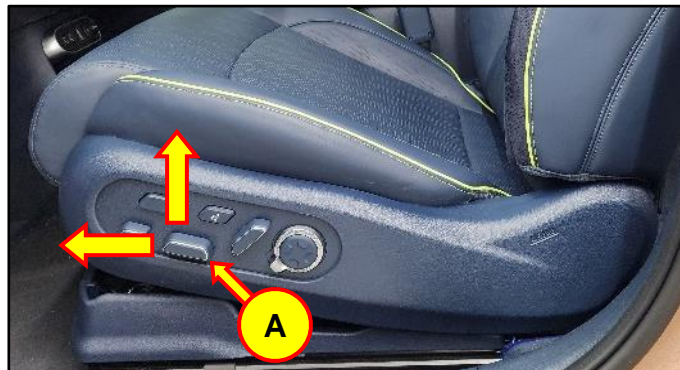
1. Use the adjustment switch (A) to move the front seat fully forward and tilt the cushion completely upward.

The seat track bolt holes may be misaligned if the seat position and cushion tilt are not in the correct position.

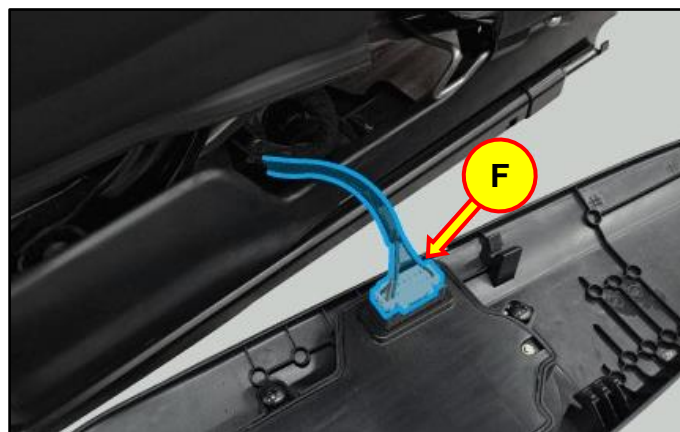
4. Disconnect the front seat power switch connector (F) and remove the outer shield cover.

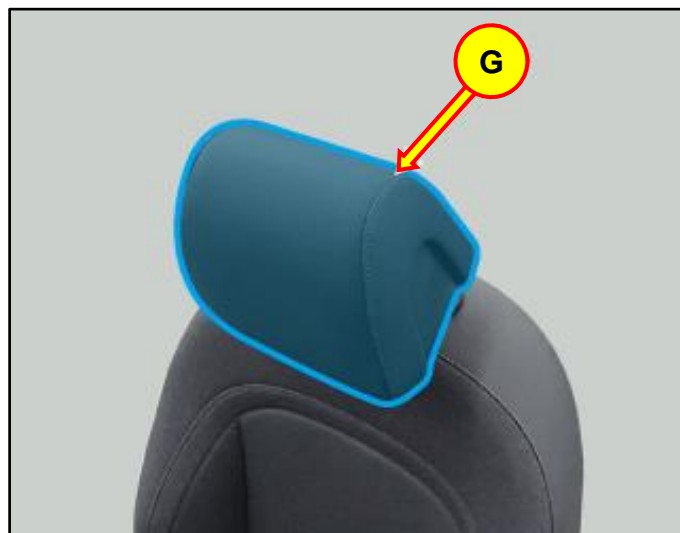
5. Remove the front seat headrest (G).

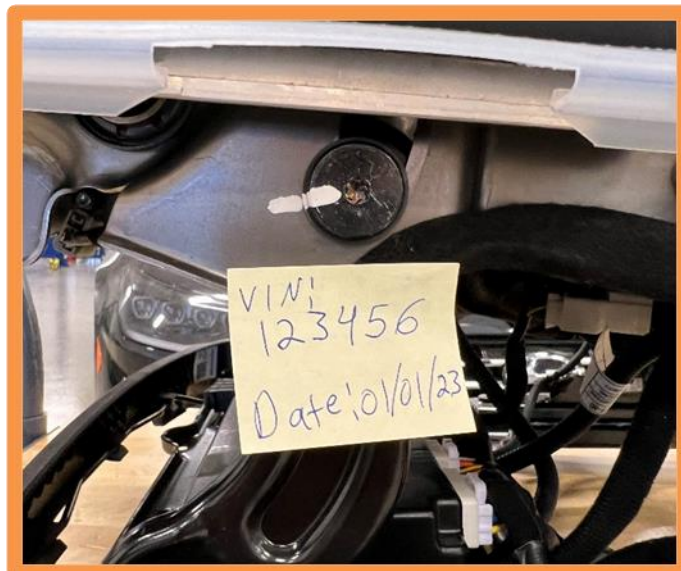
11. Install and fully tighten the new washer and bolt with a hand tool.

**Tightening Torque:**

lb-ft	12
N.m	15

Use a hand tool to remove the seat track bolt. Do **NOT** use air or power tools.  
 Only remove/install one bolt on one side at a time. Do **NOT** remove the bolts on both sides at the same time.

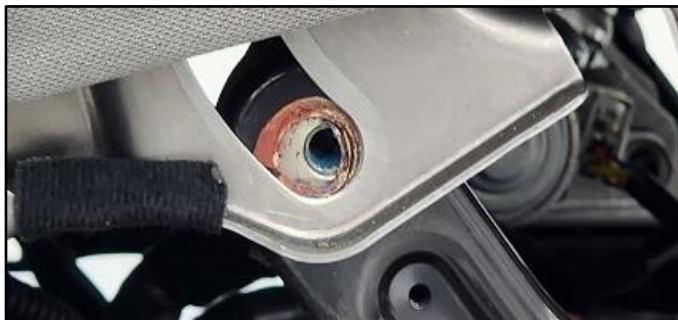
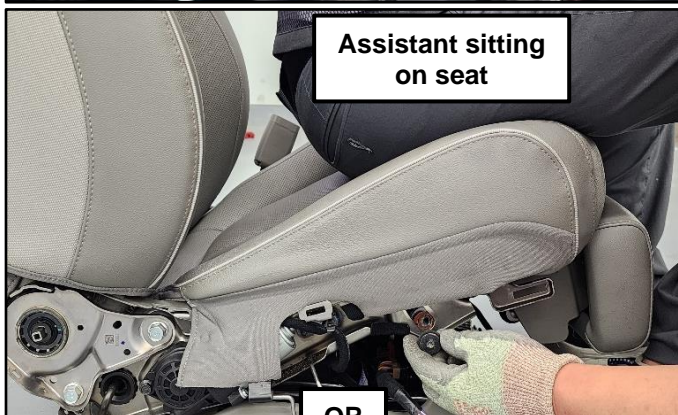
- The inner bolt hole may become misaligned when the inner bolt is removed.

If this occurs, an assistant will need to sit on the seat or apply pressure (body weight) to the opposite side of the seat cushion to realign the inner bolt hole and allow for inner bolt installation.

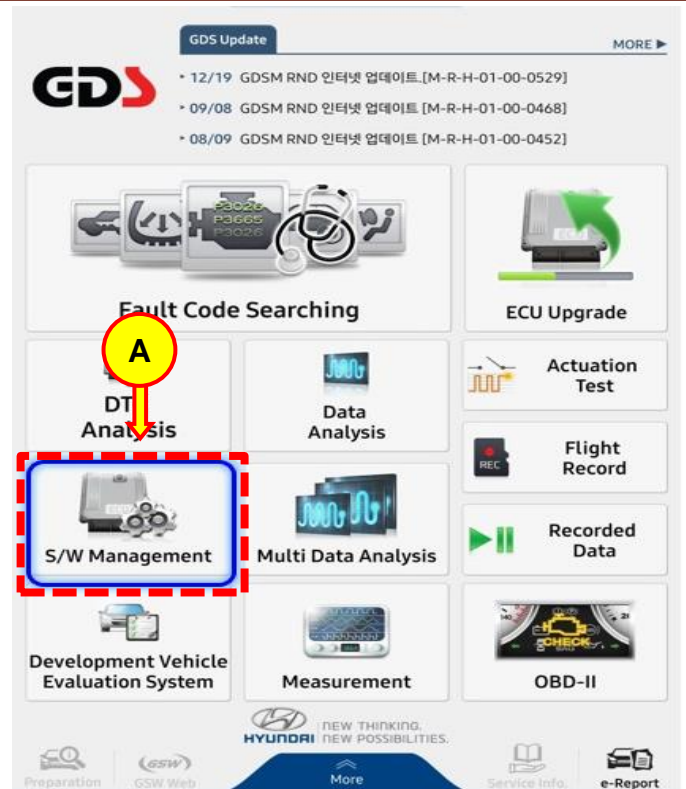
1. Connect the GDS-M and select the **S/W Management (A)**.

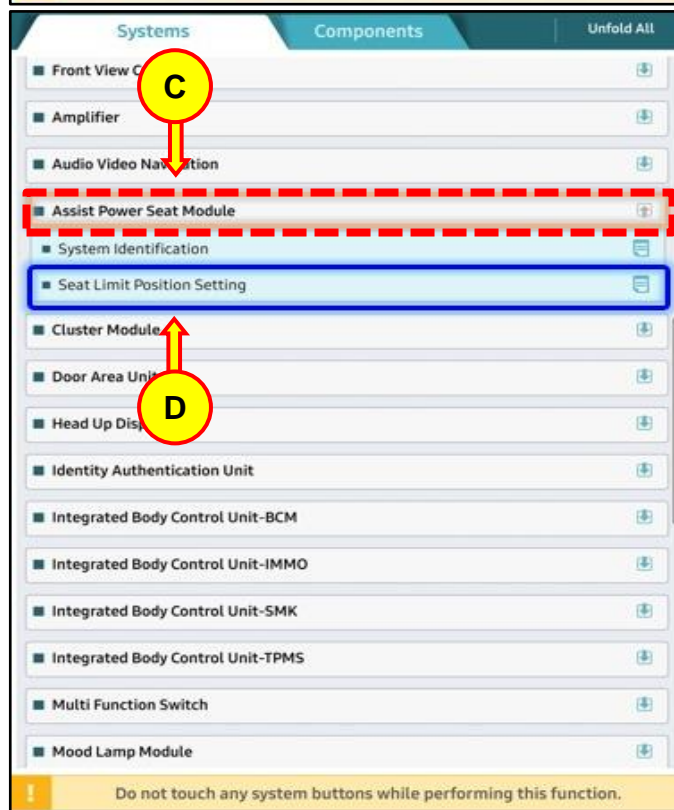
2. Select **Power Seat Module (B)** when initializing the driver's seat or **Assist Power Seat Module (C)** when initializing the passenger's seat, then select the **Seat Limit Position Setting (D)**.

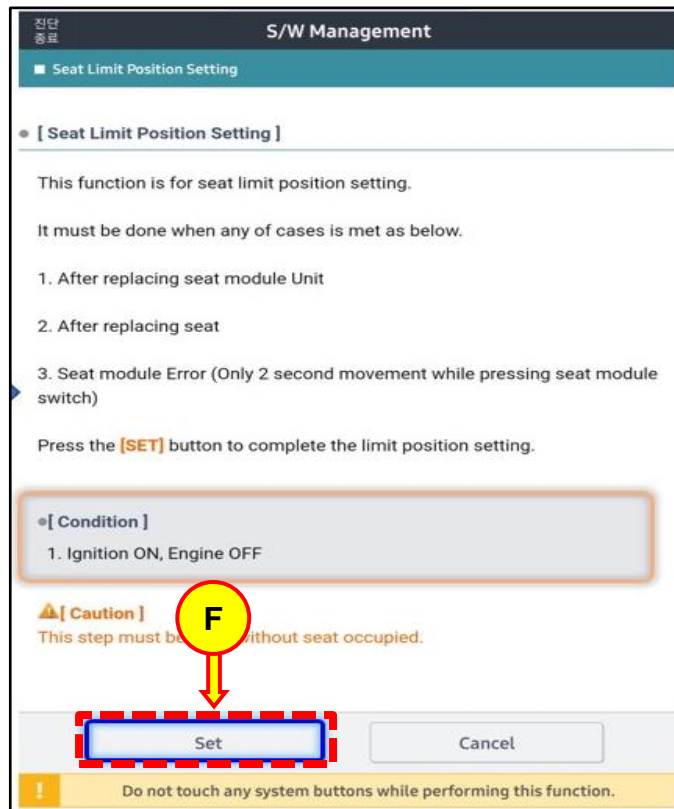
4. Ensure the engine is **OFF** and ignition key is **ON** before pressing **Set** (F).
