Bulletin type: **FIELD FIX CONDITIONAL**

Subject: SEGE passenger seat recline
lever improvement

Bulletin Number: **TS45-FC-2403**

Vehicle Model: **TS45**

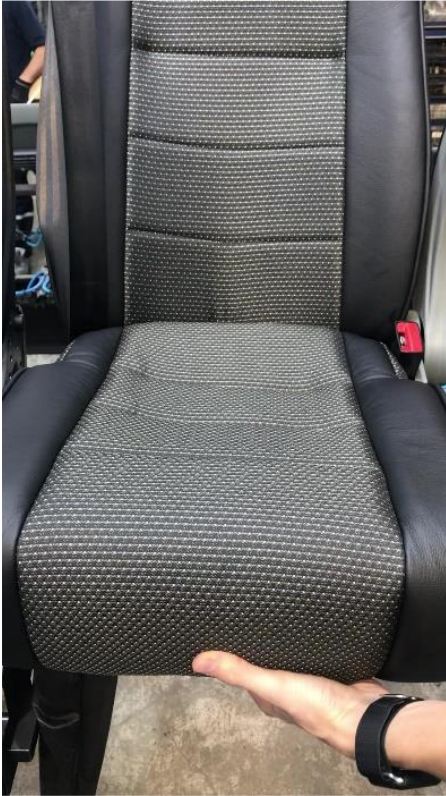
2- Remove the seat cushion.

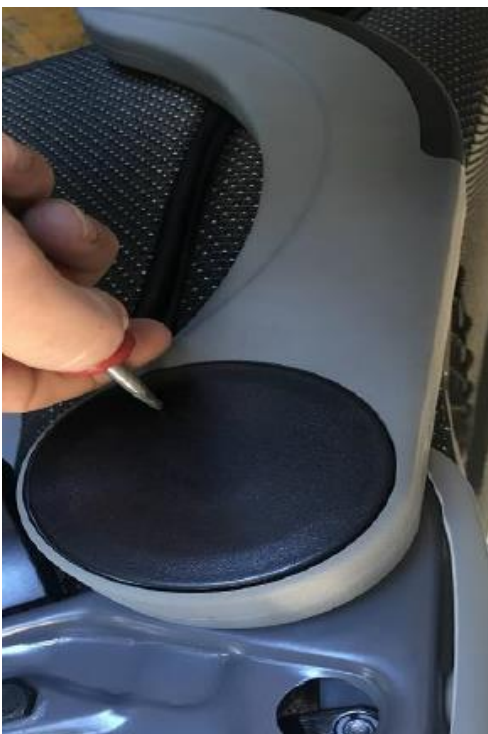
3- Remove the armrest cover with prickle needle.

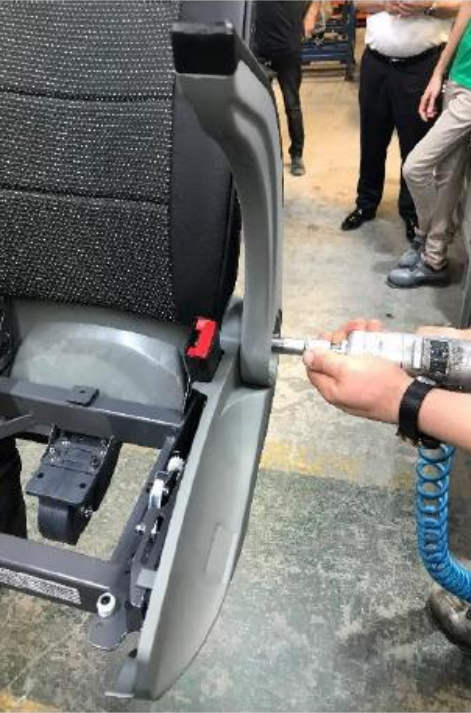
4- Armrest is removed with torque gun or wrench with 13 socket set.

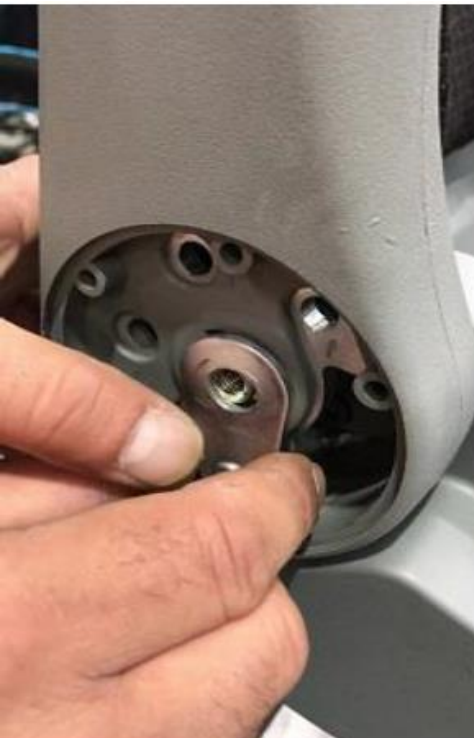
5- Remove the metal part by hand.

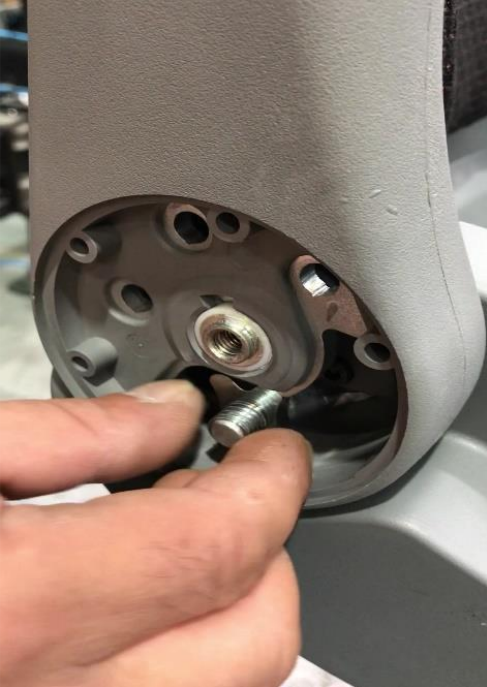
6- Remove the butterfly and spring by hand.

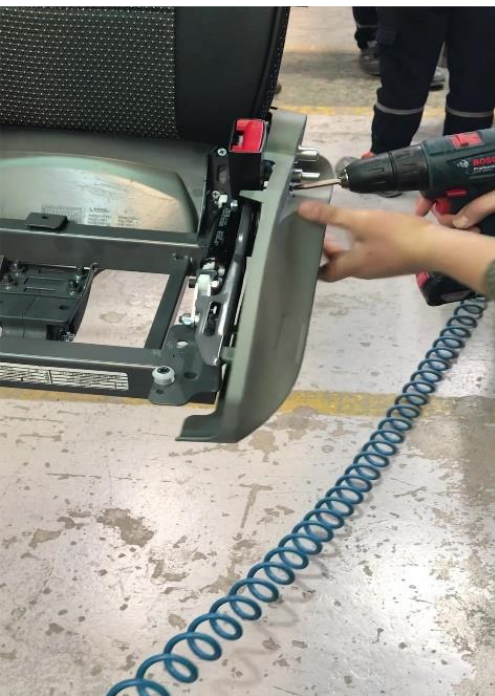
7- Remove the side cover with driller.

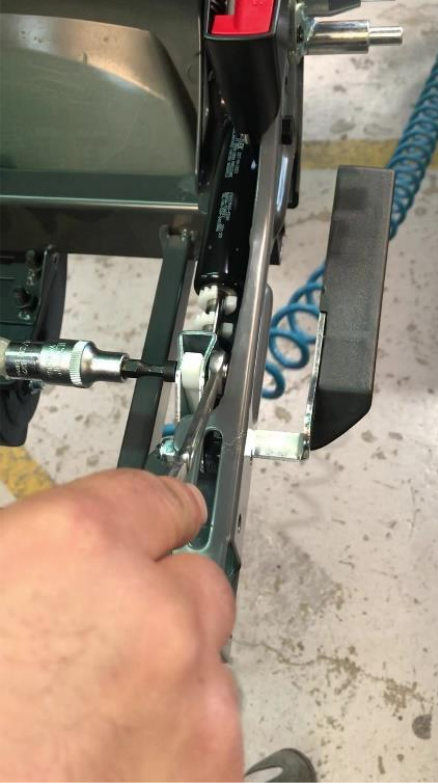
8- Remove the reclining handle with 10 wrench + 5 hex key wrench.

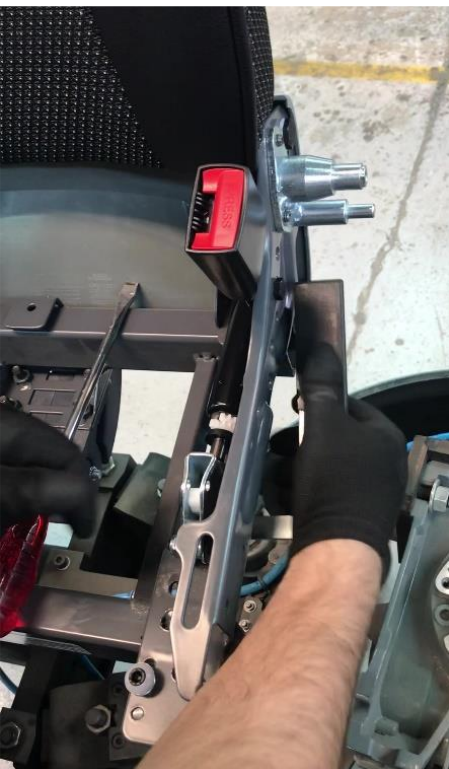
9- Remove the reclining handle completely by pulling down.

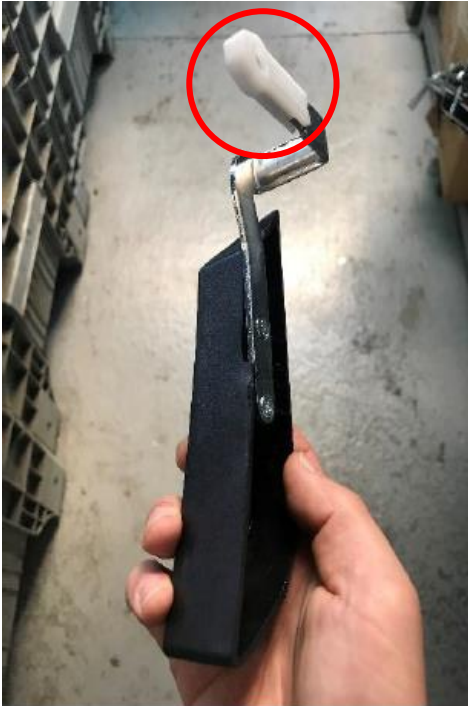
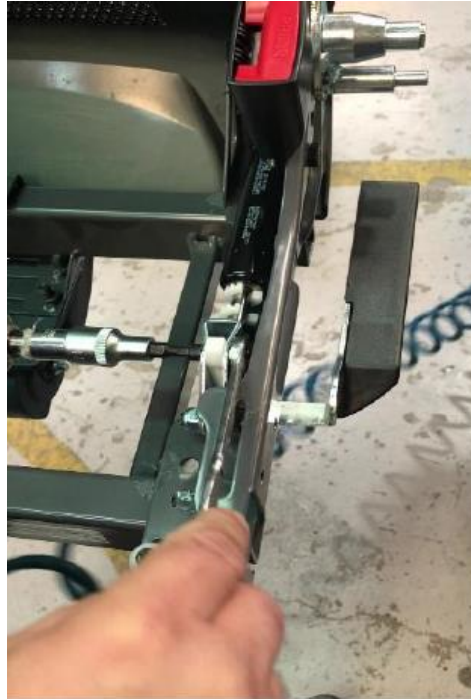
10- Mount the new handle on plastic button.

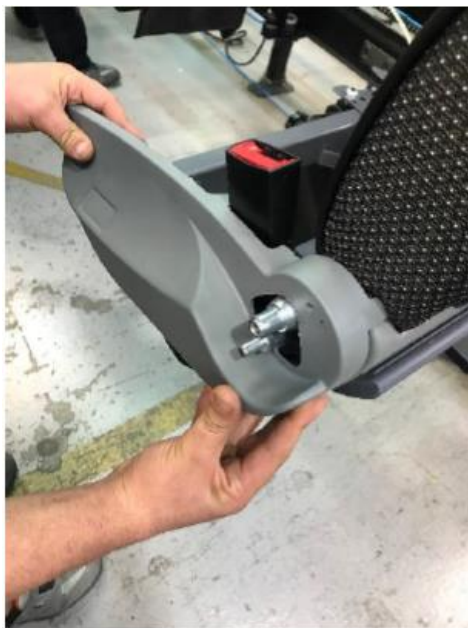
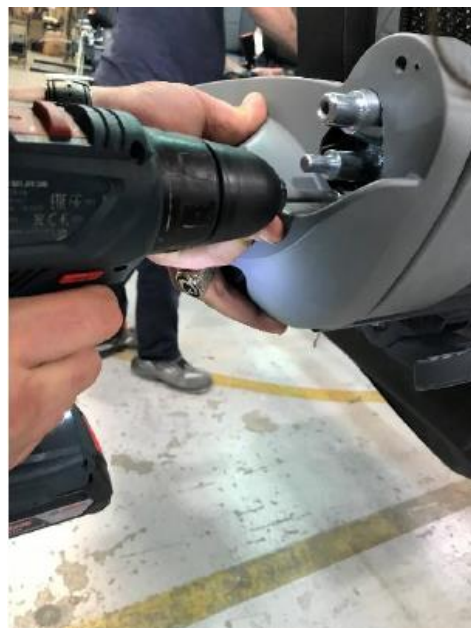
11- Mount the side cover.

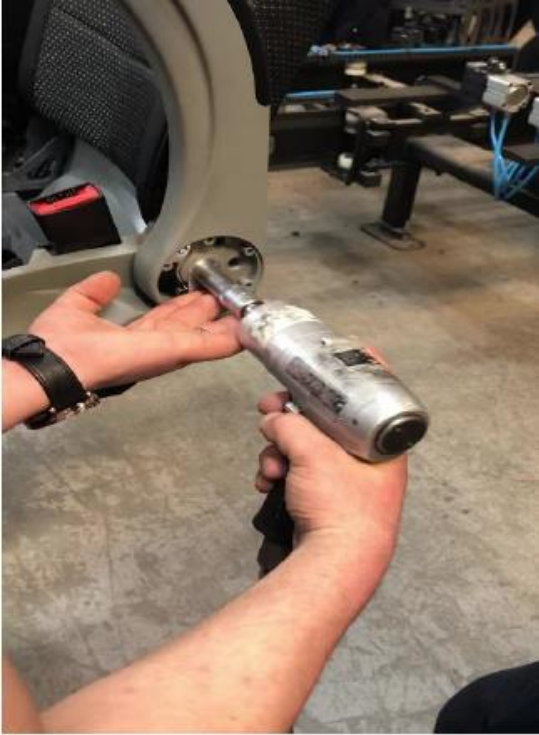
12- Mount the metal part + spring + butterfly + armrest.

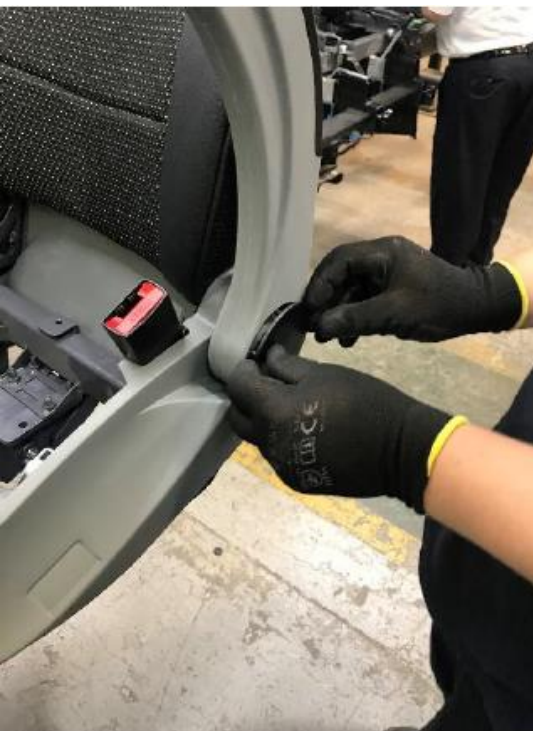
13- Mount the armrest cover.

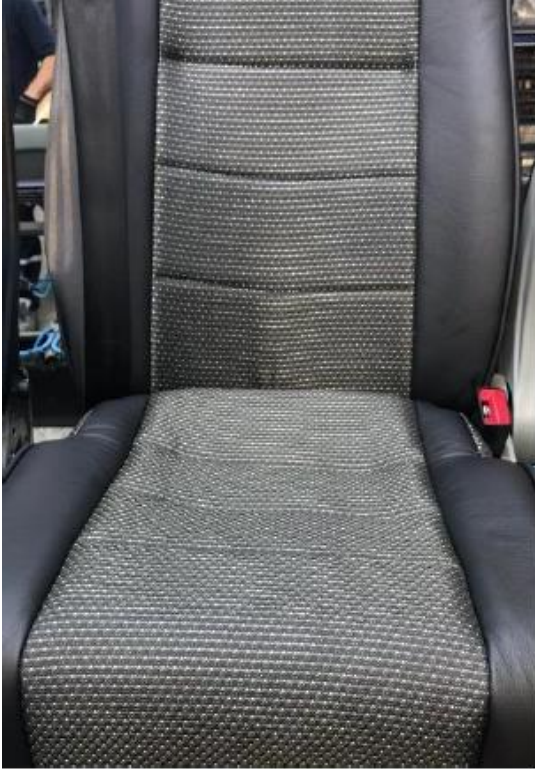
14- Mount the seat cushion.
