## SERVICE BULLETIN

<b>APPLICABILITY:</b>	2019MY Legacy & Outback				
	2019-21MY WRX

NUMBER:	15-318-24R
DATE:	02/23/24
<b>REVISED:</b>	03/19/24

SUBJECT: Data Communication Module (DCM) Bypass Box

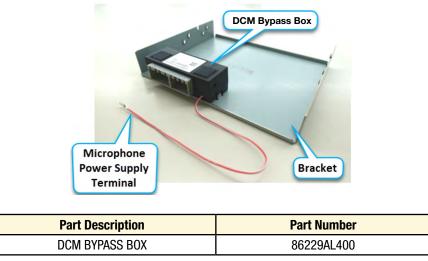
### **PART INFORMATION:**

This bulletin announces the availability of the DCM Bypass Box designed to be used as an alternative replacement part for Data Communication Module (DCM) in vehicles with no active STARLINK subscription. If the diagnosis leads to the replacement of the DCM, the DCM Bypass Box can be used in place of a DCM to support audio input/output functions for infotainment system.

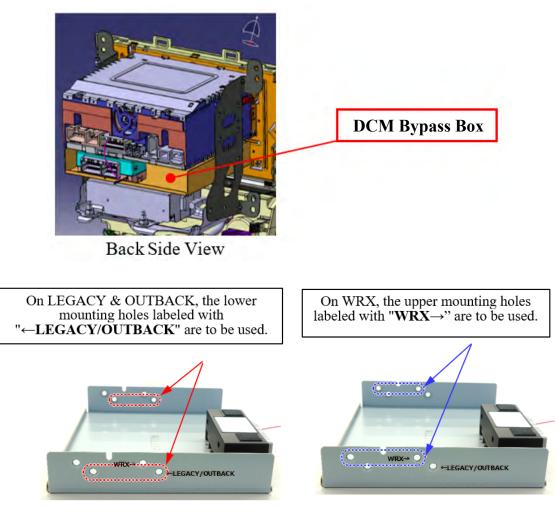
**STEP 1:** Mount the DCM Bypass Box with the brackets in place of the DCM.

Left side of the DCM Bypass Box.

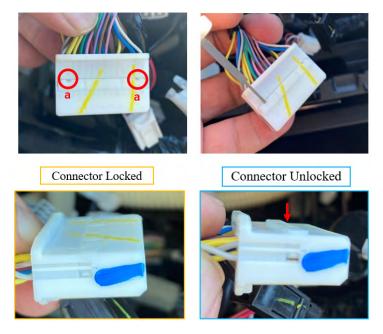
**STEP 3:** Using a small precision screwdriver or pin terminal tool, release and raise the lock located on the back on the connector. The lock release points are located as (a) in the image below.

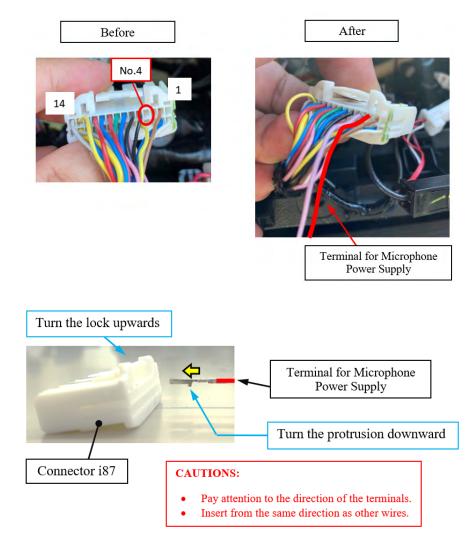
STEP 4: Insert the microphone power terminal into pin #4 of head unit connector i87.

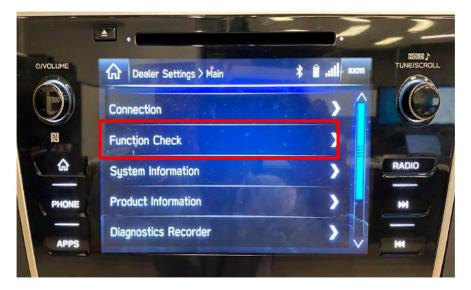
- **A.** Turn the ignition switch to ACC.
- **B.** Press the "Tune/Scroll" knob six times while pressing the "HOME" button.
- C. Select "Function Check".

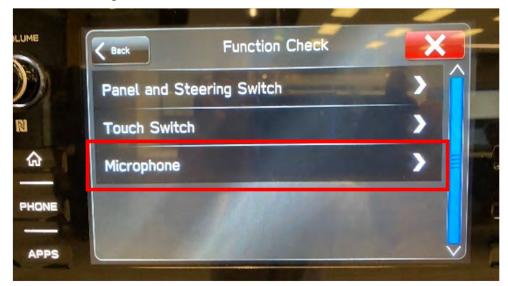
**D.** Select "Microphone".

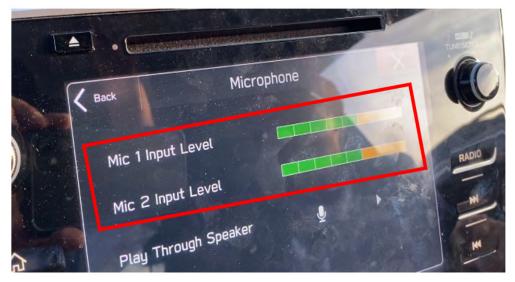
E. Confirm "Mic 1 Input Level" and "Mic 2 Input Level" are operational.

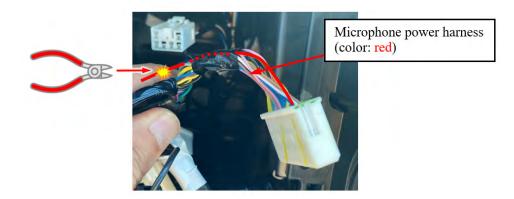
- A. Remove the screws and release the clip.
- **B.** Disconnect the connector and remove the audio assembly.
- C. Cut the microphone power wire (color: red) at the end of connector i87 pin #4.

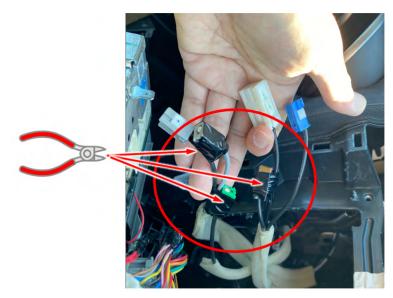
E. Remove the tape from the three bundled antenna connectors.
