TECHNICAL SERVICE BULLETIN

2019-2021 Transit - Driver Seat Cushion Sagging - Built On Or Before 11-Feb-2021

24-2053

14 March
2024

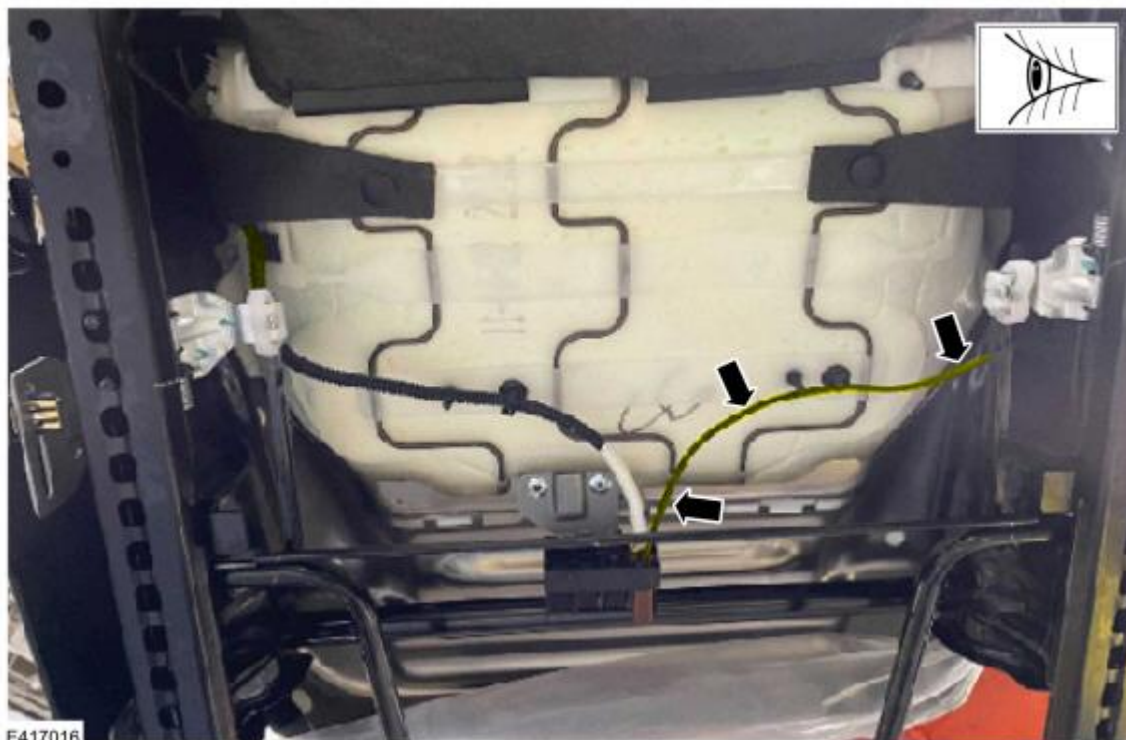
Figure 1

1. Remove the affected driver seat track. Refer to WSM, Section 501-10A, starting with Step 2.
2. Inspect the seat airbag deployment circuit for damage as shown in Figure 1. If damage is present, replace the side airbag. Refer to WSM, Section 501-20B.

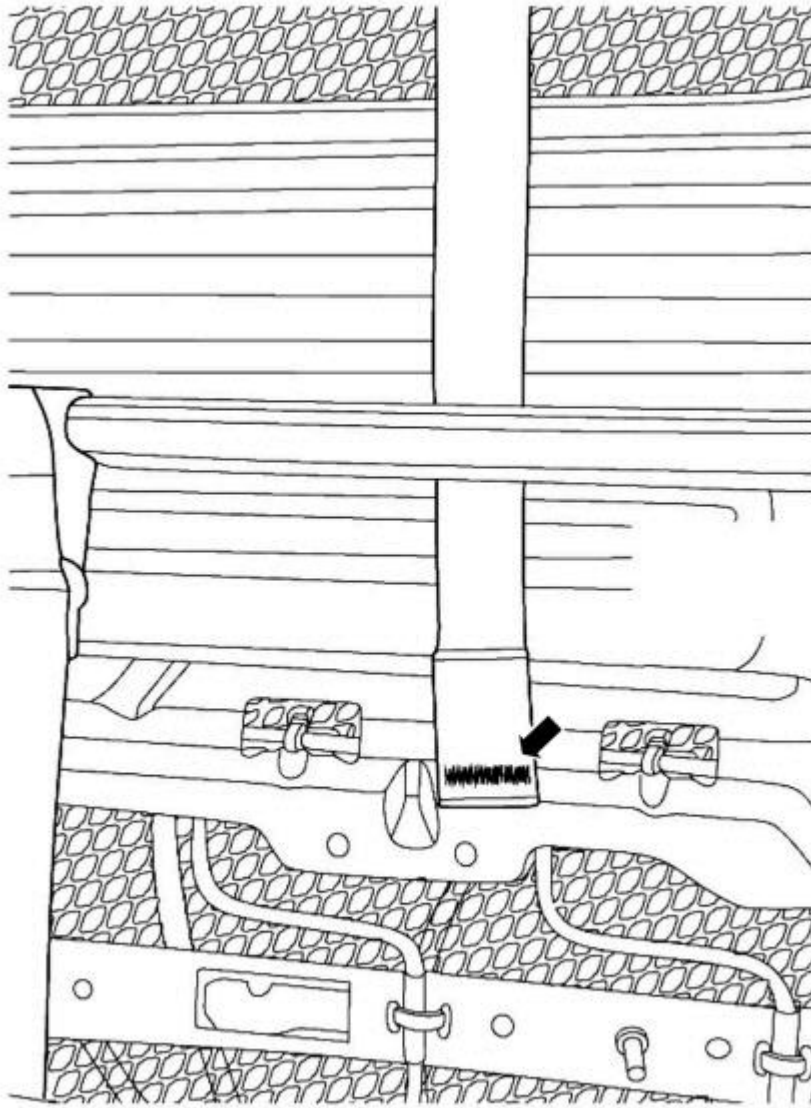
Figure 4

(1). With the red thread visible, route the end of the 1st webbing strap assembly without the metal ring between the cushion pan and the front cross-car tube. (Figure 4)

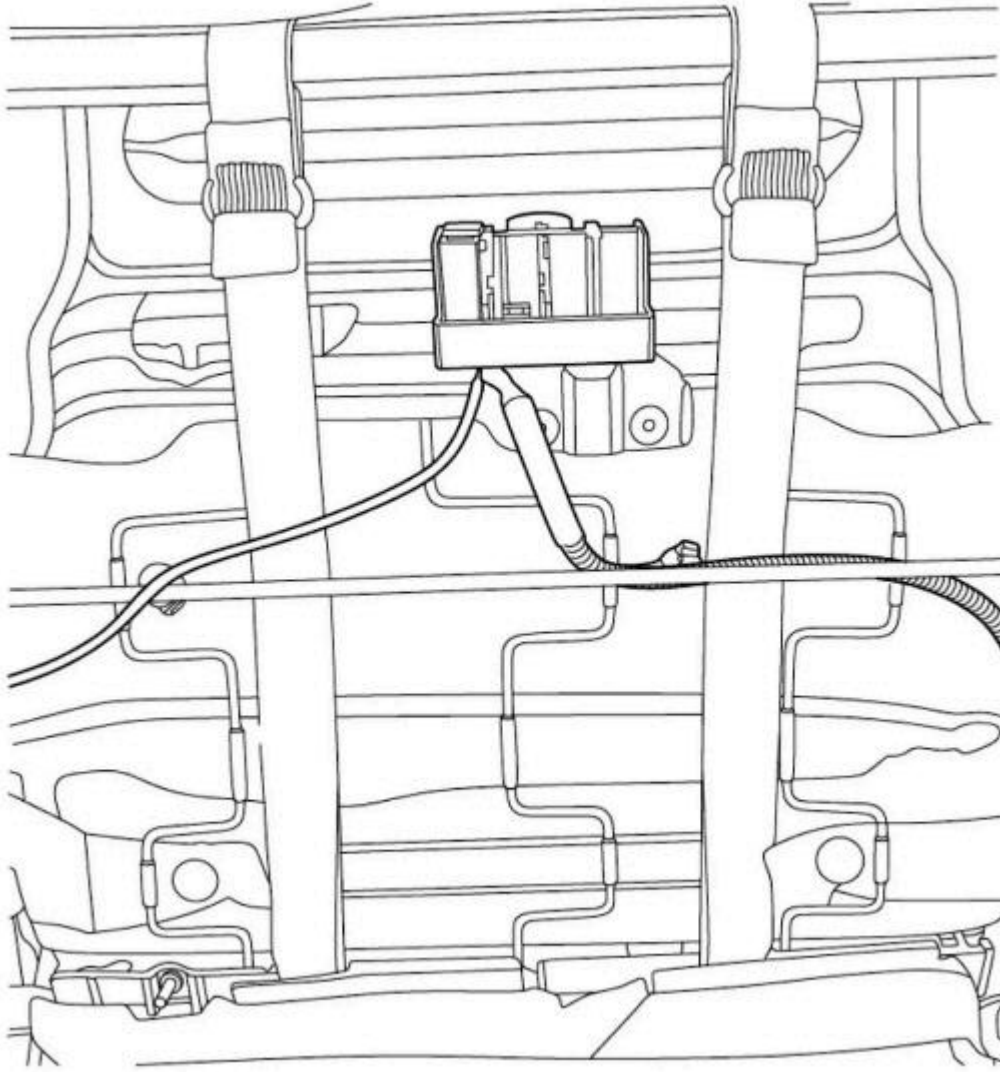
Figure 6

(3). Make sure all electrical harnesses are below the webbing. The final assembly will have the suspension mat on top (closest to the seat cushion), then the webbing straps, and then the wire harnesses on the bottom. (Figure 6)

NOTE: Make sure all electrical harnesses hang below the webbing and not between the webbing and suspension mat. When the final assembly is installed in the vehicle, it will have the suspension mat on top (closest to the cushion), then the webbing straps, and then the wire harnesses on the bottom. (Figure 6)

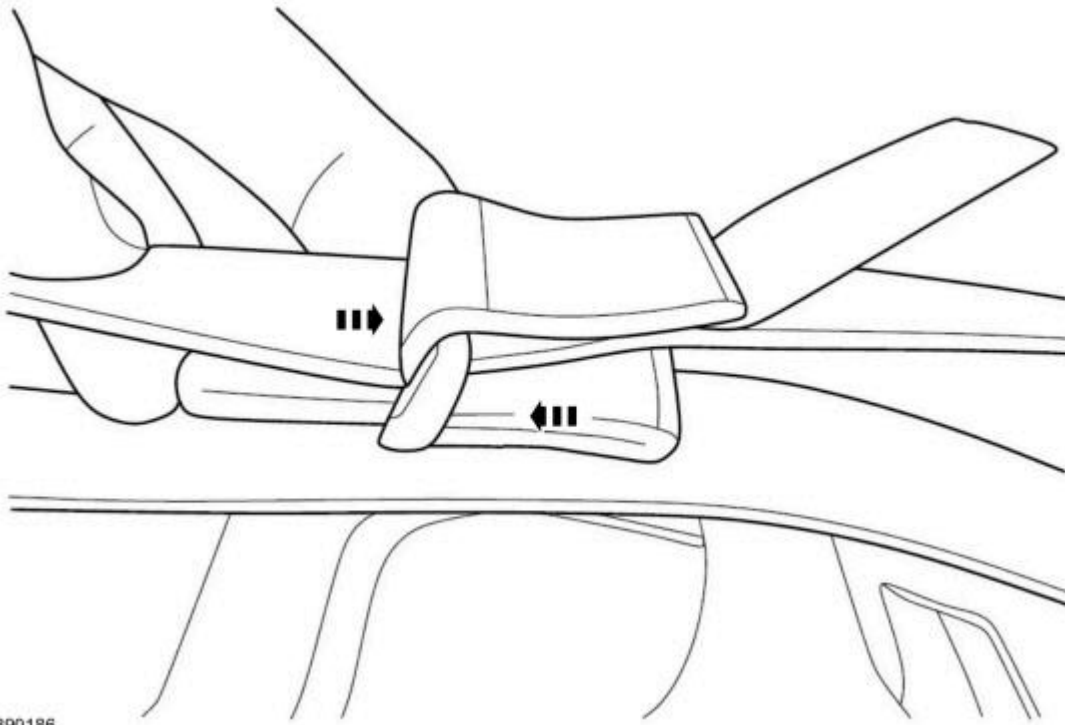
Figure 7

(4). Bring the webbing strap assembly to the metal ring and insert it. After the fold is all the way through the ring, pull the retention fold back and into position. (Figure 7)

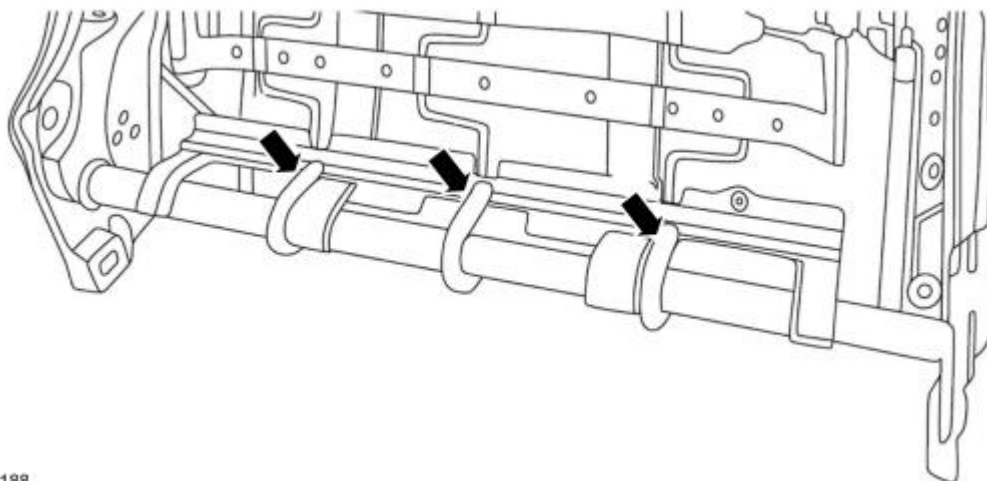
Figure 9

(2). At the rear tube verify one webbing is located between the left and center suspension attachment and the other is between the center and right suspension attachment. (Figure 9)

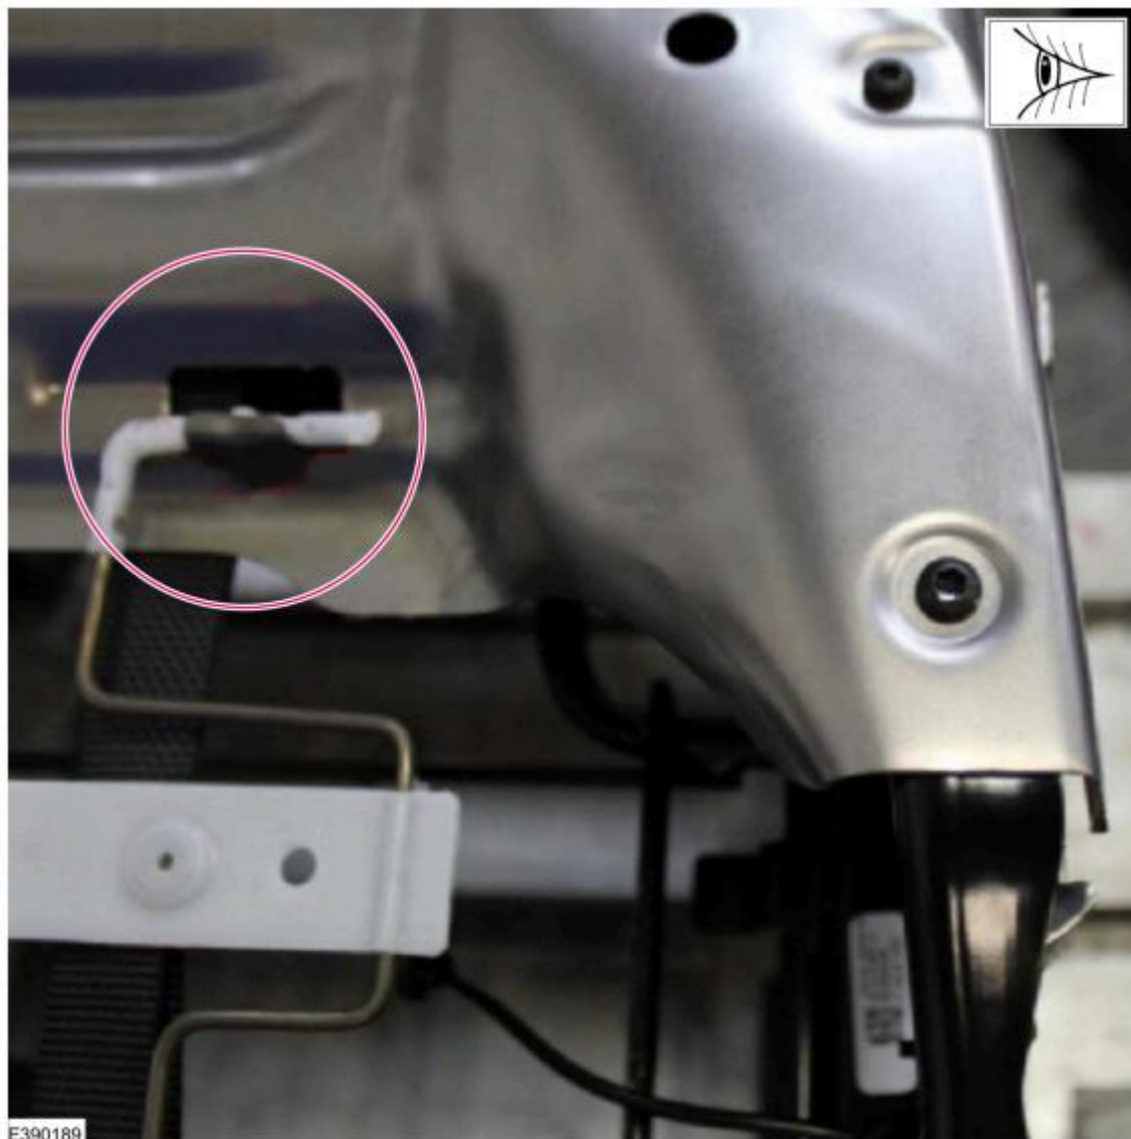
Figure 10

(4). Secure the front of the suspension mat to the retaining tabs on the cushion pan (no tools required). (Figure 10)

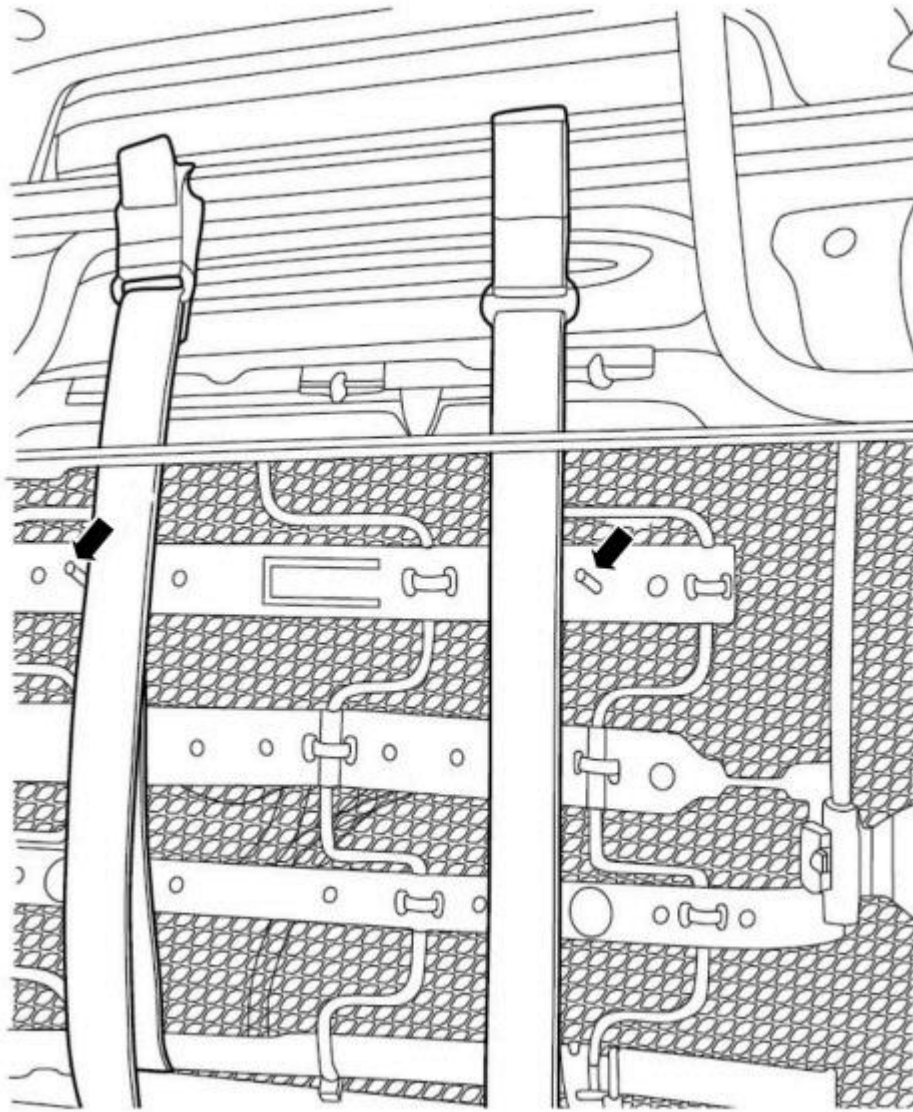
Figure 11

(5). Verify the cross-car position of the webbings. The position should be aligned with the stud on the suspension mat. (Figure 11)

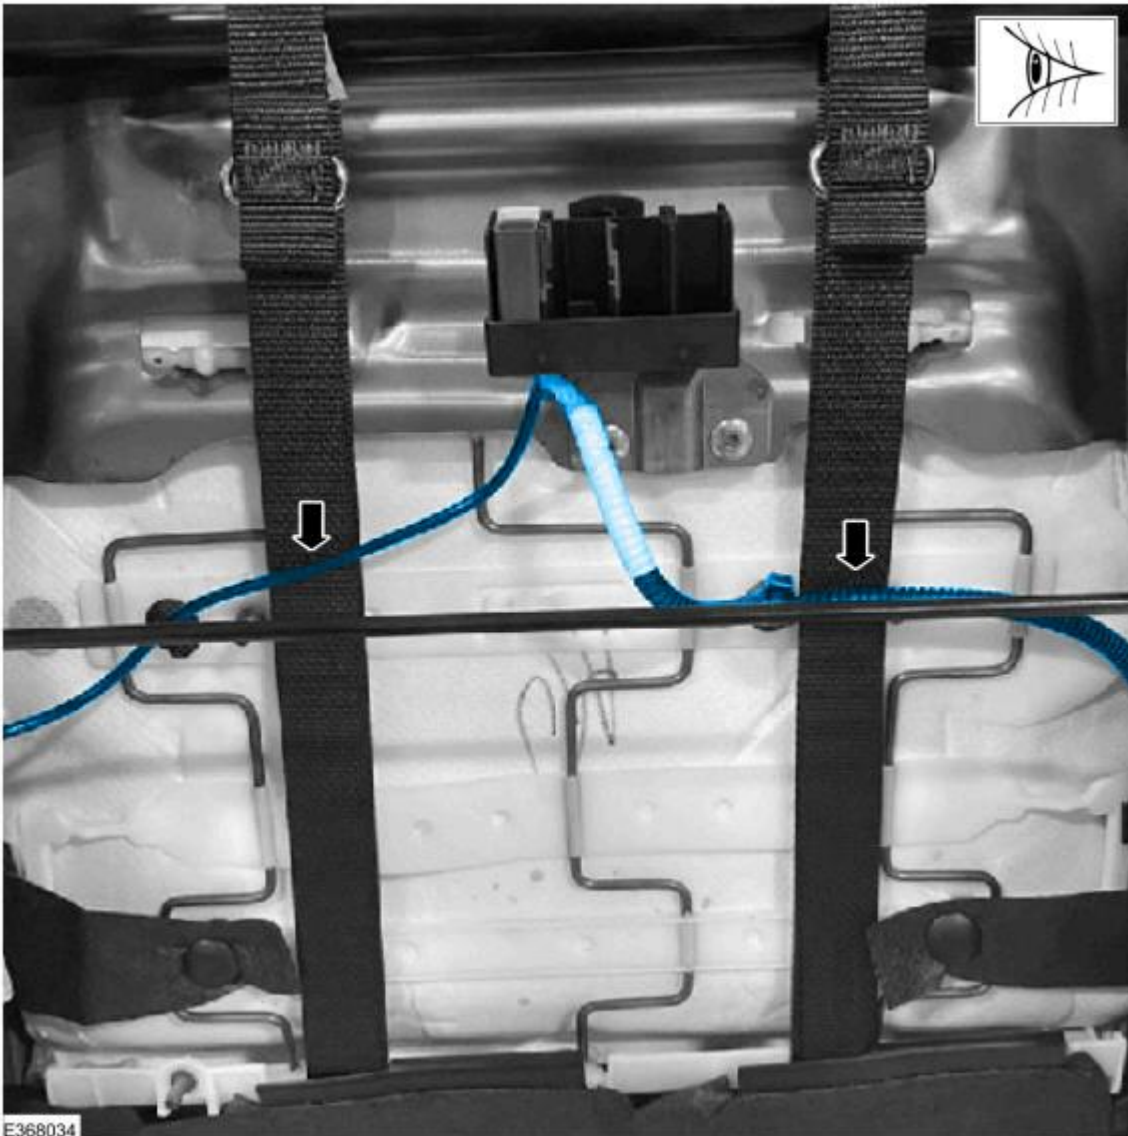
Figure 12

(6). Secure the wire harness(es) to the suspension mat. (Figure 12)

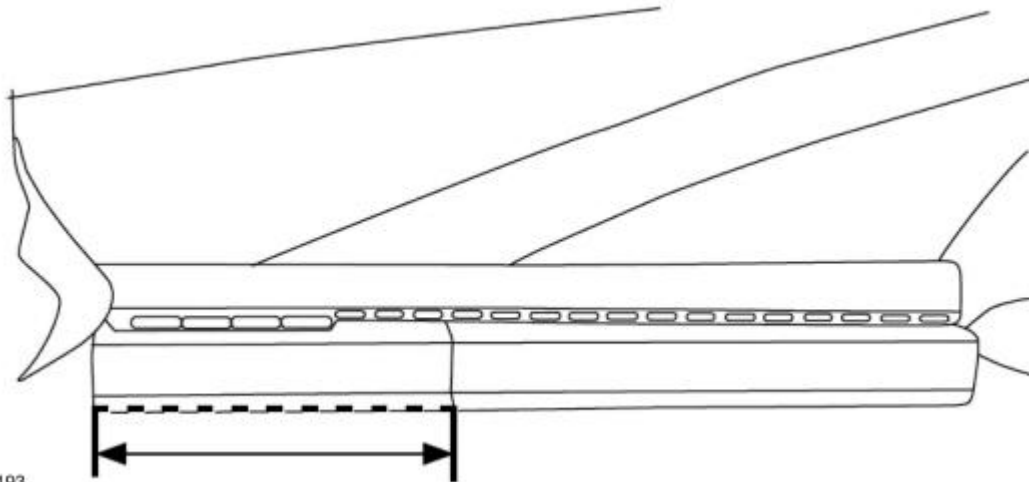
Figure 14

(2). Cut along the dotted line (Figures 14-15), perpendicular to the previous cut, so that the portion of the J retainer in Figures 16 and 17 can be removed.
