41/24 ENU 7201

Front Seat Symptom - Noises from the Area of the Seat Backrest: Rework Upholstery Support and Backrest Cover (SY 41/24)

Model Line: **Panamera (YAA)**

Model Year: **As of 2024**

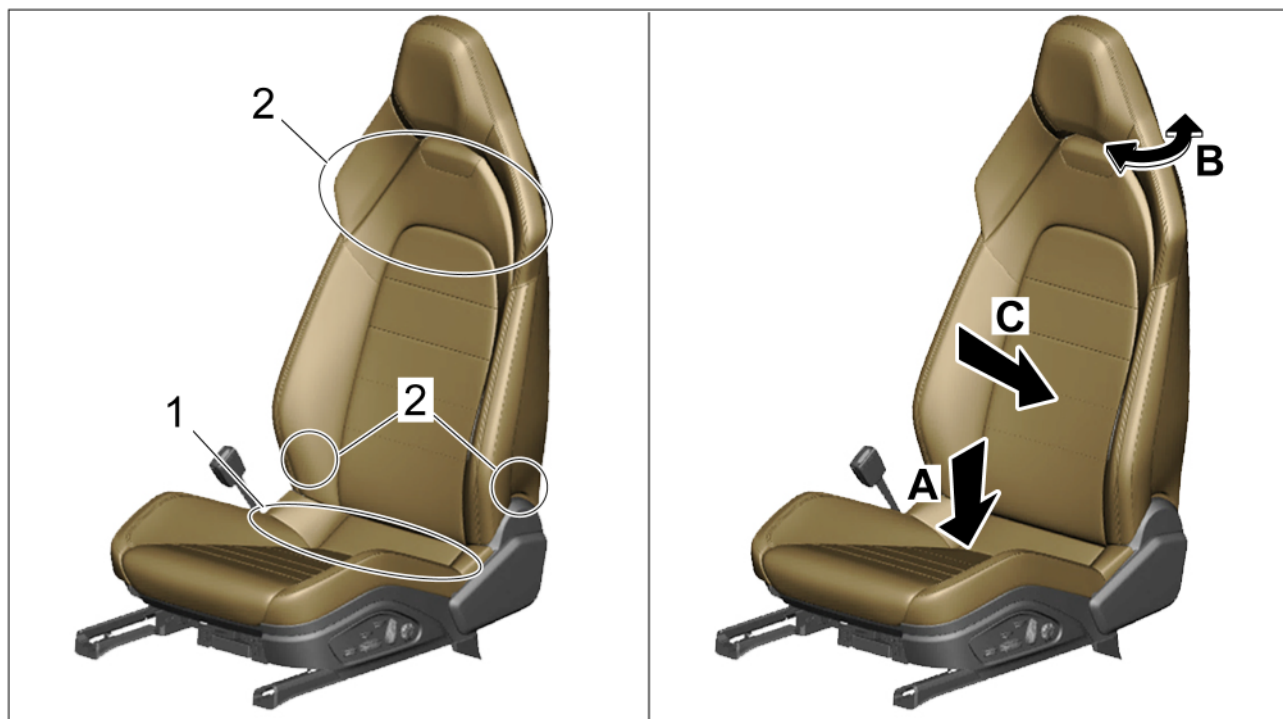
Verify fault

Creaking noise on seat cushion ⇒ *Verify fault -1-* :

- Apply pressure on the seat cushion vertically with a flat hand and check whether there are any creaking noises ⇒ *Verify fault -Arrow A-*

Creaking noise in the shoulder area ⇒ *Verify fault -2-*:

- Twist the seat backrest in both directions and pay attention to creaking noises ⇒ *Verify fault -Double arrow B-*

Creaking noise on backrest cover lower ⇒ *Verify fault -3-* :

- Sit in the front seat and apply pressure on the backrest with the upper body reclined, paying attention to creaking / cracking noises ⇒ *Verify fault -Arrow C-*

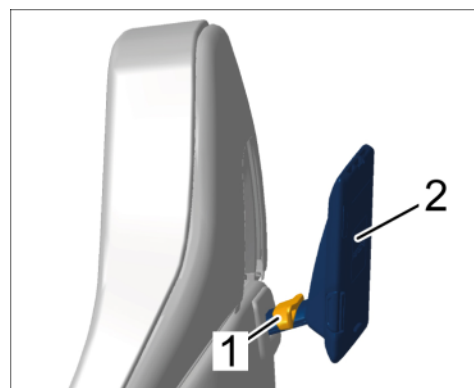
Front seat screen

- 4 Open locking mechanism ⇒ *Front seat screen-1*- and remove screen ⇒ *Front seat screen-2*- with holder.

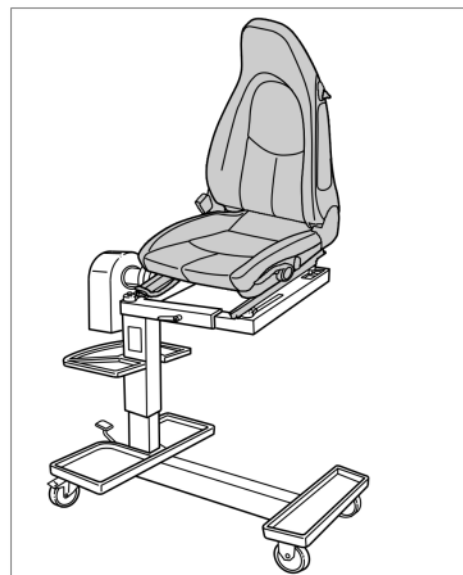
Front seat on assembly fixture

- 5 Remove front seat.
⇒ *Workshop Manual '720119 Removing and installing front seat'*
- 6 Install front seat to seat assembly device **VAS 6136 - holder for seat repair** ⇒ *Front seat on assembly fixture* and put it into position to work on the underside of the seat.
If there is no seat assembly device, carefully place the front seat on a suitable work surface to work on the underside of the seat.
- 7 Release seat cover for backrest on backrest cover.

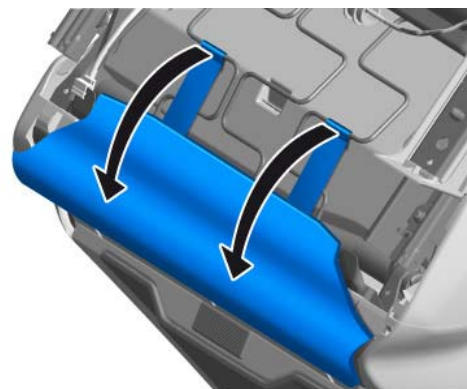
Tensioning straps for backrest seat cover

- 7.1 Unhook seat cover from suspension mat on the underside of the front seat ⇒ *Tensioning straps for backrest seat cover -Arrows-*.

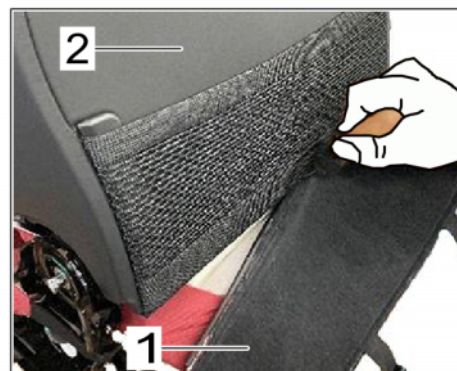
Seat cover on backrest, bottom

- 7.2 Unhook seat cover on the bottom ⇒ *Seat cover on backrest, bottom -1-* using a suitable tool from the backrest cover ⇒ *Seat cover on backrest, bottom -2-*.
- 7.3 Unhook the lower corner of ⇒ *Release seat cover for backrest on backrest cover -1-* the backrest seat cover using suitable tools on both sides of the front seat.
- 7.4 Unhook seat cover on both sides of the front seat from below, starting from the backrest cover ⇒ *Release seat cover for backrest on backrest cover -2-*.

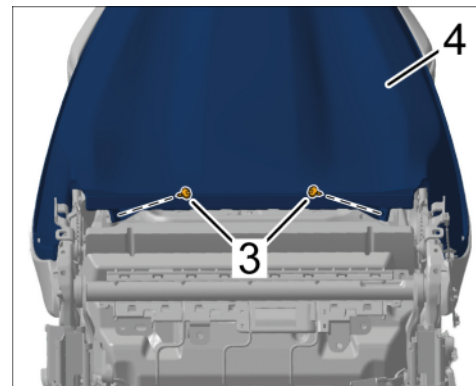
Bottom screws for backrest cover

- 8 Remove bottom screws ⇒ *Bottom screws for backrest cover -3-* from backrest cover ⇒ *Bottom screws for backrest cover -4-*.
- 9 Fold backrest upholstery support and backrest seat cover ⇒ *Screws for backrest cover top -1-* forwards until the upper screws ⇒ *Screws for backrest cover top -2-* of the backrest cover ⇒ *Screws for backrest cover top -3-* are accessible.

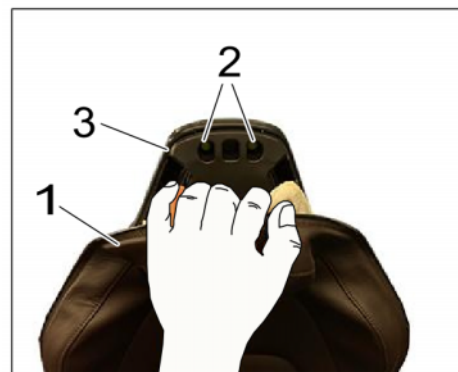
Screws for backrest cover top

- 10 Unscrew top screws ⇒ *Screws for backrest cover top -2-* on the backrest cover ⇒ *Screws for backrest cover top -3-* and remove backrest cover ⇒ *Screws for backrest cover top -3-*.

- First tighten screws on top of backrest cover with **with tightening torque 2.3 Nm (1.7 ftlb.)**.
 - Then tighten screws at the bottom of the backrest cover with **with tightening torque 2.3 Nm (1.7 ftlb.)**.
- 2 Install front seat.
⇒ *Workshop Manual '720119 Removing and installing front seat'*
 - 3 Check seat functions.
 - 4 End of remedial action.

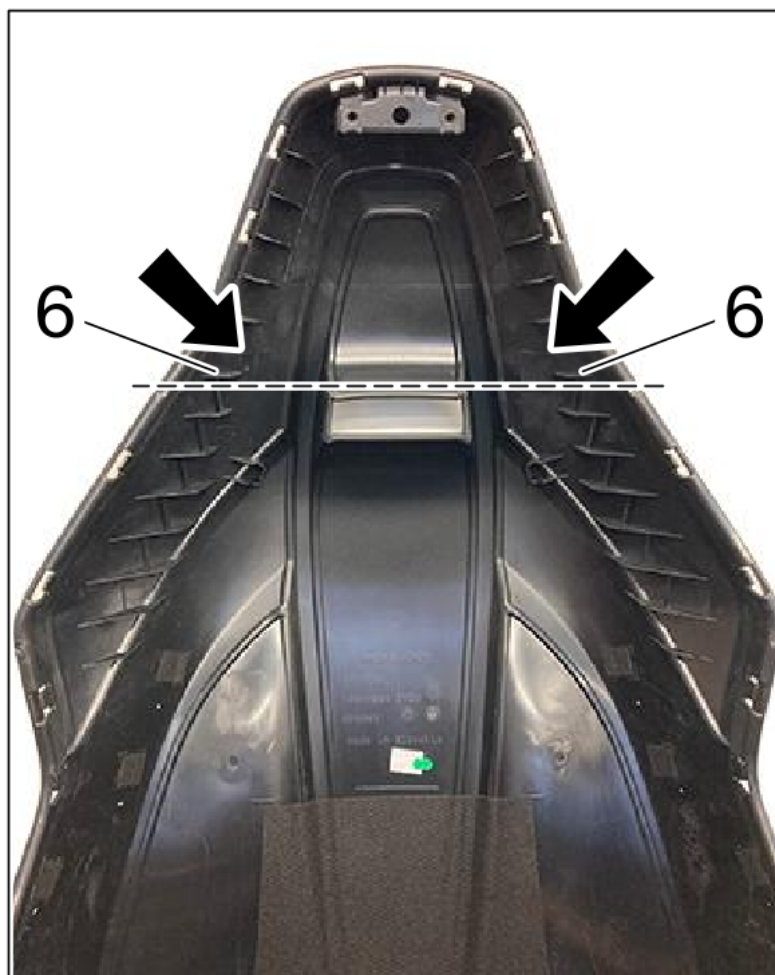
Check inner side of the backrest cover

- Work Procedure: 1 Check the inside of the backrest cover and rework if necessary.
- 1.1 Glue felt with part number **99955113840** in the adhesive areas ⇒ *Check inner side of the backrest cover -Arrows-* on the left and right side of the backrest cover.
Depending on the production date, square markings may indicate adhesive areas.
If this is not the case, Glue the felt from above at the height of the sixth transverse rib ⇒ *Check inner side of the backrest cover -6-* on the left and right side of the backrest cover.

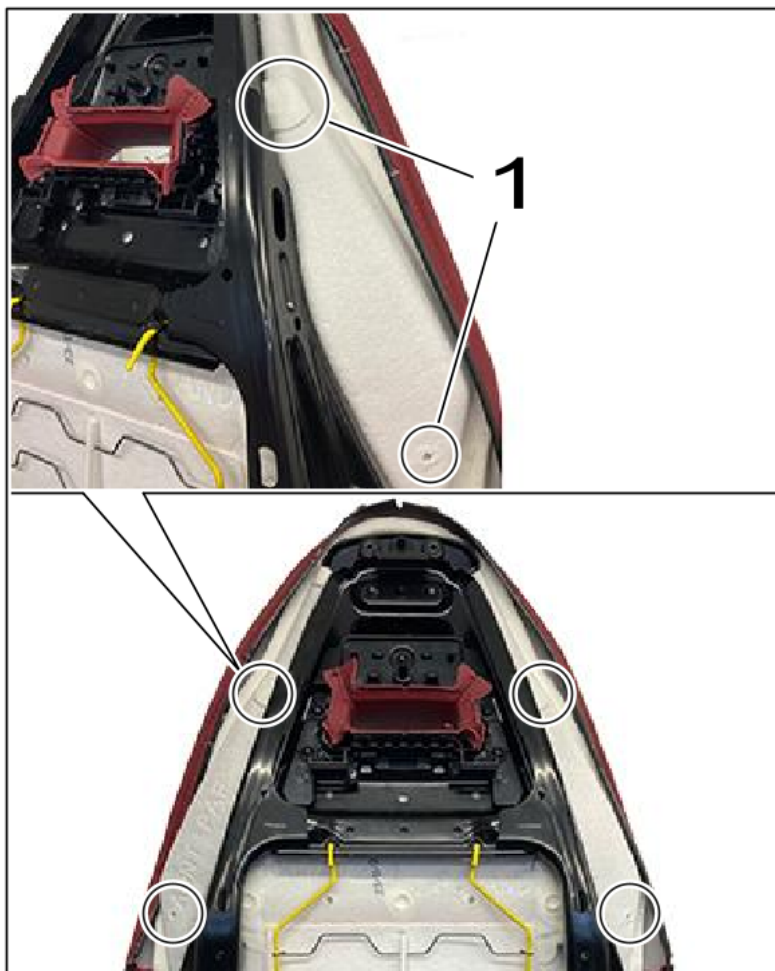
Excess foam residues on the upholstery pad

- 2 Rework area of excess foam residues ⇒ *Excess foam residues on the upholstery pad -1-* on the upholstery backrest on the left and right side of the seat.

The amount of excess foam residue on the upholstery pad may vary depending on the equipment and production period.

- 2.1 Remove excess foam residue ⇒ *Excess foam residues on the upholstery pad-1-*.
If necessary, a commercially available cutter blade can be used for this purpose.
- 2.2 Remove residues with **grain 180** sandpaper and roughen the surface.
- 3 Rework backrest frame in the area of excess foam residue on the backrest cushion on the left and right side of the front seat.

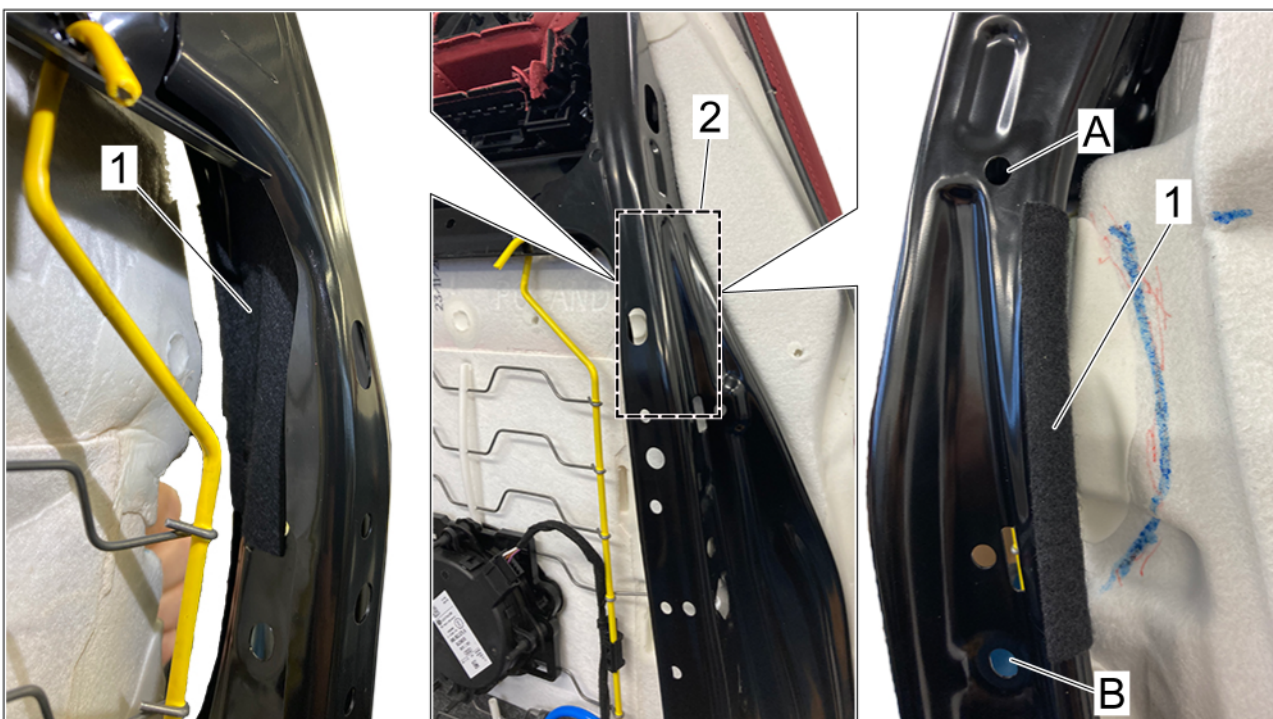
Reworking backrest frame

- 3.1 Cut four 100 mm/ 3.94 in long felt strips ⇒ *Reworking backrest frame -1-* off the felt strip with part number **00004320744**.
- 3.2 Push backrest pad away from backrest frame until the adhesive area ⇒ *Reworking backrest frame -2-* between the backrest pad and backrest frame is accessible.
- 3.3 Glue two felt strips ⇒ *Reworking backrest frame -1-* next to each other in the adhesive area ⇒ *Reworking backrest frame -2-* inside on the backrest frame between holes ⇒ *Reworking backrest frame -A and B-*.
- 4 Rework backrest frame at the bottom left and right in the area of the outside of the installing ⇒ *Rework installing on backrest frame -2-*.

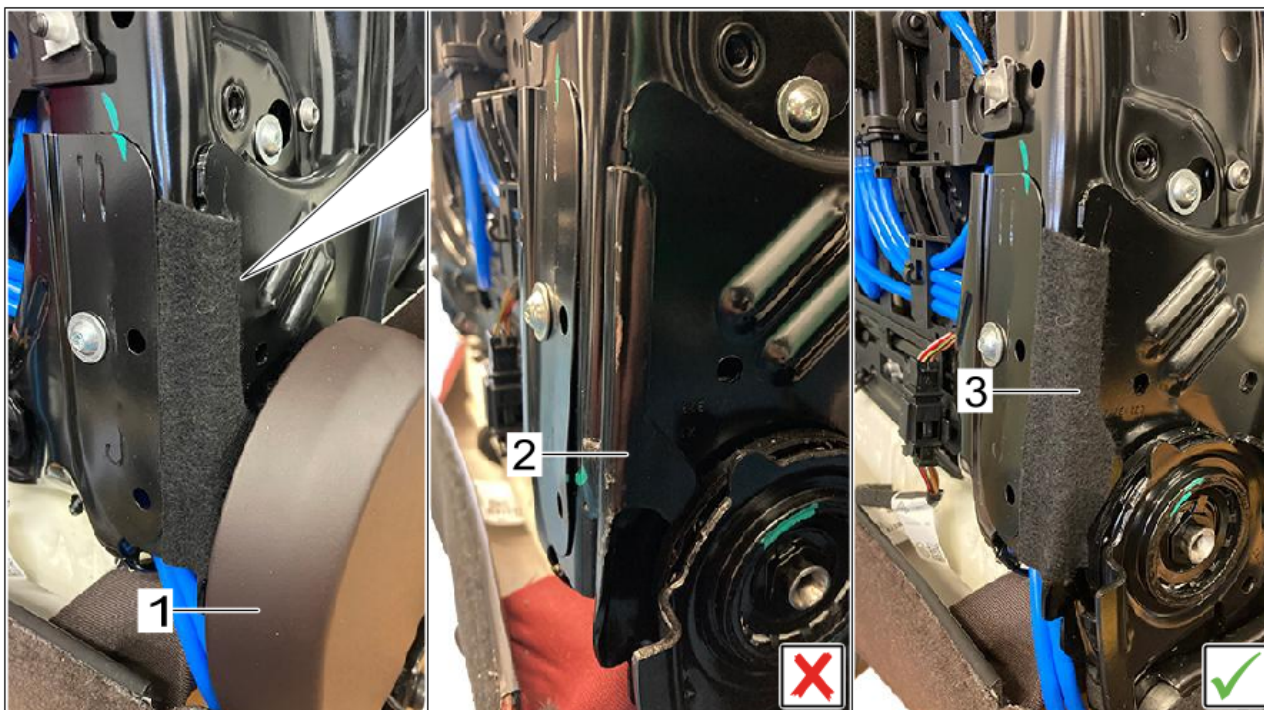
Rework installing on backrest frame

- 4.1 Cut a 100 mm/ 3.94 in -long felt strip ⇒ *Rework installing on backrest frame -3-* from the felt strip with part number **96455556500**.
- 4.2 Affix felt strips ⇒ *Rework installing on backrest frame -3-* to outside of the installing ⇒ *Rework installing on backrest frame -2-*.
The felt strip ⇒ *Rework installing on backrest frame -3-* must cover the entire outside of the installing ⇒ *Rework installing on backrest frame -2-*.
A commercially available plastic wedge can be used for process-safe operation. Removing the side trim ⇒ *Rework installing on backrest frame -1-* is not mandatory for this.

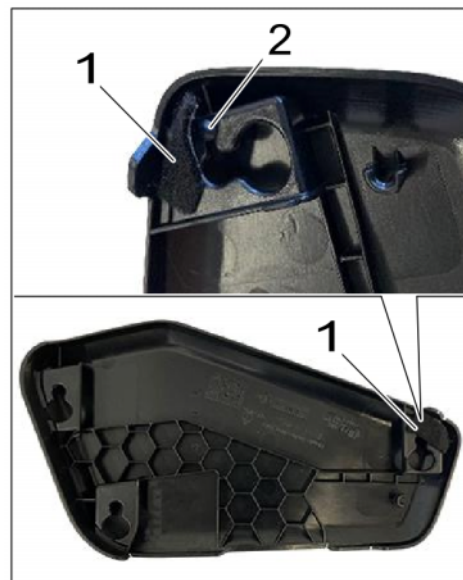
Reworking belt attachment trim panel

5 Check belt attachment trim and rework if necessary.

5.1 Cut a 15 mm long felt strip ⇒ *Reworking belt attachment trim panel-1-* from the felt tape with part number **00004320744**.

5.2 Affix felt strips ⇒ *Reworking belt attachment trim panel-1-* over the rubber buffer ⇒ *Reworking belt attachment trim panel-2-*.

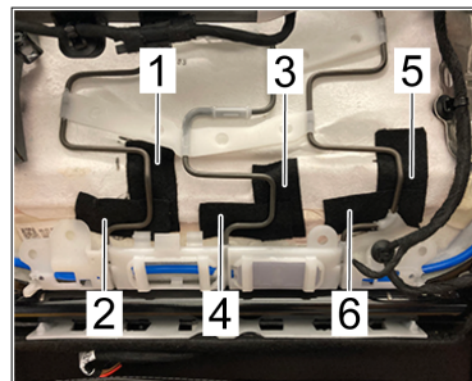
Reworking front seat cushion cover

6 Rework front seat cushion cover.

6.1 Cut off six 60 mm long felt strips ⇒ *Reworking front seat cushion cover-1 to 6-* from the felt tape with part number **00004320744**.

6.2 Apply felt strips ⇒ *Reworking front seat cushion cover-1 to 6-* in the area shown below the metal struts to the cushion support.
⇒ *Reworking front seat cushion cover.*

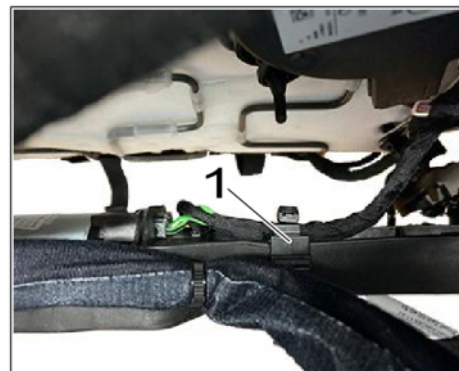
Edge clip for front seat wire harness

- 7.1 Unclip edge clip \Rightarrow *Edge clip for front seat wire harness -1-* using a suitable tool.
Disconnect edge clip cable ties \Rightarrow *Edge clip for front seat wire harness -1-* and dispose of edge clip \Rightarrow *Edge clip for front seat wire harness -1-*.
- 7.2 Lay front seat wire harness \Rightarrow *Fastening wire harness for front seat -1-* along the engine bridge \Rightarrow *Fastening wire harness for front seat -2-*.
- 7.3 Fasten front seat wire harness \Rightarrow *Fastening wire harness for front seat -1-* with **new** cable tie \Rightarrow *Fastening wire harness for front seat -3-* through opening on the engine bridge \Rightarrow *Fastening wire harness for front seat -2-*. The closure of the tie-wrap must point downwards.
- 7.4 Cut off the extra length at the end of the tie-wrap \Rightarrow *Fastening wire harness for front seat -3-* using side cutters.
