TECHNICAL SERVICE BULLETIN

Classification: FE23-001B	Reference: NTB23-055B	Date: March 12, 2024
------------------------------	--------------------------	-------------------------

FUEL ODOR

APPLIED VEHICLES: 2021-2023 Rogue (T33)
APPLIED DATES: Built on or before July 28, 2023
APPLIED ENGINES: KR15DDT

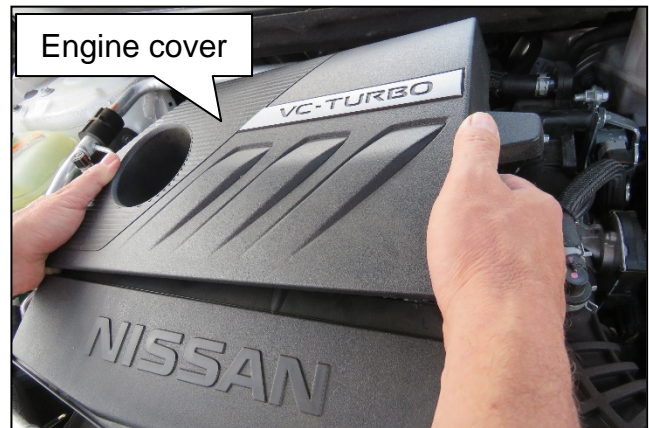
Figure 1

- a. Remove the engine cover by pulling it off in an upwards direction.

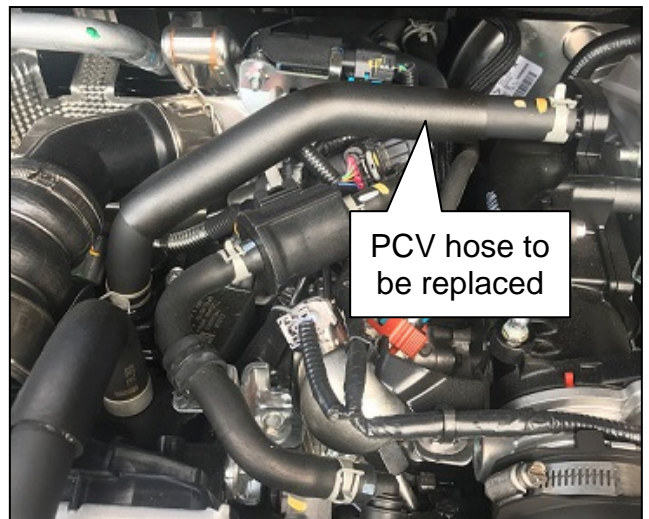
Figure 2

- b. Locate the PCV hose to be replaced.

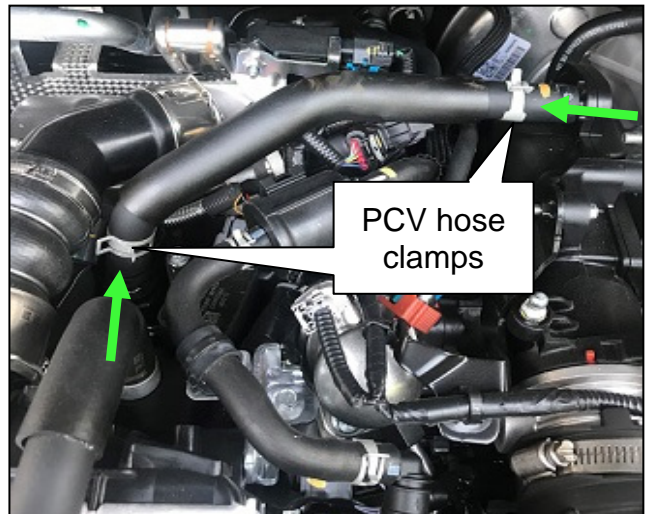
Figure 3

- c. Relocate the clamps that secure the PCV hose, to allow for PCV hose removal.

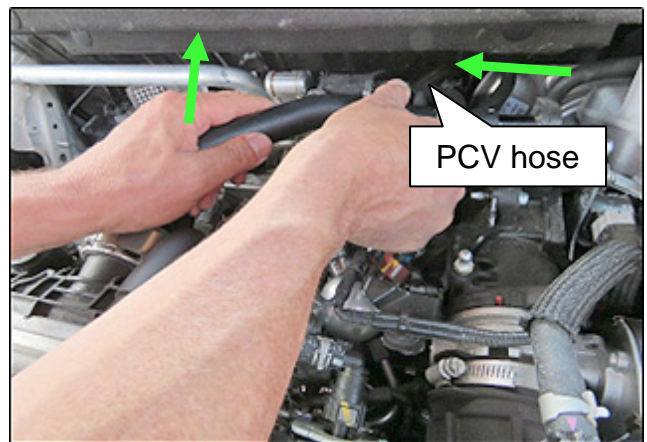
Figure 4

- d. Pull on the PCV hose in the directions shown in Figure 4, for PCV hose removal.

- e. Install the new PCV hose in the reverse order of removal.
- f. Reinstall the engine cover.
