<b>Subject</b>	Momentum and Solitude Upper Deck Flex Inspection					<b>Number</b>	24-001
						<b>Date</b>	3/7/2024
						<b>Model</b>	Solitude & Momentum Model Years 2021, 2022 & 2023
						<b>Build Date</b>	
<b>Circulate To:</b>	Service Manager	x	Parts Manager		Technician	x	4 pages
	Warranty Admin	x	Sales Manager	x	Part Number (s)		
<b>Concern:</b>	Complaint of upper deck flex which results in cosmetic damages to the interior and excessive flex at the pin box.						
<b>Remedy:</b>	This TSB relates to customer concerns of upper deck failure. The procedure outlined below is to assess damages if any and direct customers to next steps.						
<b>Flat Rate:</b>	920006

**Solitude & Momentum Flex Measurement  
Frame Flex Inspection Form 24-001**

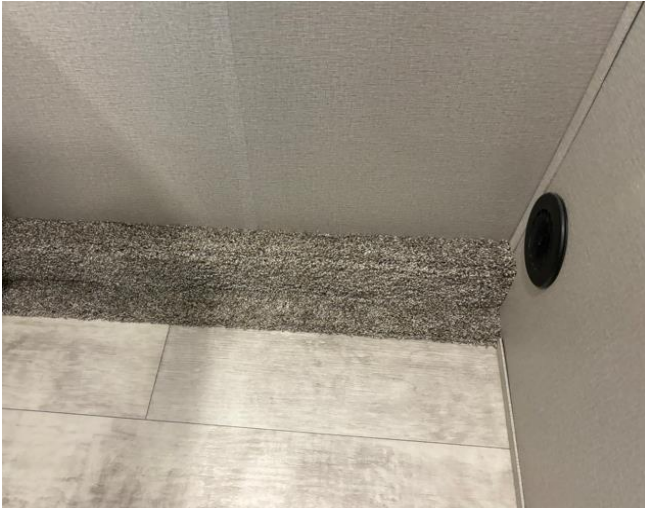
*Horizontal lag bolts located behind carpet block.*

3. In the interior of the unit, identify any damaged cabinetry, or trim located in the upper deck. Where possible, verify any loose, bent, broken or missing lag bolts. **Note:** *Not all lag bolts can be examined from the interior. See example photos page of interior lag access on pages 2 & 3.*

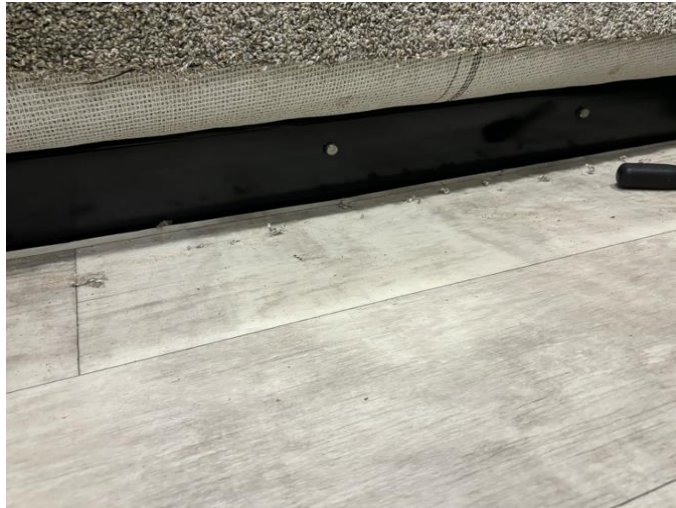
*Roll carpet back to expose lags in upper deck.*

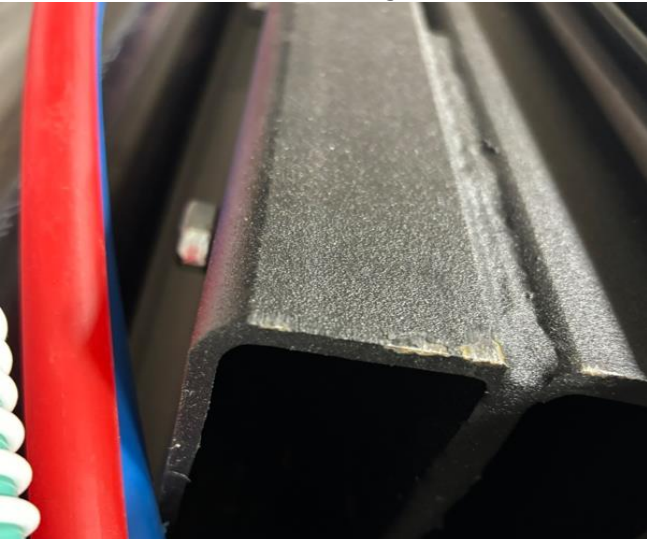
*Double tube main rail with 5" lag bolts*

14. Replace existing lags and fill all accessible lag holes in the main rail with 1/2" lag bolt. With a 3/16" bit, drill a pilot hole in the designated frame locations where a lag is NOT present. Be sure to measure the depth prior to drilling to prevent breaching the exterior wall. The pilot hole should only penetrate the first layer of aluminum. Before installing the lags, place a bead of epoxy or SikaFlex the length of the threads. **For units with double main rail tubes, use GDRV part # 961671. For all single tube main rails, use Grand Design part # 961661. See photo examples below for interior lag access.**

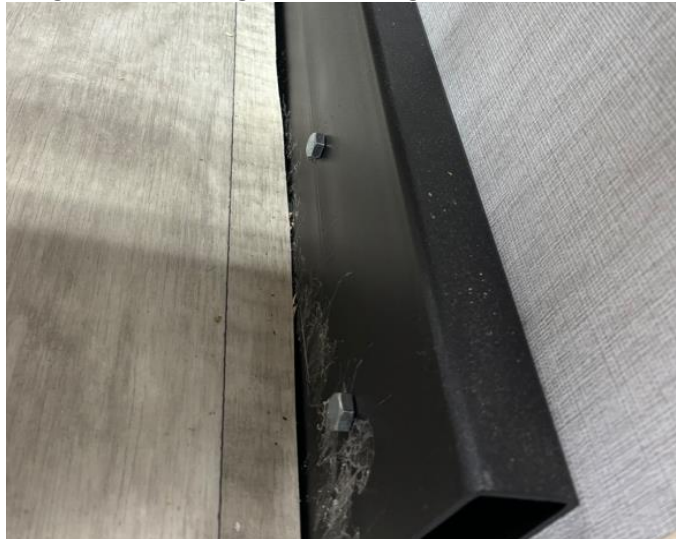
*Single tube with lags with 3.5" lag bolt.*

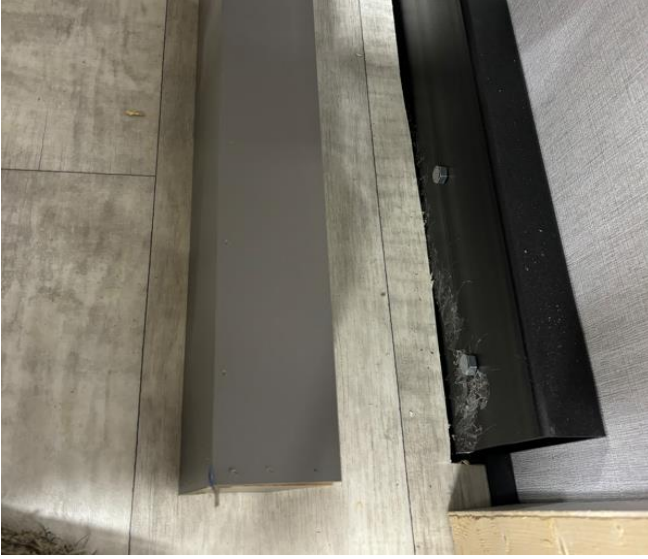
*Main rail located behind wood cover - interior*

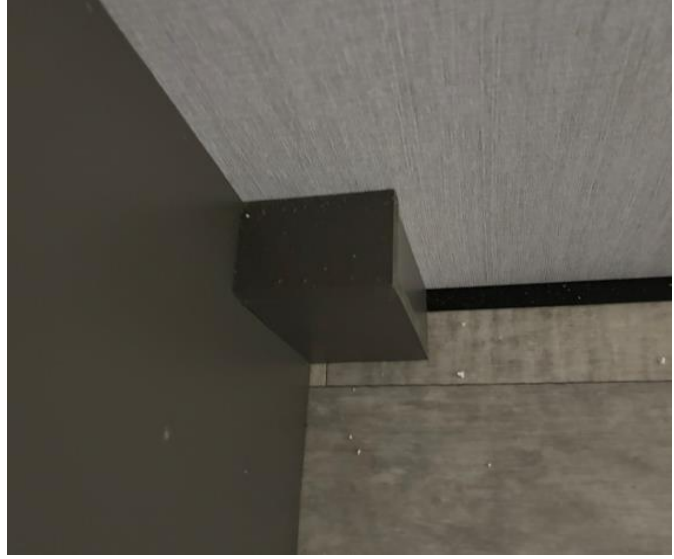
*Cover block for rear of upper deck tube by dresser*

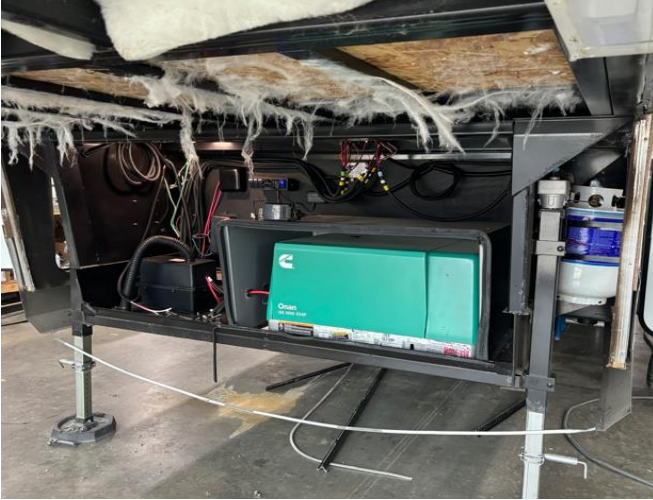
Photo of front bulkhead and cage removed

4. Remove the compartment door(s), trim molding and TPO bulkhead around the pin box.
5. Remove the forward aluminum cage.
6. Inspect the frame structure for broken welds, cracked or torn steel. Contact Grand Design Customer Service if any structural damage is found for further instructions.

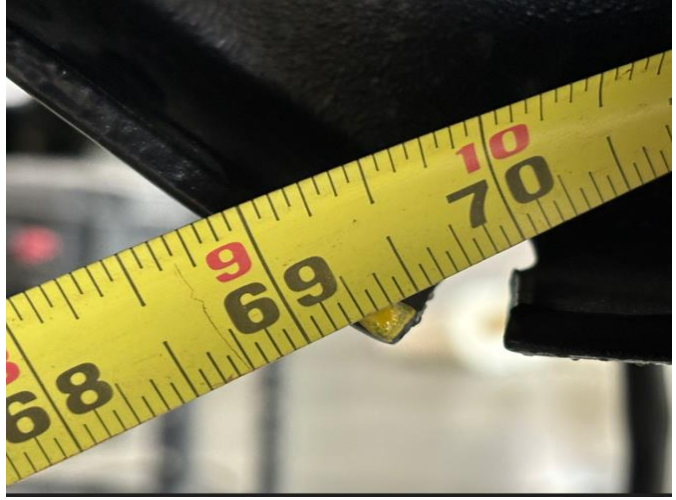
Example photo of index mark on pin box side plate

7. With a paint marker or painters tape and sharpie, mark a fixed point on the lower corner of each pin box side plate and on the bottom of the main I-beam. *See example photos page 2.*

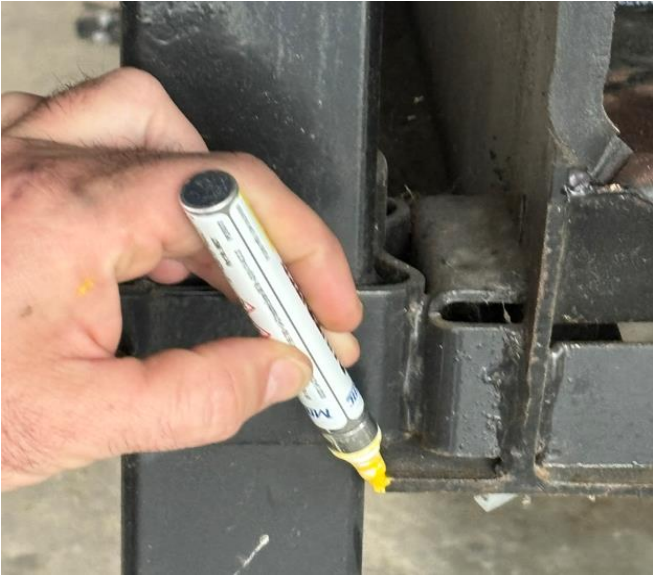
Example photo of index point on I-beam

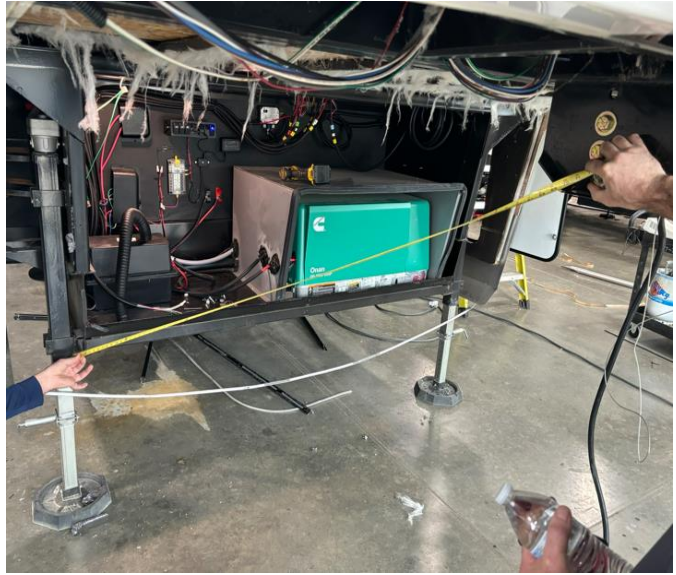
Example of measurement from I-beam to pin box

8. With the weight of the unit on the front landing gear, measure the distance from the marked position on the pin box side plate to the marked position on the I-beam. Do this on both door side and off door side. Record the measurements on the attached form.

10. Repeat the measurement process outlined in step 7. Record the measurements on the attached form.
11. Subtract the "weight on" measurements from the "weight off" measurements. The difference between the two should be **no more than 3/8"** (weight on vs. weight off).
