## PIT6137 Diagnostic Tip - Service Park Brake Message / MIL DTC C15DD

### Models

Brand:	Model:	Model Years:	VIN:		Engine:	Transmissions:
			from	to		
Chevrolet	Silverado 2500/3500	2020 - 2023	All	All	All	All
GMC	Sierra 2500/3500	2020 - 2023	All	All	All	All

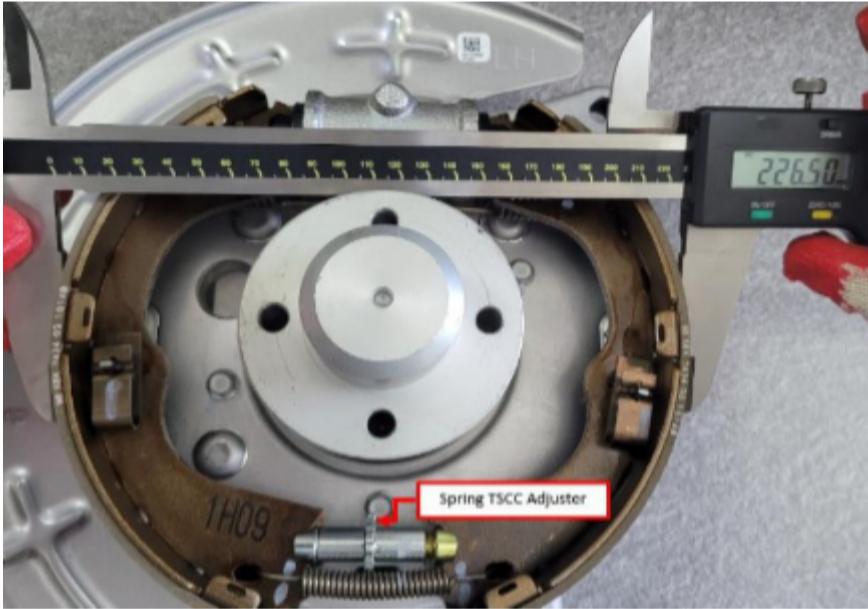
1) Make sure the shoe clearance diameter, Seen Below in the released position, is adjusted to 226.5 mm (+/- 0.2). The smaller the value is, the more release time increases causing DTC C15DD SYM00 to reset right away.

2) After park brake shoe adjustment is at proper range as shown above, perform the following reset procedure to clear codes.

- A) Put the vehicle in Service mode and apply and release the park brake 5 times
- B) Attempt to clear DTCs
- C) Start the vehicle and apply and release the park brake 5 more times
- D) Clear DTCs again and allow vehicle to go to sleep by letting vehicle sit for 10 Minutes.

**Note:** You may have to perform this procedure a couple times to clear DTCs
