GROUP	MODEL
	BOD	2024MY Telluride (ON)
	NUMBER	DATE
	325	April 2024

TECHNICAL SERVICE BULLETIN

SUBJECT: SERVICE ACTION: RADIATOR GRILLE EMBLEM INSPECTION AND REPLACEMENT (SA566)

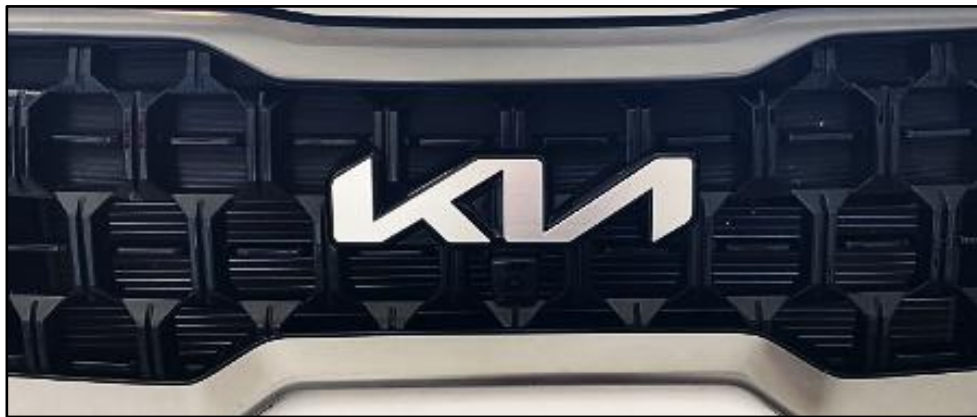
This bulletin provides information to inspect and if necessary, replace the front grille emblem on certain 2024MY Telluride (ON) vehicles, produced from November 27, 2023 through February 15, 2024, which may have an improperly adhered (partially detached) or missing front grille emblem. Follow the procedure outlined in this publication to inspect and, if necessary, replace the front grill emblem on the applicable vehicle. Before conducting the procedure, verify that the vehicle is included in the list of affected VINs.

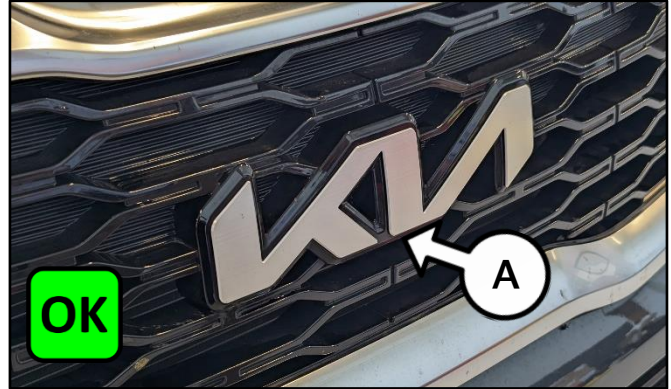
1. Locate the front Kia emblem and confirm that the emblem (A) on the front grille is properly adhered flat against the mounting surface.

- If the emblem (A) is properly adhered to the front grille (OK), then no further action required. This action is complete (inspection only).

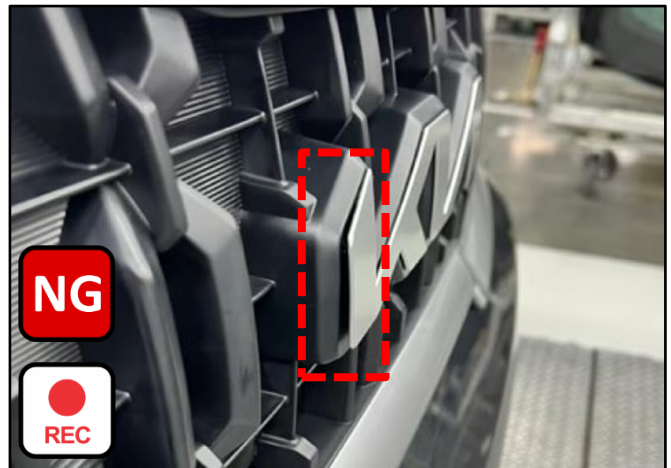
- If the emblem (A) is not properly adhered to the front grille (or is found to be detached/missing) (NG); take a KVID video starting from the VIN label and show the partially adhered, detached, or missing emblem, and then proceed to the 'Replacement Procedure' below.
