REFERENCE:	Nova Bus Manuals
SECTION:	17: Radios and accessories
RS N°:	MQR 7621-2237
EFFECTIVE IN PROD.:	NA

SUBJECT:	Front camera bracket breaking.
JUSTIFICATION:	Failure of camera bracket will cause the camera to swing while bus is in motion.

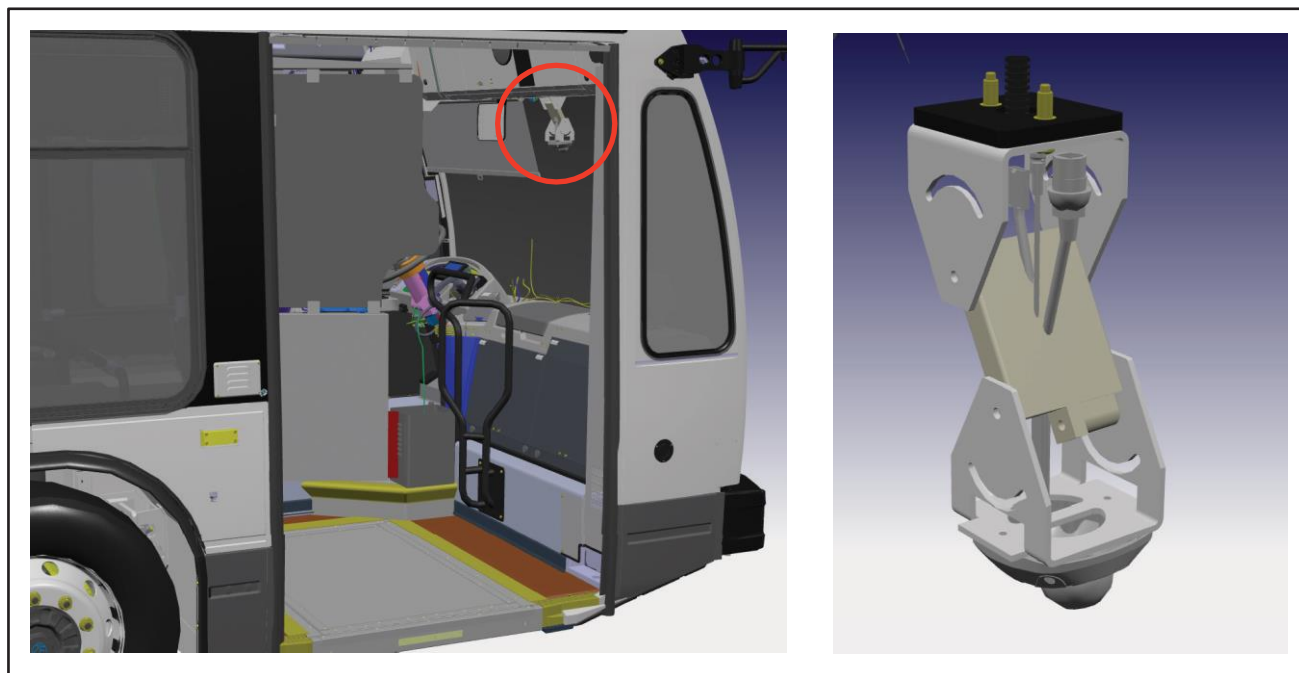
Figure 1 - Location of Front Camera

- 1.1. Park the vehicle on an even surface with the transmission on neutral.
- 1.2. Apply the parking brake and set the master control switch to the **stop** position.
- 1.3. Set the battery disconnect switch in the battery compartment to the **off** position.
- 1.4. Locate the front camera under the front destination sign.

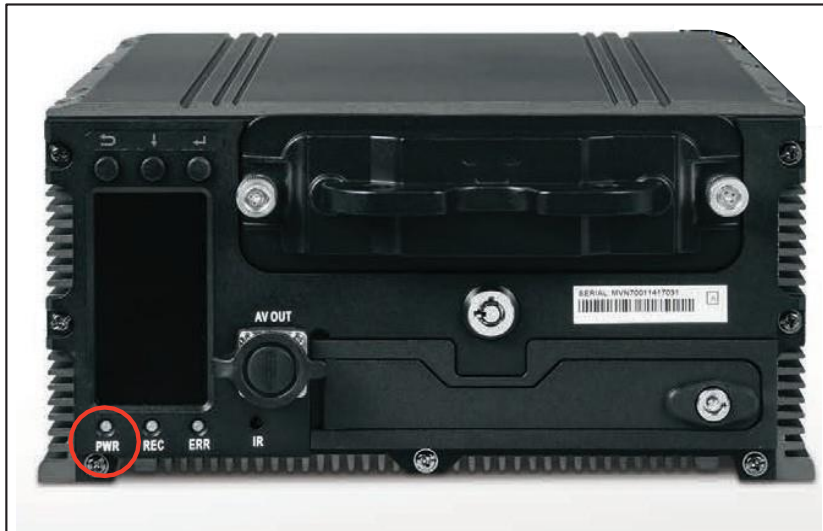
Figure 2 - NVR Front Panel

- 1.5. Ensure that the NVR is powered down.

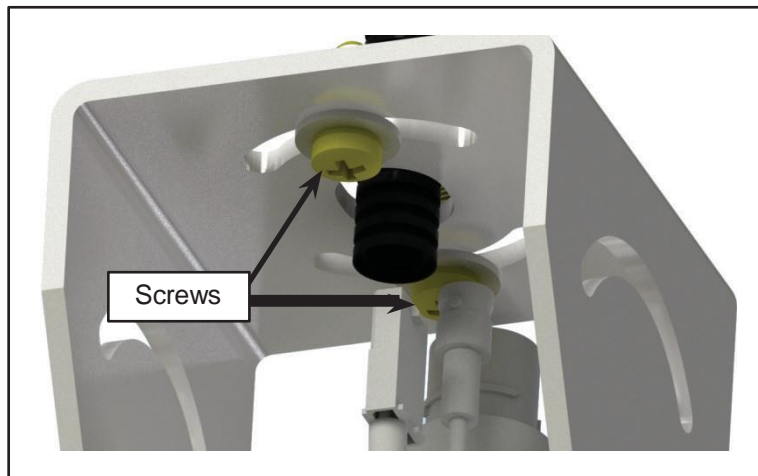
Figure 3 - Removal of Screws from Bracket Assembly

- 1.6. Remove the two Philips screws that secure the N108657 bracket assembly to the mounting surface.

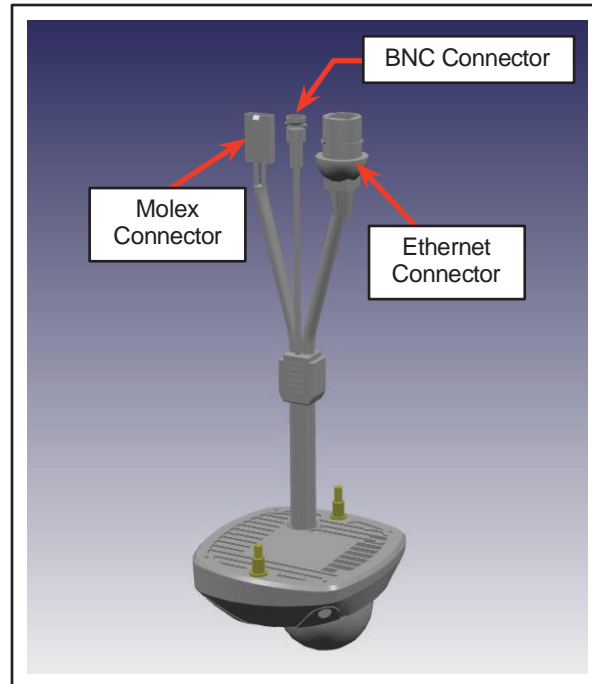
Figure 4 - Removal of Camera

- 1.9. Gently pull the assembly downwards to expose the connections on the end of the camera pigtail.
- 1.10. Fully disconnect the camera from the camera harness (Ethernet cable). If the Standard Definition Analog Out feature on the camera is being used, disconnect the corresponding BNC connector.

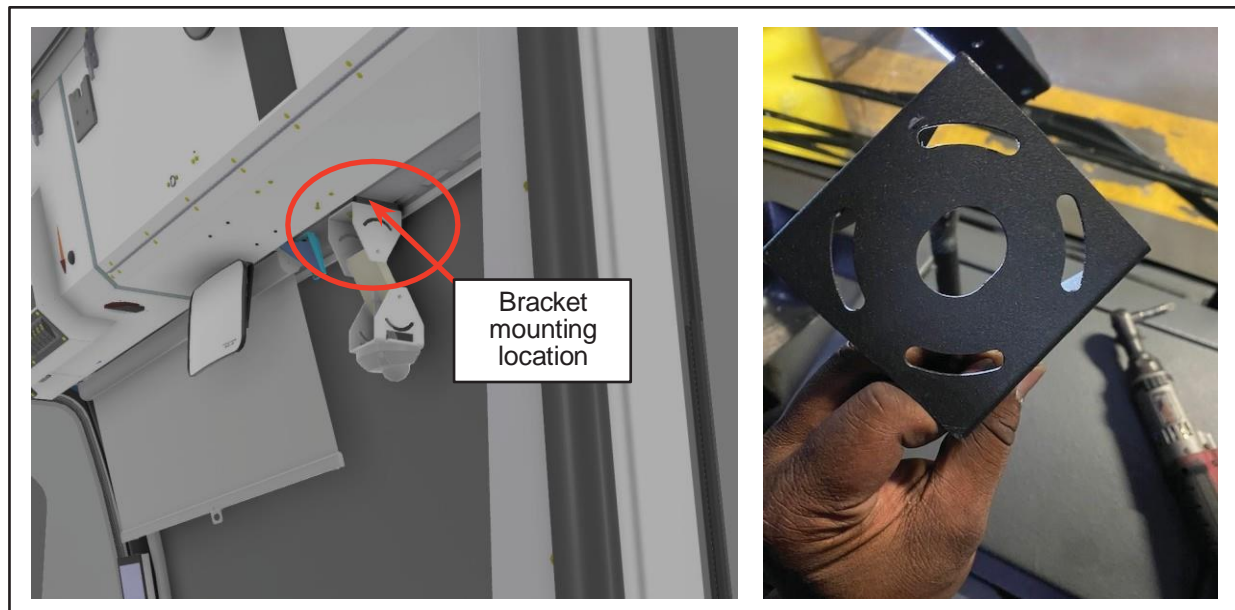
Figure 5 - Bracket Mounting Location and New Top Bracket

- 1.11. Remove the old Top Bracket "C" from the upper panel.
- 1.12. Temporarily place the New Top Bracket "C" at the same place where old bracket removed.

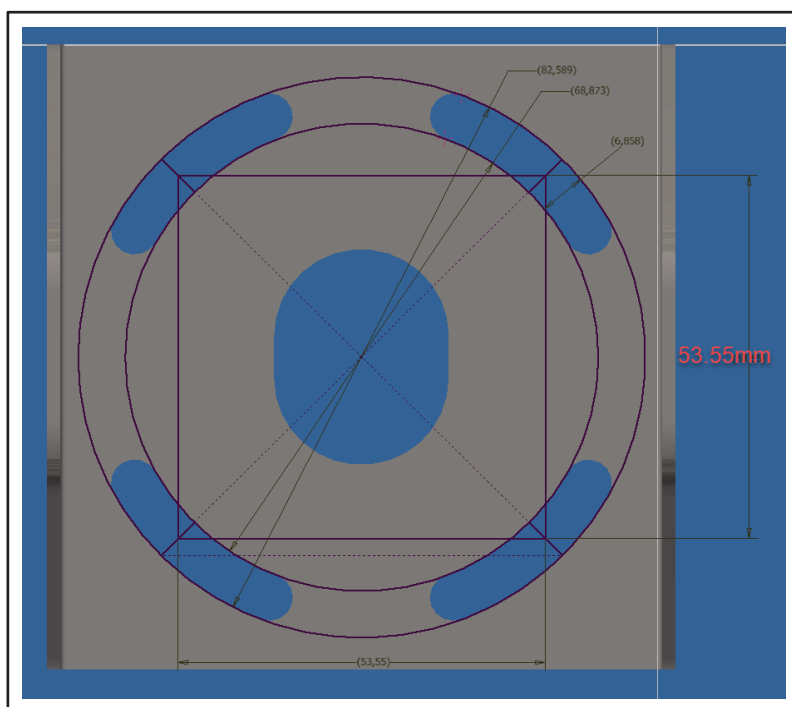
Figure 6 - Marking Four Holes on the Bracket's Base

- 1.13. Use the center of the slots on the bracket's base to mark the four holes required to accommodate the screws or rivnuts. Drill the holes at $\varnothing 9\text{mm}$ and install the rivnuts.

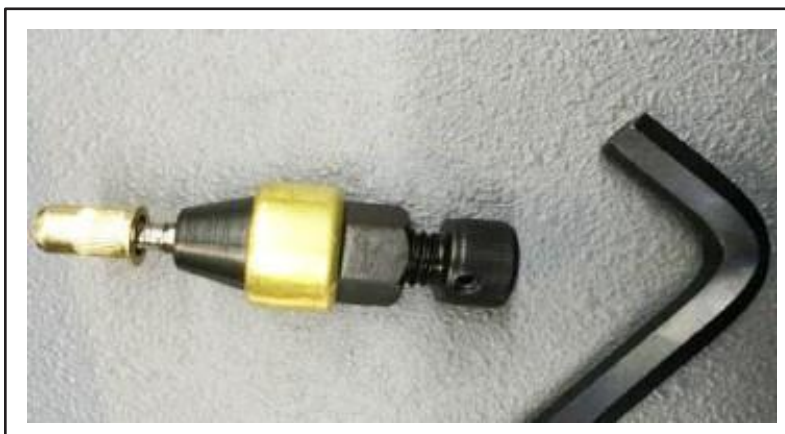
Figure 7 - Rivnut Tool

- 1.14. Install the new rivnut using a rivnut installation tool.

Make sure that the rivnut does not spin when a torque is applied.

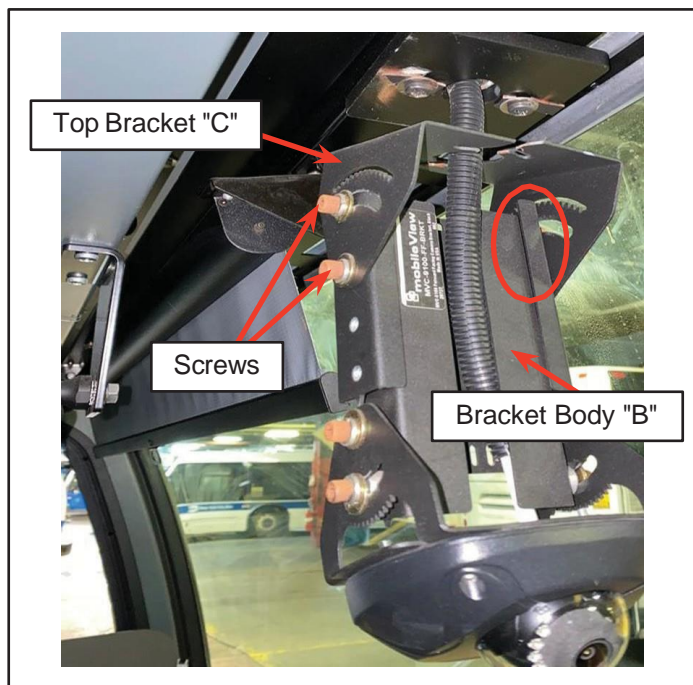
Figure 8 - Removal of Headscrews

- 1.15. Use a 3/16" Allen wrench to remove the four 1/4" -20 Thread Size, 1/2" Long Alloy Steel Socket Head Screws that secure the Top Bracket "C" to the "B" FF Bracket Body.

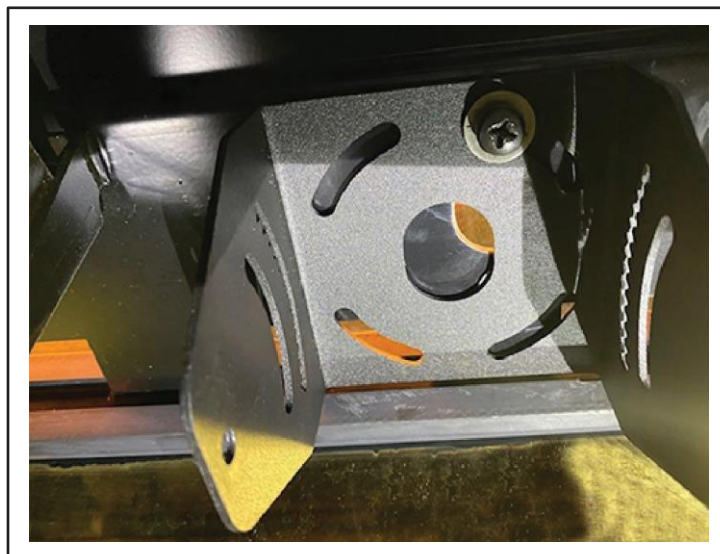
Figure 9 - Installation of New Top Bracket

- 1.16. Install the new Top Bracket "C" under the front destination sign.

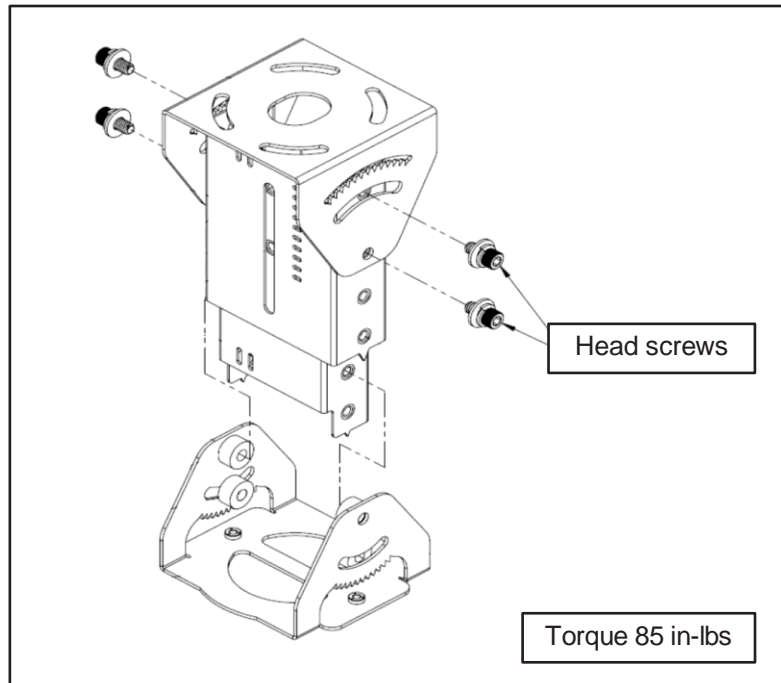
Figure 10 - Reinstallation of Headscrews

- 1.17. Apply Threadlocker loctite 243 N97665, reinsert the 1/4" -20 Thread Size, 1/2" Long Alloy Steel Socket Head Screws. Apply a torque value of 85 in-lbs.

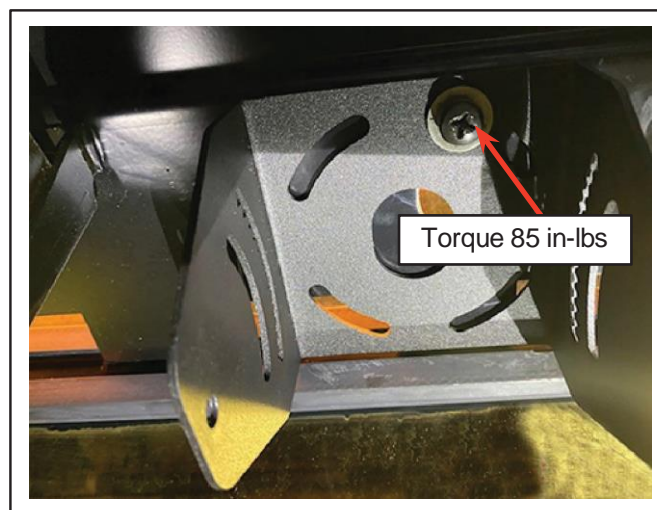
Figure 11 - Installation Torque

- 1.18. Route the camera pigtail through the hole of the New Top Bracket "C".
- 1.19. Connect the camera to the camera harness (Ethernet cable). If the Standard Definition Analog Out on the camera is being used connect the corresponding BNC connector.
- 1.20. Secure the updated N108657 bracket assembly to the mounting surface using four screws. Apply a torque value of 85 in-lbs.

Clamp load not to exceed 1000 lbs

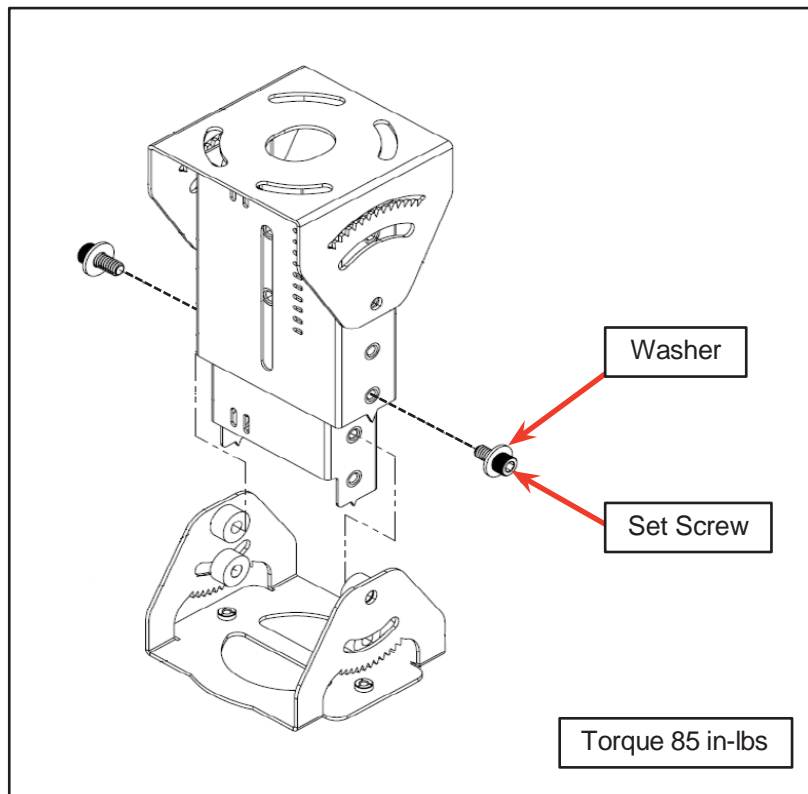
Figure 12 - Installation of Set Screw and Washer

- 1.21. Place a washer N17565 on each bracket set screw N16729, apply threadlocker loctite 243 N97665 and thread the screws into the inner slide bracket "B", Tighten the screws. Apply a torque value of 85 in-lbs.

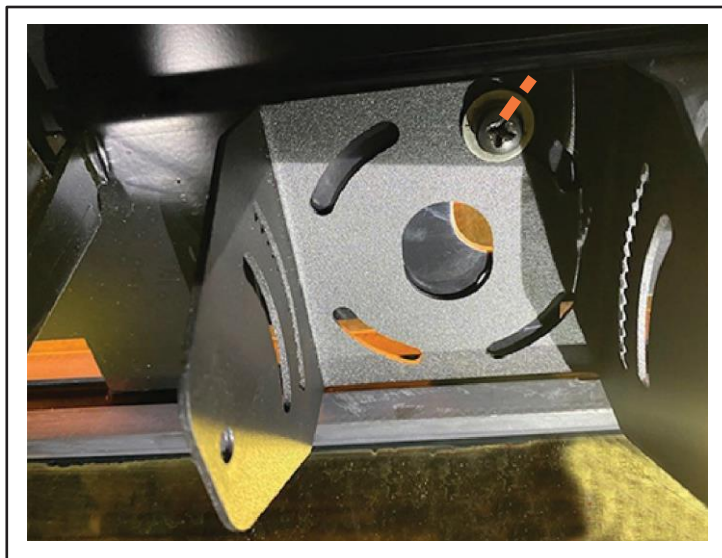
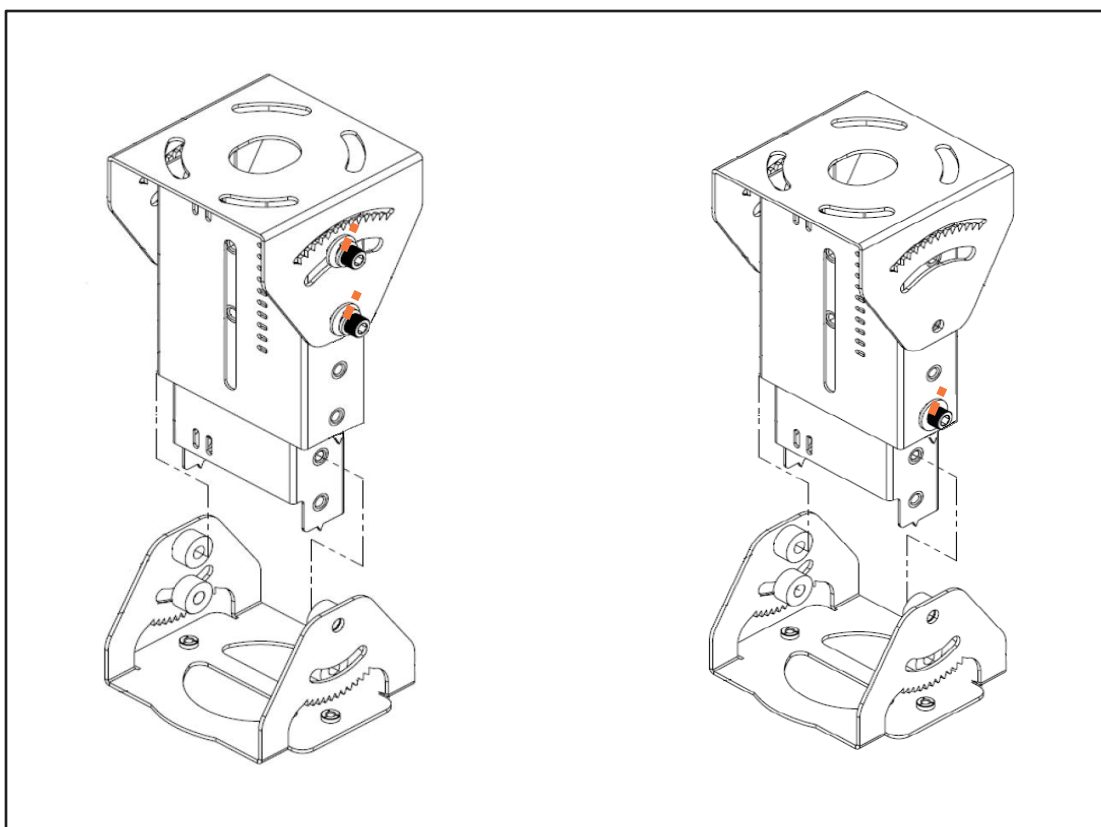
Figure 13 - Torque Stripe

- 1.23. Make sure the part is properly secure.
1.24. Clean the area the product will be applied to.
1.25. Apply the ink to the area so that the two or more adjoining parts are all connected by the applied ink.
1.26. Allow the ink to dry. Ambient temperature is fine, the drying process can be speed up by applying warm air.
1.27. Upon future inspection, if the torque stripe is broken, the parts have loosened or have been tampered with.
