Turbo Compound (TC) Hot Side Noise, Diagnostic Information

Published 2 April 2024

All Volvo VNL and Mack AN,CHU,CXU,PI models with a turbo compound

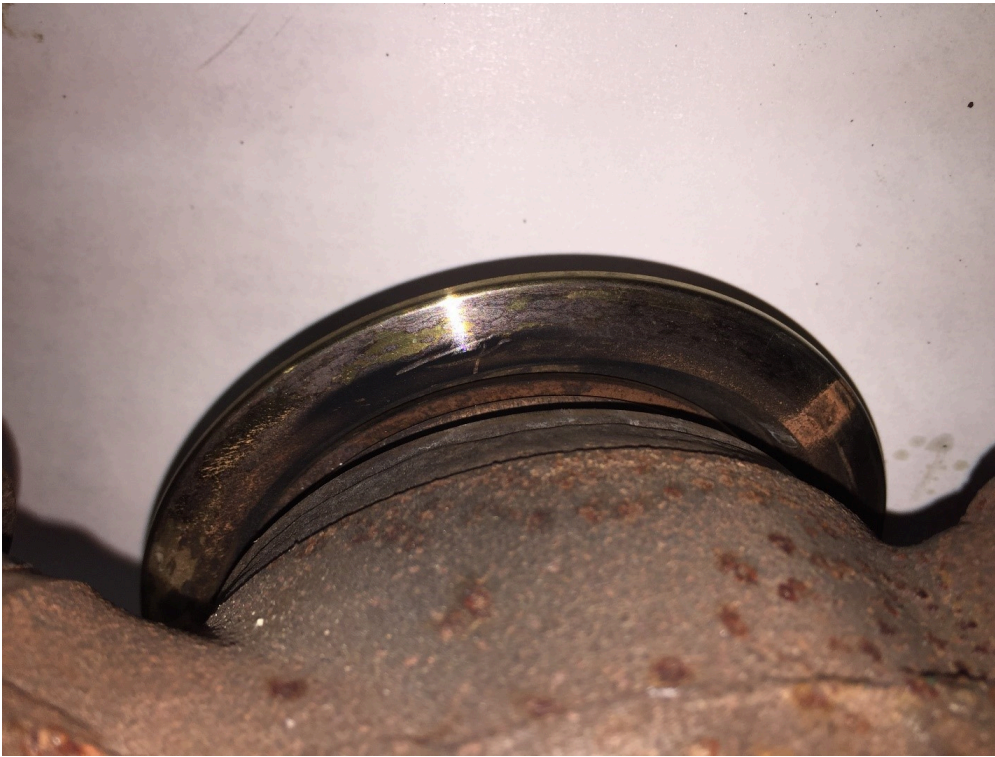
If the noise goes away or gets quieter: Focus on the EGR Hot pipe.

Flange weld at EGR cooler inlet

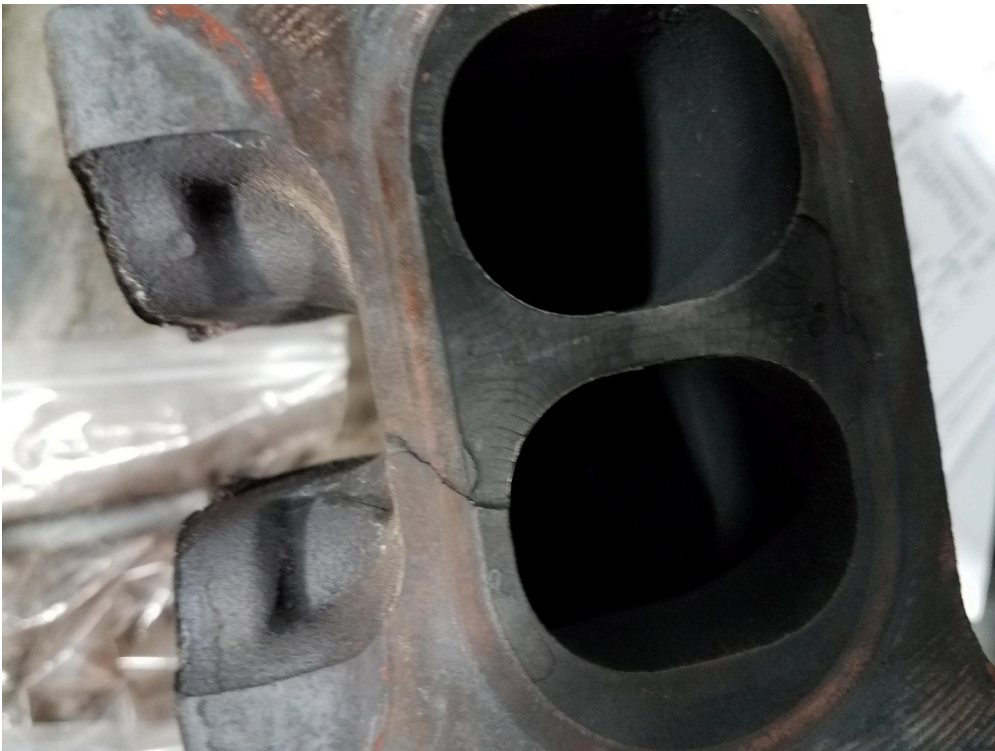
If the noise gets louder or worse: Focus on the exhaust manifold.

Cracks in the manifold or warped face causing leaks at gasket

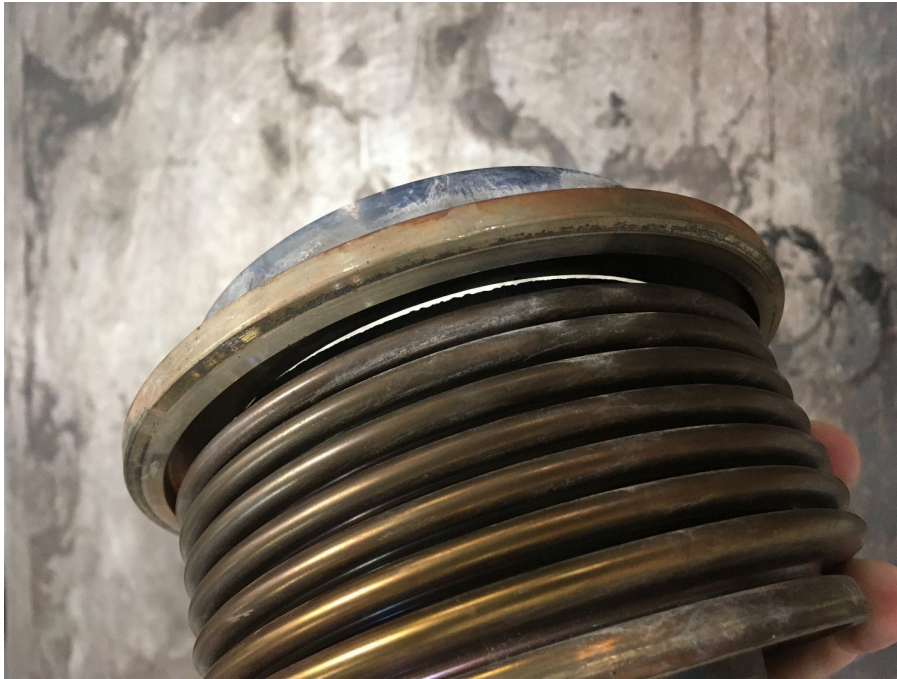
If noise gets louder or worse: Focus on the Diffuser pipe (between the TC unit and turbo).

2. Perform a Soot Regeneration.
