GROUP	MODEL
Voluntary Emissions Service Campaign	2024MY Sportage HEV (NQ5 HEV)
NUMBER	DATE
SC293	April 2024

### FUEL INJECTOR HARNESS INSPECTION AND REPLACEMENT (SC293)

This bulletin provides information to inspect and if necessary, replace the fuel injector wire harness on certain 2024MY Sportage HEV (NQ5 HEV) vehicles equipped with a GAMMA II 1.6L T-GDI engine, produced from November 15, 2023 through November 20, 2023. The subject vehicles may have been assembled with a fuel injector harness that can cause a poor electrical terminal connection. A poor connection can cause uneven fuel delivery to the engine, affecting engine performance and emissions. Follow the procedure outlined in this publication to install a new fuel injector harness on the applicable vehicle. Before conducting the procedure, verify that the vehicle is included in the list of affected VINs.

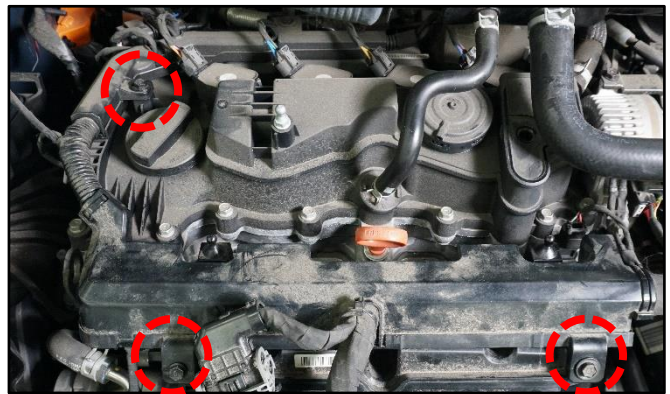
2. Loosen the three (3) wiring harness retaining bolts.

Tightening torque for bolts:  
5.1 - 7.2 lb.ft (6.9 -9.8 N.m)

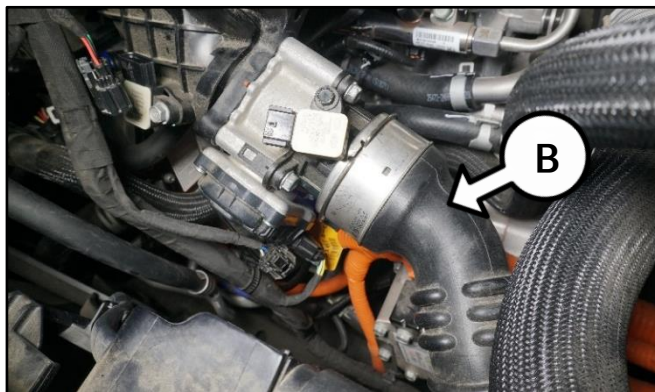
5. Remove the intercooler outlet pipe (B).

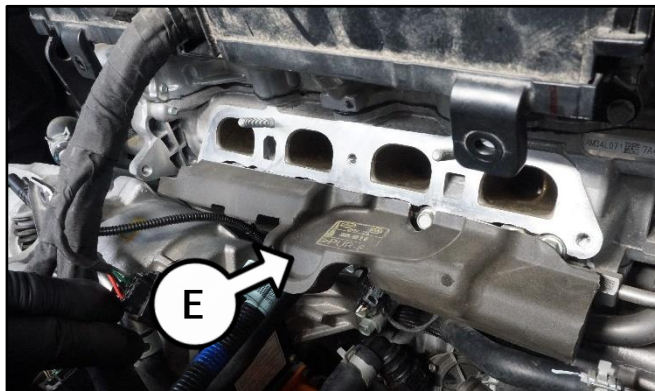
8. Remove the injector foam pad (E).

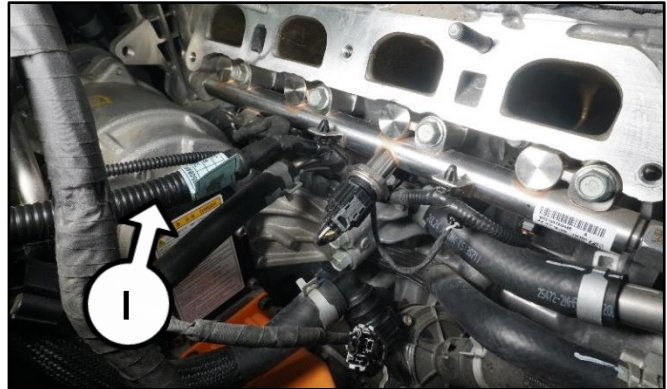
12. Remove the existing fuel injector harness (I) by disconnecting the four (4) injector connectors.

13. Install the new fuel injector harness (D) in the reverse order of removal.

**Note:** Use a long thin screwdriver/pick to unclip injector connectors. Fuel injector #1 connector is marked with a white tape end.

14. Reinstall all removed parts in the reverse order of removal.
