Stacy L. Balzer
Director
Service Engineering Operations
Ford Customer Service Division

SUBJECT: NEW VEHICLE RECOMMENDED DEMONSTRATION / DELIVERY HOLD

Update Before Sale 24U04

Certain 2024 Model Year F-150, F-150 Lightning, F-150 Raptor, 2024 Ranger, 2024
Ranger Raptor
Enhanced Pre-Delivery Inspection (PDI)

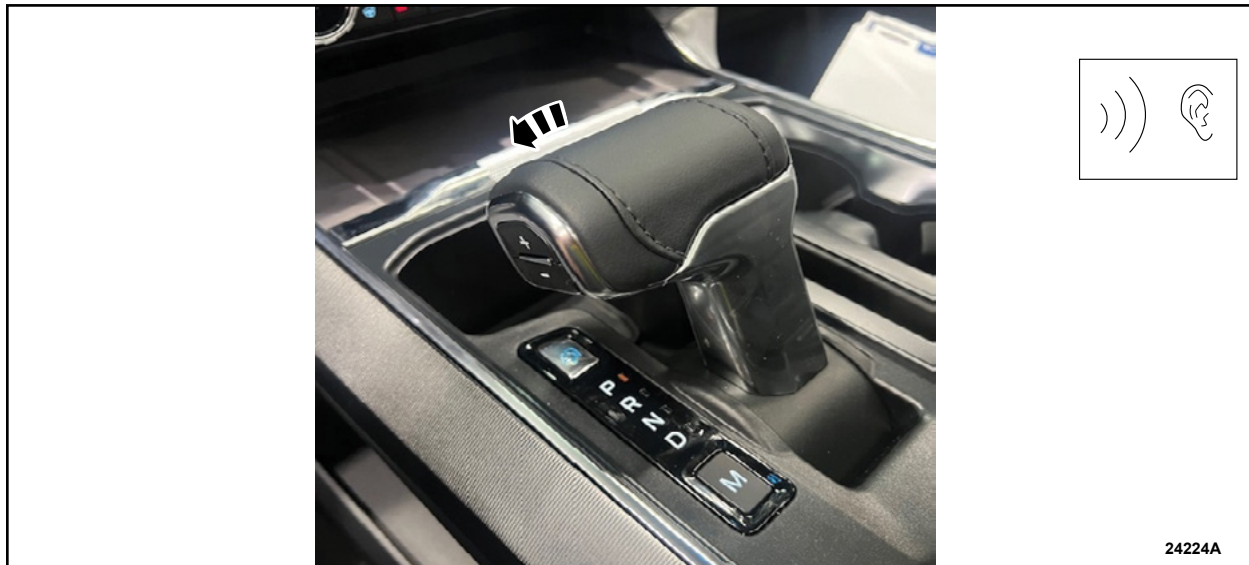
FIGURE 1

1. With the Key on and Engine off, verify the seatbelt and door open chimes.
2. Cycle the gear shifter stowage, verify that it operates smooth and is not noisy. See Figure 1.

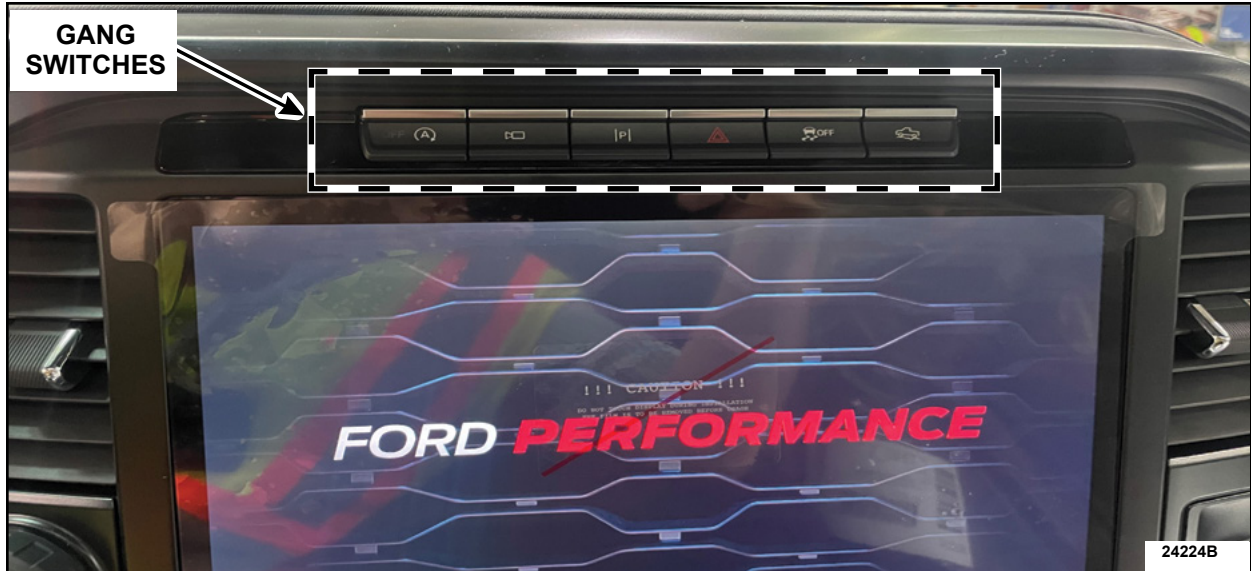
FIGURE 2

5. Press each gang switch individually and verify function. See Figure 2.

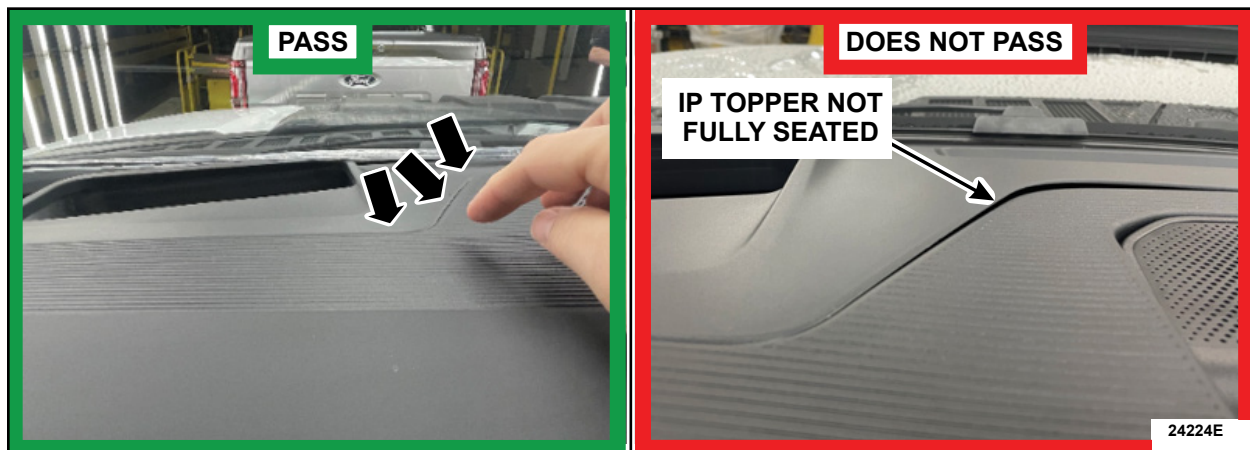
FIGURE 5

11. Verify the LH IP topper is fully seated. See Figure 5.

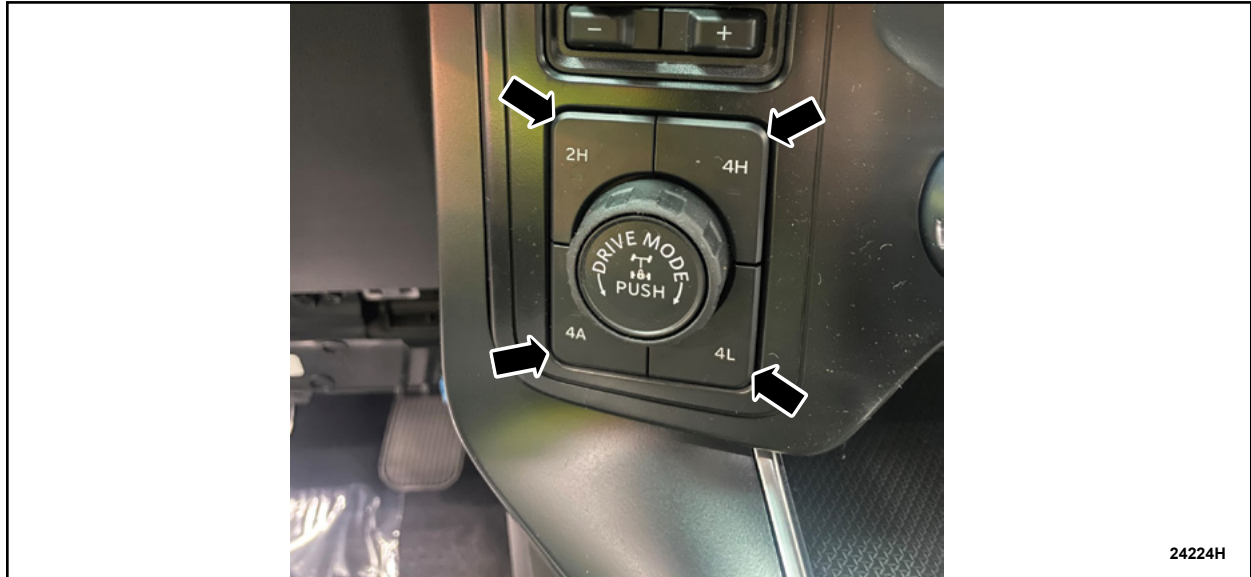
FIGURE 8

14. Verify the four wheel drive buttons are functional. See Figure 8.

- a. Cycle through all four mode buttons checking for sticking.
- b. Verify each button light turns on and off.

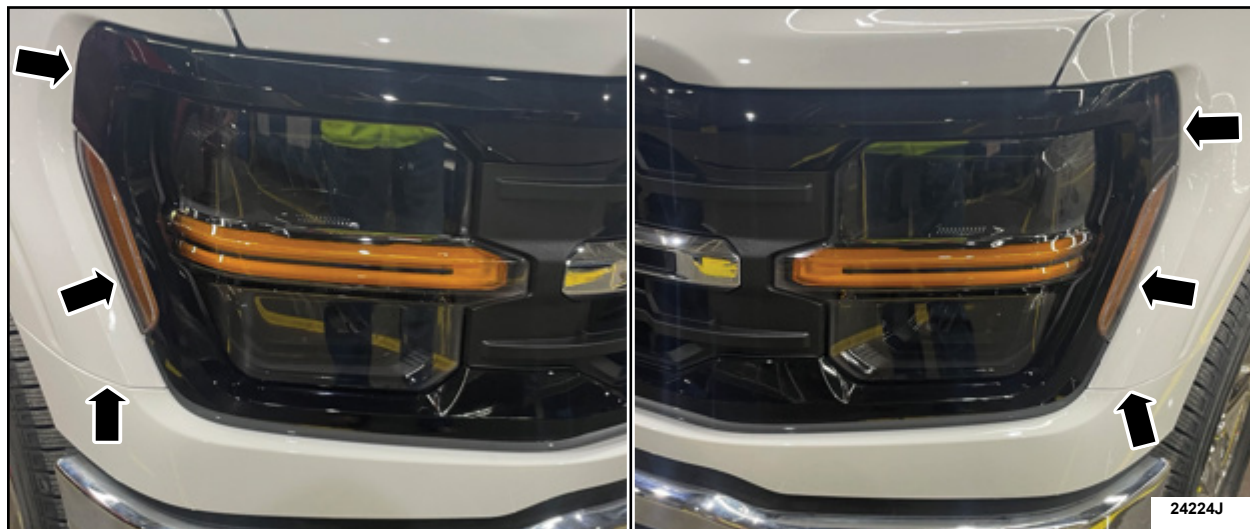
FIGURE 11

18. Verify the headlamp, tail lamp and CHMSL for fit, function and any signs of obvious damage. See Figure 11.

NOTE: Headlamps shown, inspection for tail lamps and CHMSL similar.

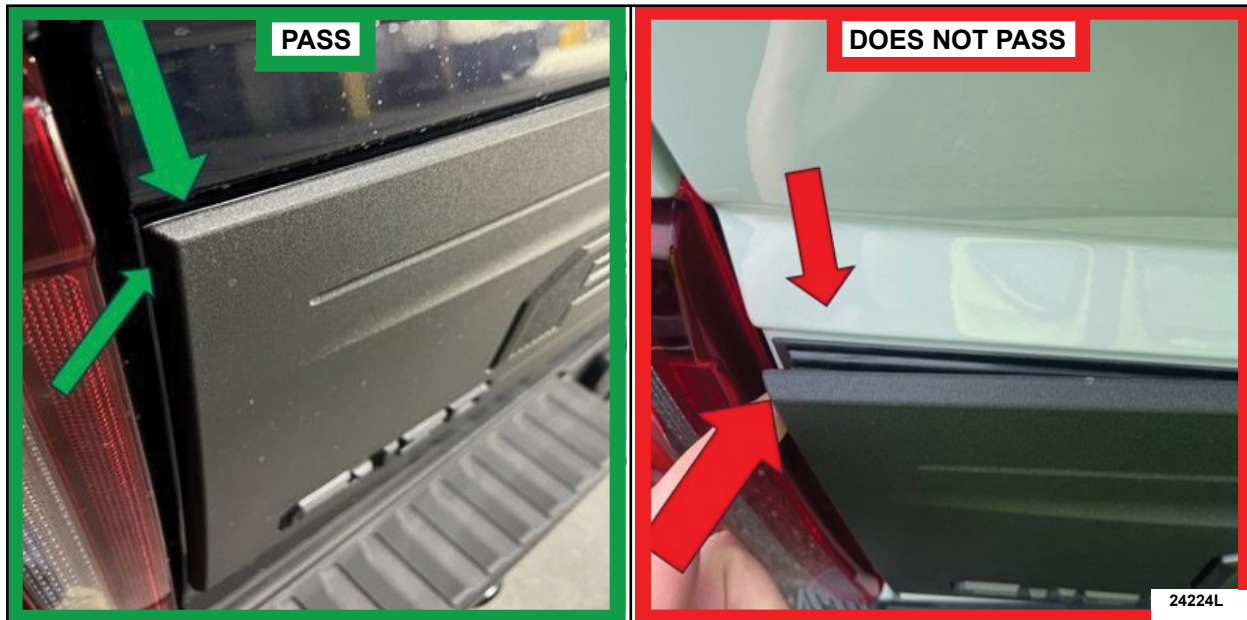
FIGURE 12

19. Verify all four doors open and close freely, without binding, rubbing and/or noise.
20. Check that all the badges are correct, present and undamaged.
 - Front Grill
 - Fenders
 - Charge Port (if equipped)
 - Pick-up Box
21. Verify the front and rear bumper parking aid sensors are fully seated.
22. Check the tailgate for function.
 - a. Cycle open and close a total of 5 times.
 - b. Verify that the rear camera is fully seated.
23. **For Raptor Vehicles Only:** Check ALL four corners of the tailgate for applique delamination. See Figure 12.

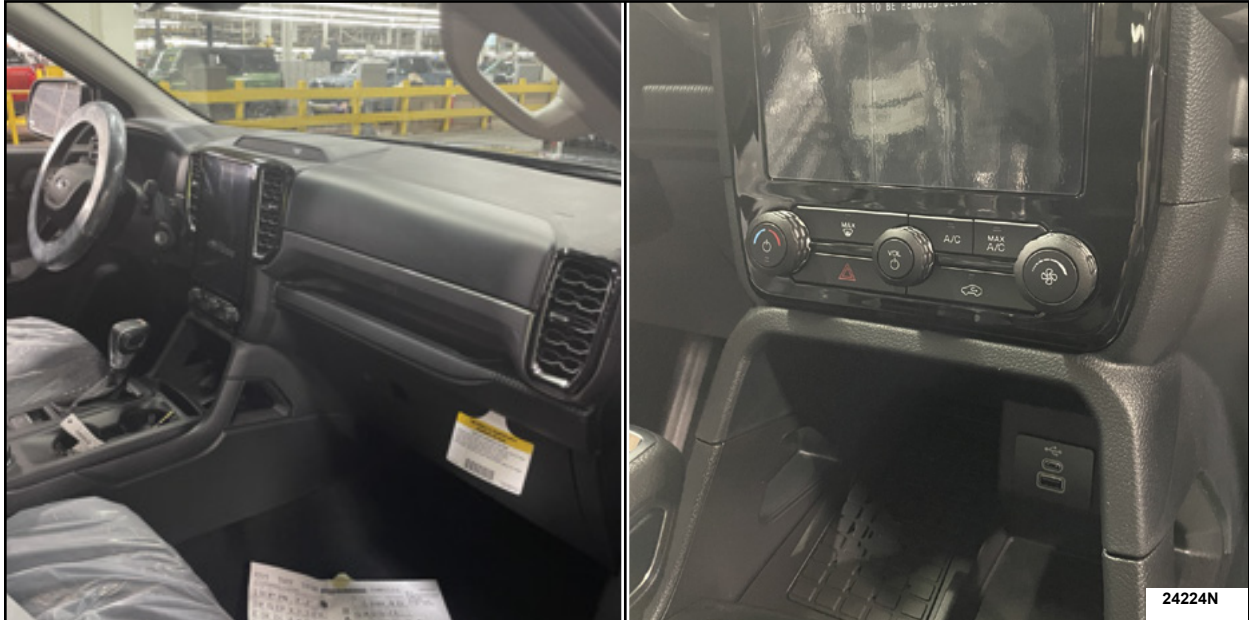
FIGURE 2

4. Inspect the Instrument Panel (IP) for fit, finish, and for any loose, damaged or missing trim.
See Figure 2.

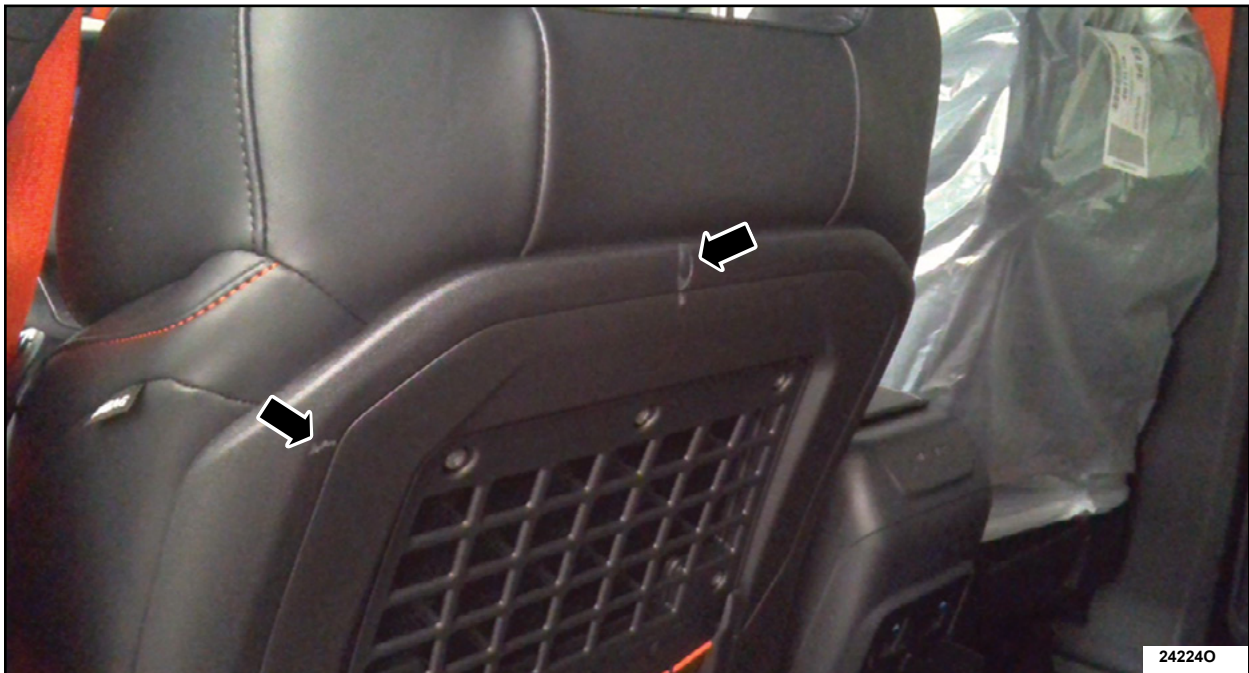
FIGURE 3

5. Check all seats for defects, tears or wrinkles. See Figure 3.

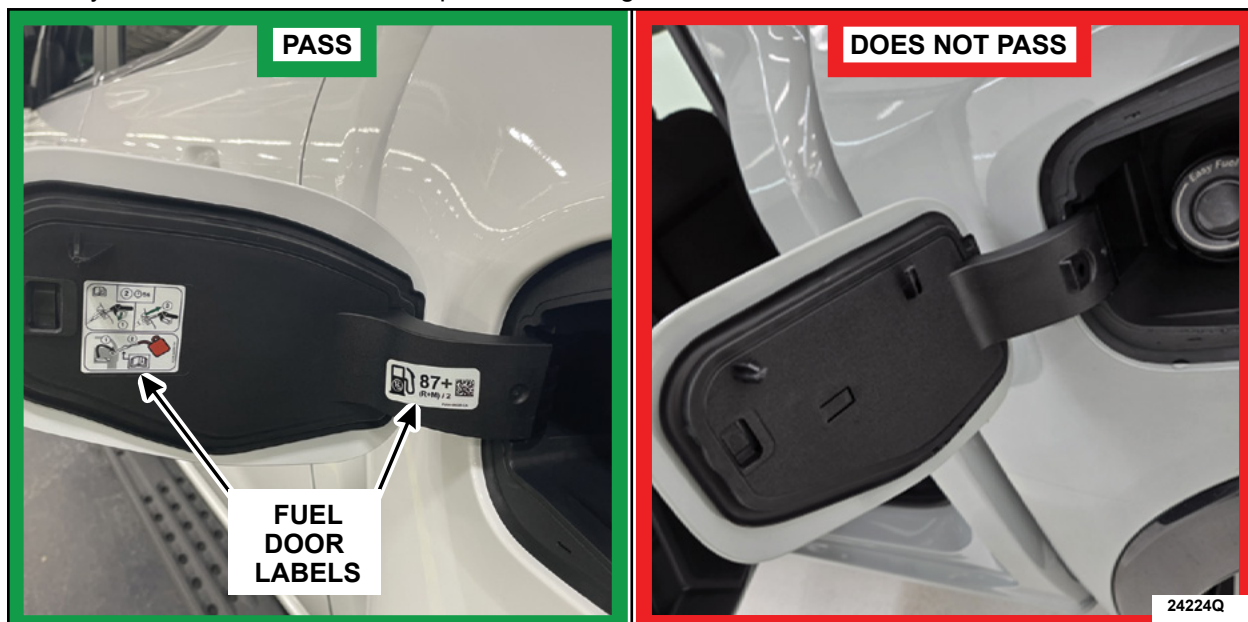
FIGURE 4

9. Verify the fuel door fuel labels are present. See Figure 4.
