**Taycan - Squeaking Noises from Front Seats**

**Vehicles Affected**

Models	Model Year	Model Type	VIN Range	Vehicle-Specific Equipment
Taycan	As of 2020	Y1A, Y1B, Y1C	n/a	n/a

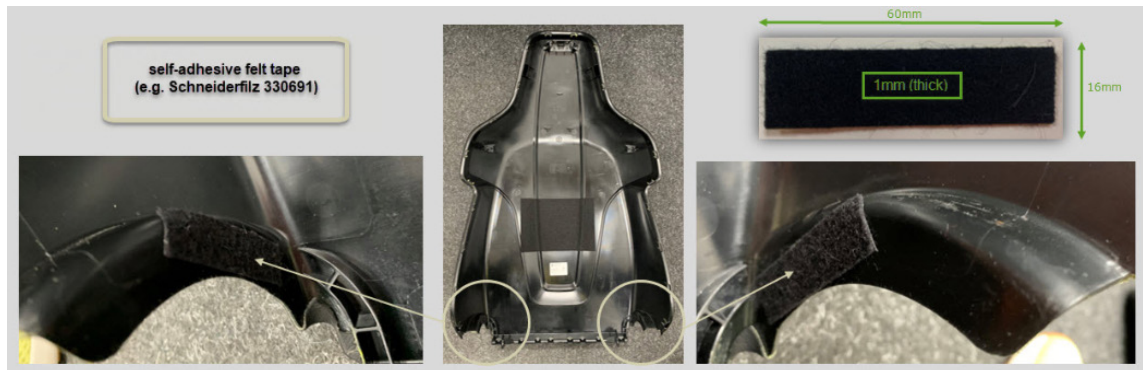
Figure 1 - Felt Application Points

The subject condition may be caused by multiple contact points within the seat assembly.

Please follow typical workshop procedures to locate and address contact points causing noise. The illustrations below show possible locations to apply felt tape or other insulating materials to address verified customer complaints. The materials listed are recommended but not required. The technician performing the repair must determine the best insulating materials and application locations.

Recommended insulating material:

999 551 140 40

999 551 138 40
