#### **Volvo Car USA LLC Technical Journal** Technical Journal Title Ref. No. SR PHEV ECM P0EA773 Auxiliary Cooling System Performance TJ 34123.1.7 Issuer (Dept.) Issue Date Status Date **Technical Service** 4/24/24 5/2/24 Car Market Partner Function Group United States and Canada 3 US 7510 Volvo Car USA, LLC 2647 Function Description Page Heater, Thermostat Page 1 of 4

If a vehicle experiences the code Engine Control Module (ECM) - P0EA773 "Auxiliary Cooling System Performance Mechanical Failures Actuator stuck closed" please follow the advice under "Service".

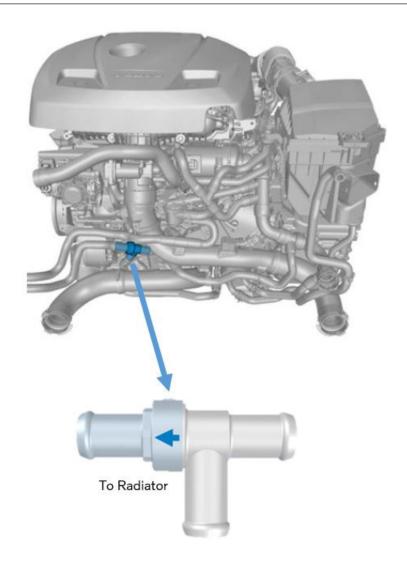
NOTE: Orientation of the component is critical to correct operation. See attached photo US34123\_Orientation\_Illustration.jpg

Please order and install component 32139082. This part number may be superseded by 32263957 & 32263958. These three part numbers are identical in function.

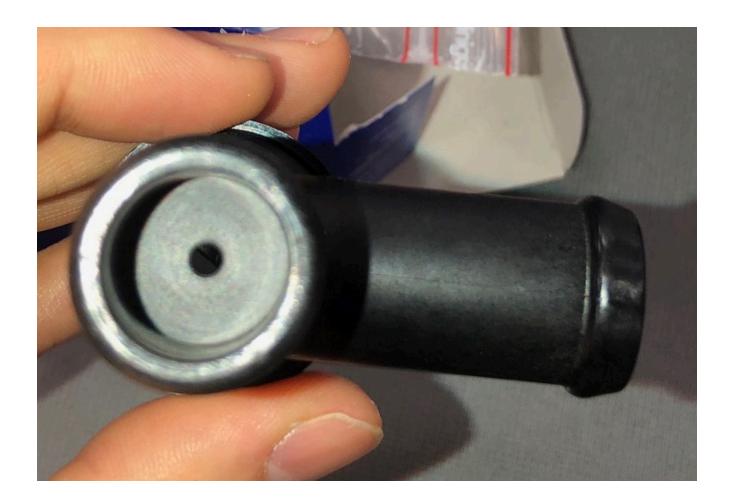
Verify that an updated design component is being installed. The updated design components can be recognized by the orifice visible from one side. See the attached photo as an example.
